Collision with terrain involving Air Tractor AT-502, VH-LIK

50 km east of Walgett Airport, NSW | 5 November 2016

ATSB Transport Safety Report
Aviation Occurrence Investigation
AO-2016-146
Final – 20 November 2018

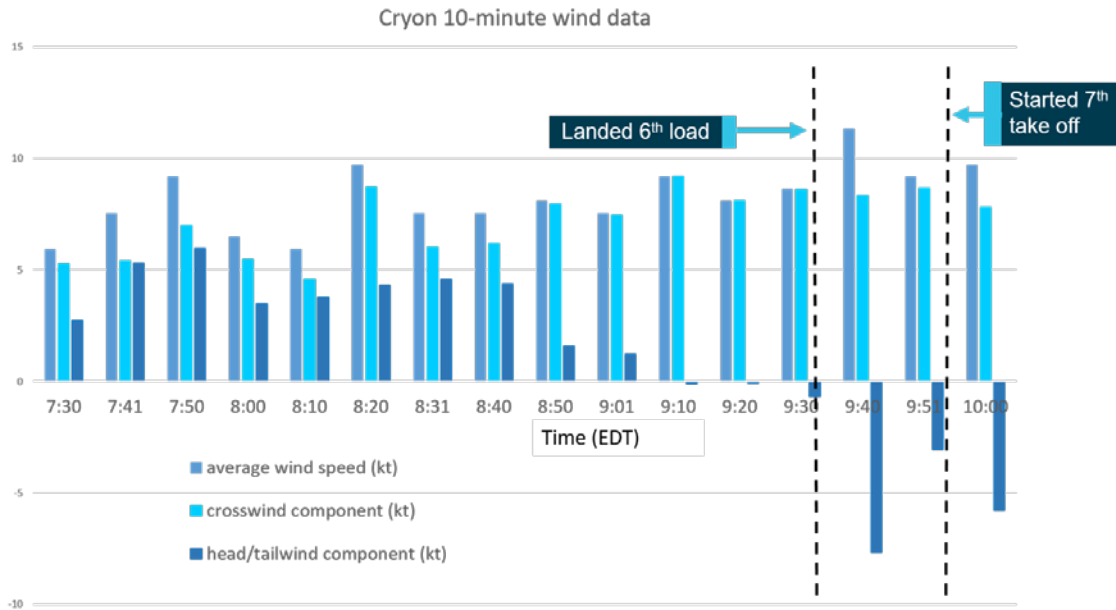
Figure 2: Recorded wind data at Cryon showing headwind and crosswind components for a runway heading 017° T

The average wind speed and direction for each 10-minute period was recorded at Cryon Station, about 7 km south-west of the accident airstrip. Figure 2 shows the recorded 10-minute data divided into the crosswind and tailwind components for the runway heading 017° True. During the 24 minutes the pilot was on the ground between the sixth and seventh loads, the average wind speed increased to about 11 kt and changed direction so that there was a tailwind of about 6 kt and a crosswind of about 8 kt for the final take-off. Shortly after take-off, the aircraft turned to track in a more north-easterly direction (Figure 6), which would have increased the tailwind component by about 1.5 kt.

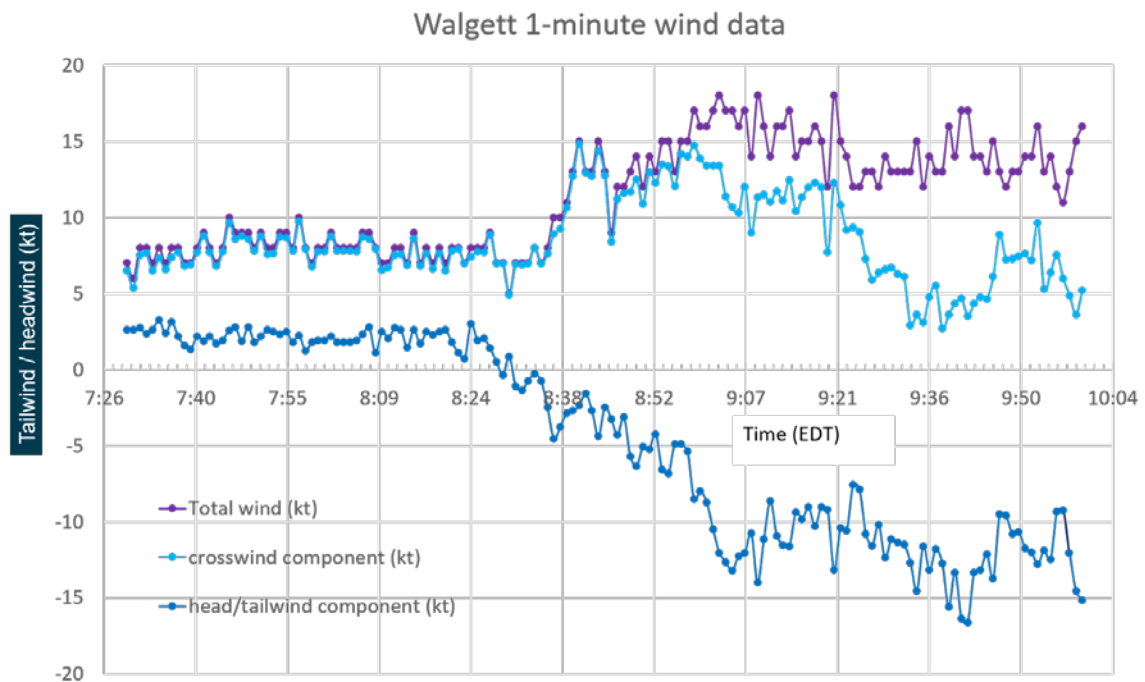
Figure 3: Recorded wind data at Walgett Airport showing tailwind and crosswind components for runway heading 017° T

South-westerly winds at Walgett were at 14 kt, gusting to 20 kt between 0930 and 1000. Figure 3 shows the crosswind and tailwind components for the runway heading 017° True if the wind at the accident site was similar to that recorded at Walgett Airport.

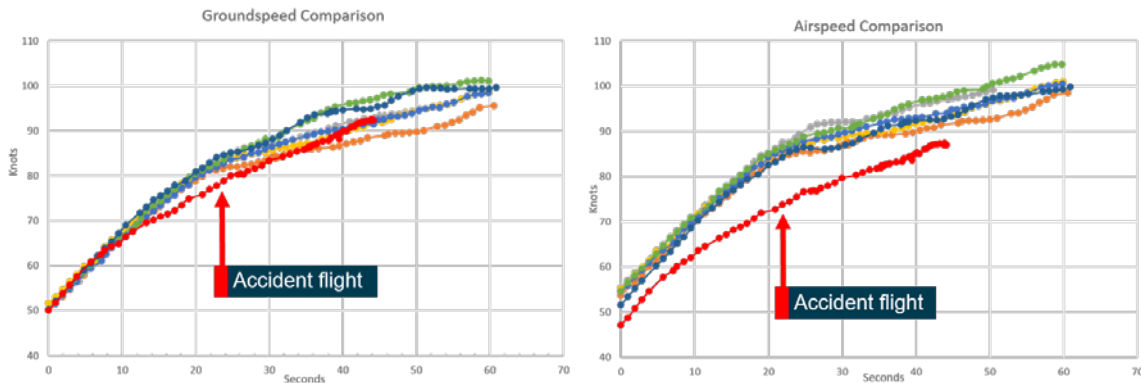
Figure 4: Comparison of LIK's seven flights from the day of the accident – groundspeed (left) and airspeed (right) calculated from recorded groundspeed and adjusted for recorded wind

Data from the seven flights (loads) that day were recovered from the device and the accident flight was compared with the first minute of the six previous flights (Figure 4). On each flight, the system started recording when the aircraft reached 50 kt on the take-off run and stopped when the aircraft decelerated below 50 kt during the landing roll.

Based on the recorded groundspeed and 10-minute average wind data at Cryon, the aircraft's maximum airspeed on the accident flight was about 87 kt (and 80 kt based on the Walgett 1-minute data) immediately before impact.

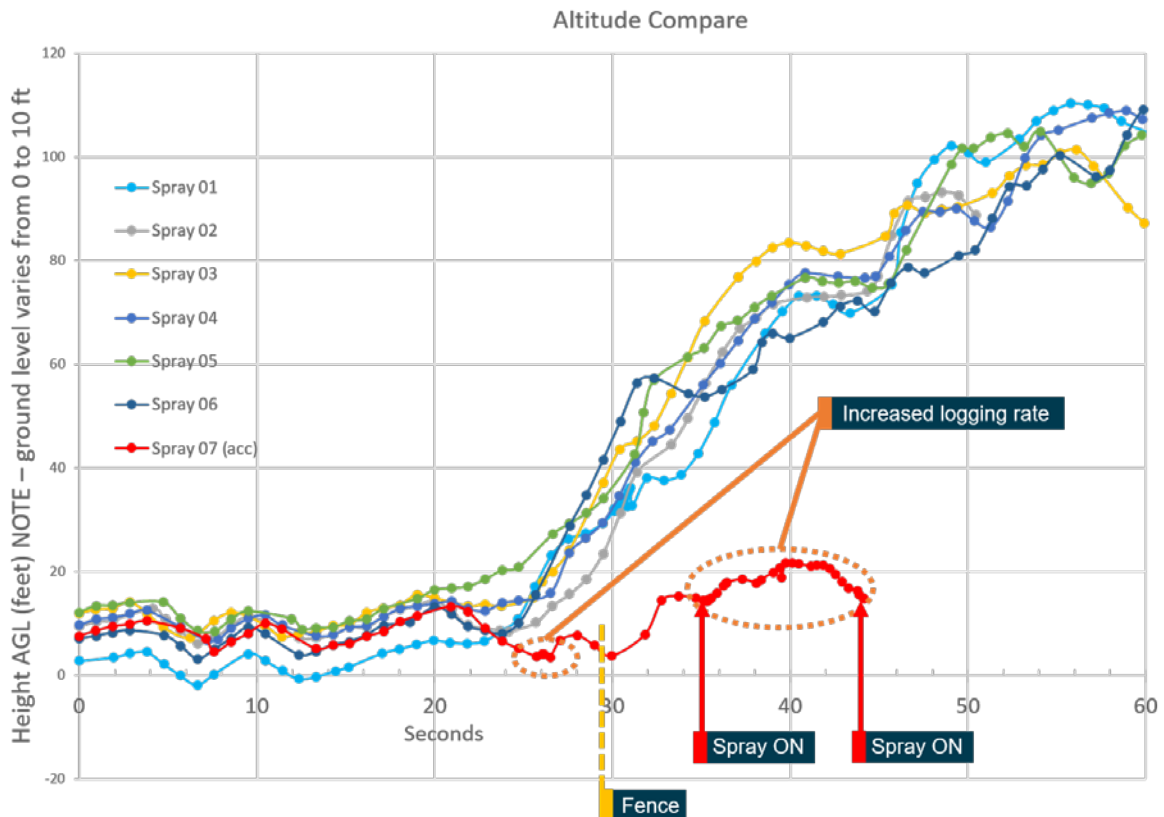
Figure 5: Navigation system recorded data comparing the aircraft's recorded height above ground on the day's flights

Altitude data from the day's flights revealed that the aircraft did not climb more than 20 ft above the ground on the final take-off. The data does not depict the exact flight profile and height due to data accuracy limitations (the 'ground level' for the accident take-off varies between about 5 and 10 ft), but provides a reliable comparison of the flights (Figure 5).

At 0954:19 on the final take-off, 26 seconds into the recording the system briefly recorded at a higher rate without the spray discrete parameter activating (Figure 5). This occurred just before the aircraft reached a one-metre high fence, about 1.3 km beyond the start of the runway.

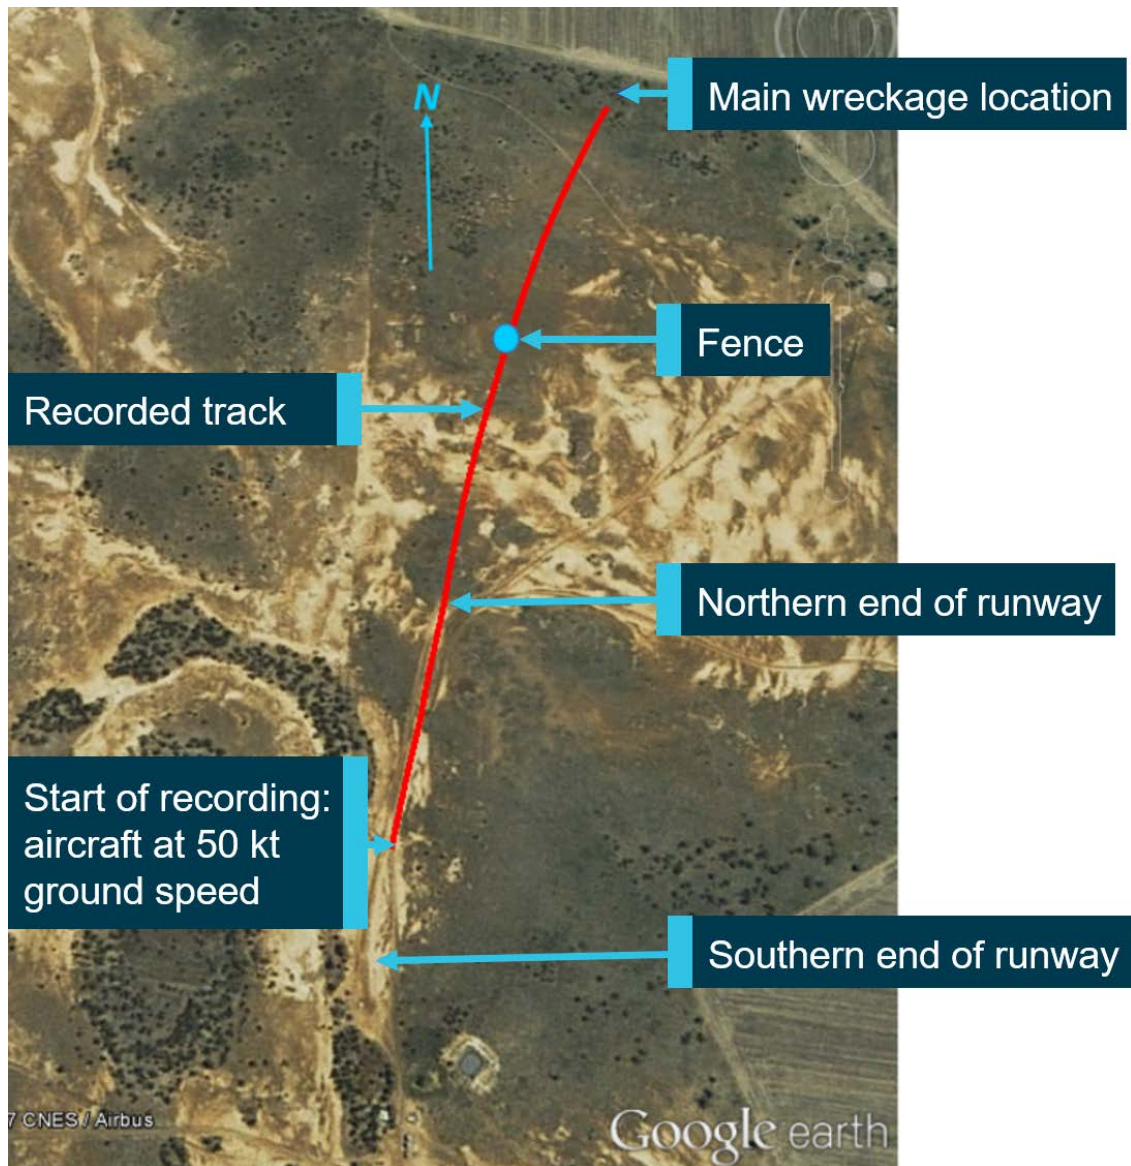
Figure 6: Recorded aircraft track for accident flight

The aircraft's recorded flight path on the accident flight showed the aircraft's take-off and a turn gradually to the right, consistent with previous flights and in the direction of the target area to be sprayed on that load (Figure 6).
