Collision with water involving de Havilland Canada DHC-2 Mk 1 (Beaver), VH-NOO

Jerusalem Bay (Hawkesbury River), New South Wales, on 31 December 2017

ATSB Transport Safety Report
Aviation Occurrence Investigation
AO-2017-118
Interim – 20 December 2018

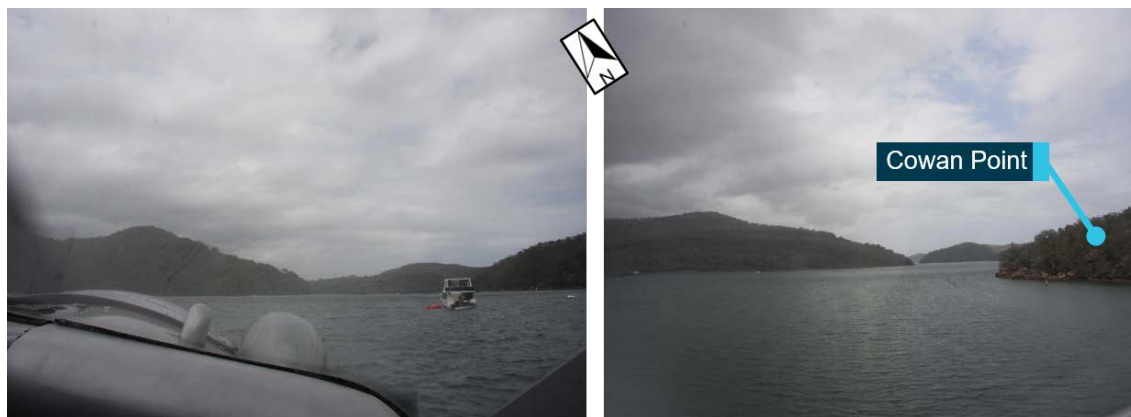
The passenger photographs showed that, at about 1505, the aircraft commenced taxiing toward the designated take-off area in Cowan Creek as per the operator's authorised landing area (ALA) procedure (refer to section titled *Cottage Point departure*) (Figure 2). At about 1512, the aircraft had become airborne and was at an altitude of about 43 ft³ above the water, approaching Cowan Point.

Figure 2: Passenger photograph taken through the front windscreen while taxiing to the designated take-off area (left) and shortly after becoming airborne (right)

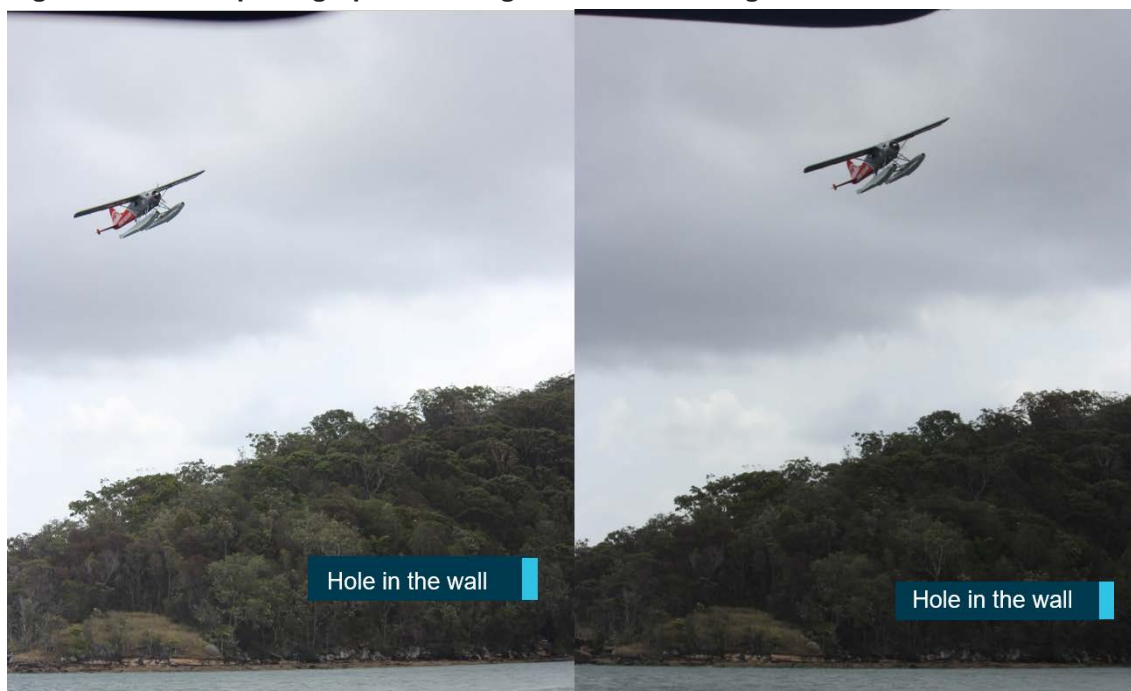
The aircraft climbed straight ahead for about 2 km before commencing a right turn into Cowan Creek, heading towards the main Hawkesbury River, at a bank angle estimated to be about 20°. A witness on the river who was travelling across Cowan Creek towards Halletts Beach provided the ATSB with photographs (Figure 3) of the aircraft turning near the Hole in the Wall (Figure 4).

Figure 3: Witness photographs showing the aircraft turning near the Hole in the Wall

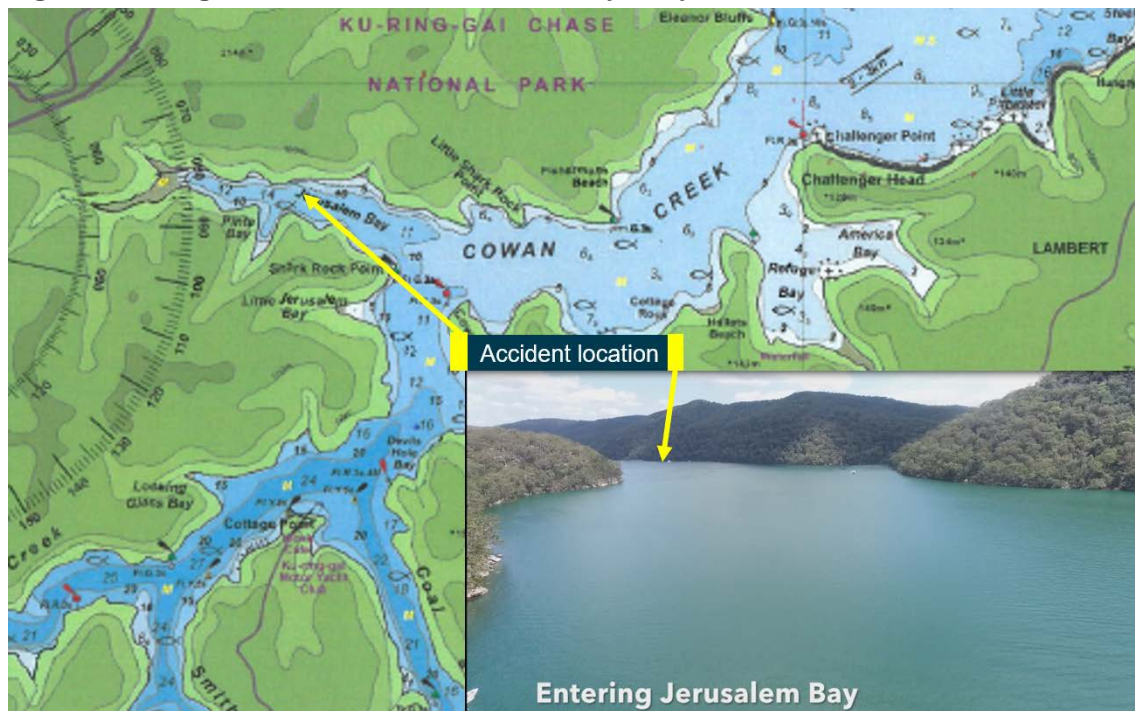
The aircraft was observed by several witnesses to then head directly towards Jerusalem Bay at an altitude below the height of the surrounding terrain (Figure 4 and Figure 5). Several witnesses

Figure 5: Cottage Point area with Jerusalem Bay entry viewed from Cowan Creek

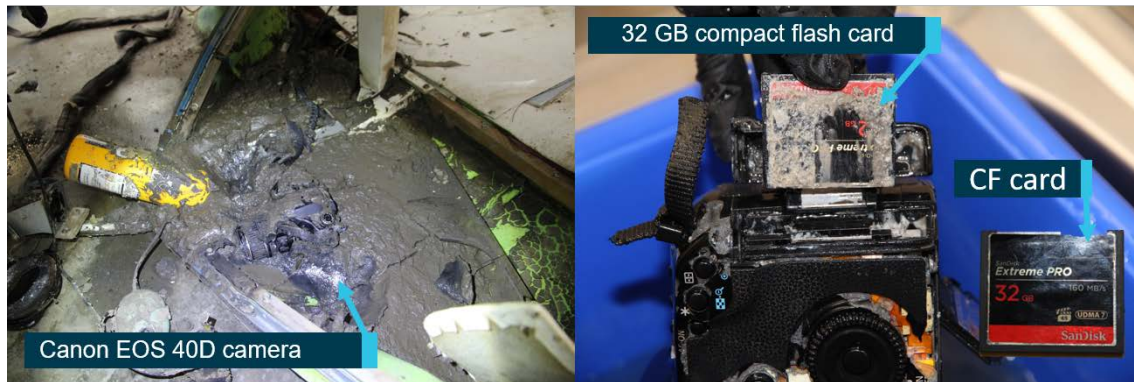
During the aircraft examination, a Canon EOS 40D digital single-lens reflex camera (DSLR) containing a compact flash (CF) card was found inside the cabin (Figure 9). The camera was identified as belonging to the front right seat passenger.

Figure 9: Passenger camera as found in the aircraft (left) and CF card removal (right)

The CF card (Sandisk 32 GB Extreme PRO 160 MB/s) was cleaned and dried before X-ray examination. Corrosion was identified and the card was unable to be read directly by the ATSB's standard card reader. The four memory chips and one controller chip were removed from the CF card and transplanted onto a donor CF card circuit board.

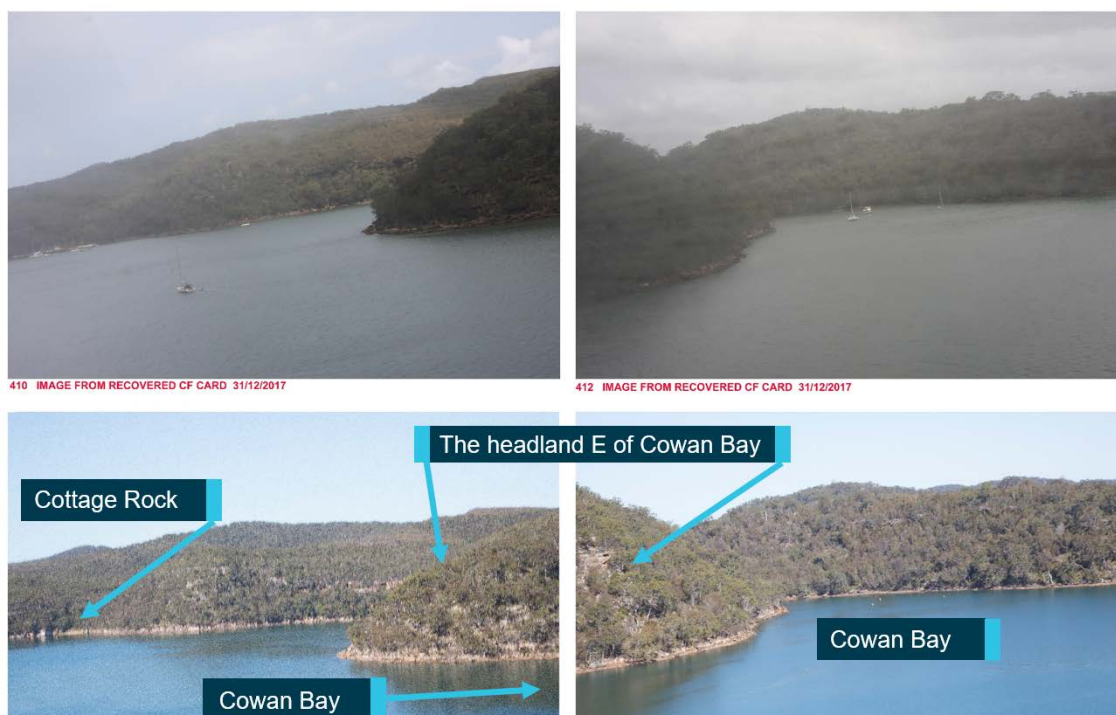
The right turn was observed to continue above Little Shark Rock Point and Cowan Creek (Figure 4). The last photograph taken by the passenger was near Little Shark Rock Point, with the aircraft heading in a southerly direction towards Cowan Bay (refer to Figure 12 in section titled *Passenger camera*). At that time, the aircraft was estimated to be at an altitude of 175 ft.

Five⁸ photographs were taken while the passengers boarded the aircraft at Cottage Point at about 1457. An additional 22⁹ photographs were taken during the taxi and after becoming airborne from Cottage Point along Cowan Creek, from 1505 to 1512. These were taken through either the front windscreen or the front right passenger window. Nine¹⁰ of these photographs were taken while airborne over a 39-second interval. The last photograph on the CF card (412) was through the front windscreen with the aircraft in a right bank over Little Shark Rock Point heading south towards Cowan Bay (Figure 12).

Figure 12: Comparison photographs for CF card images 410 (looking right) and 412 (looking forward)

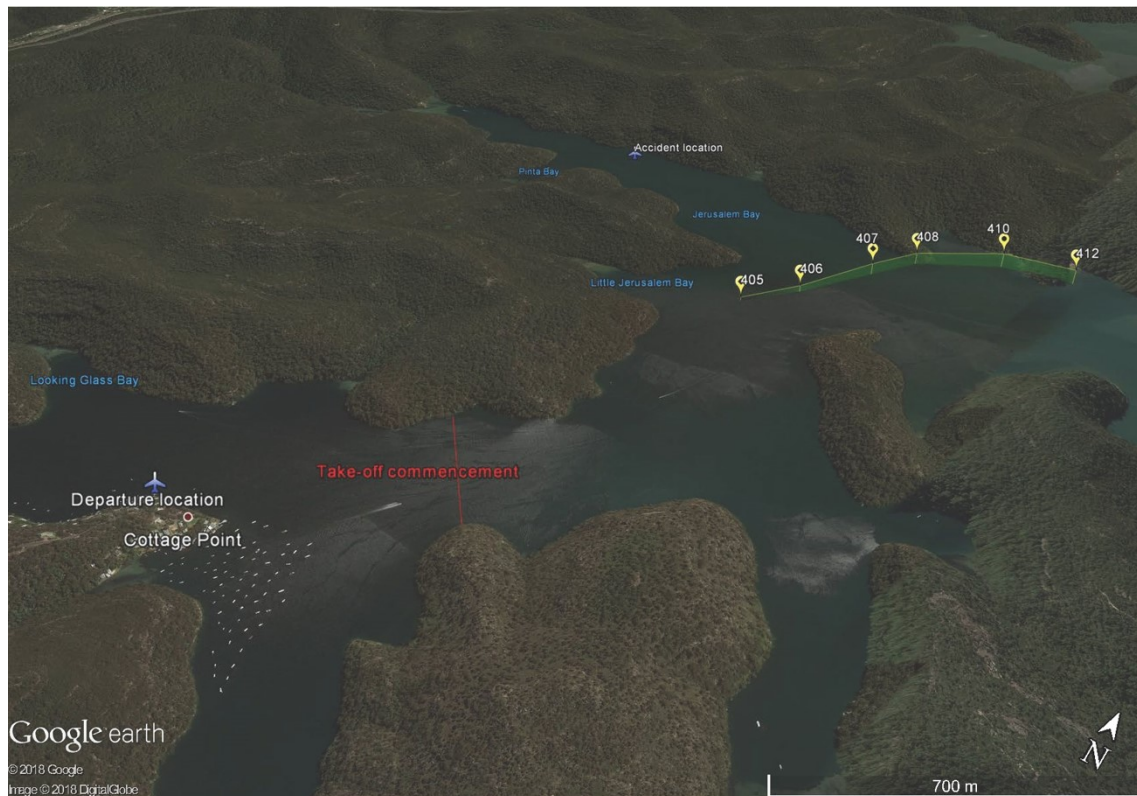
Using the information in Table 1, a flight path model was developed for the portion of the flight where camera images were available (Figure 13 and Figure 14).

Figure 13: View towards Jerusalem Bay of flight path developed from passenger images

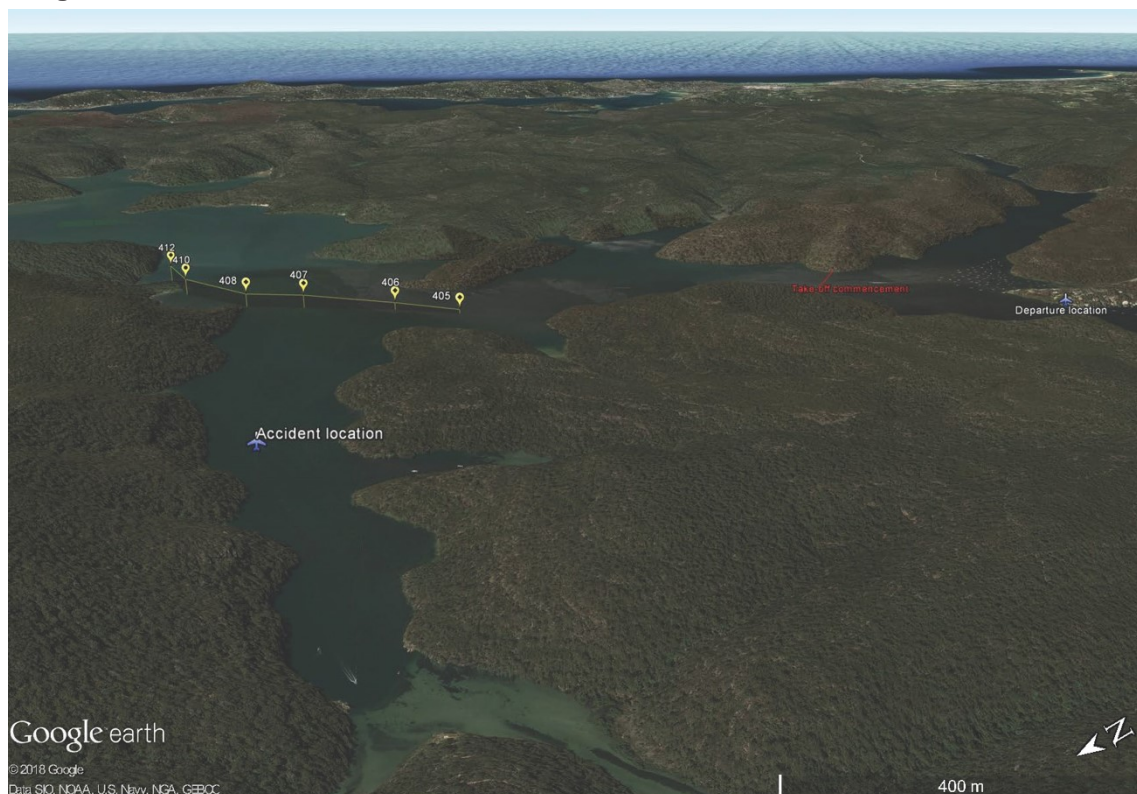
Figure 14: View towards Hawkesbury River of flight path developed from passenger images

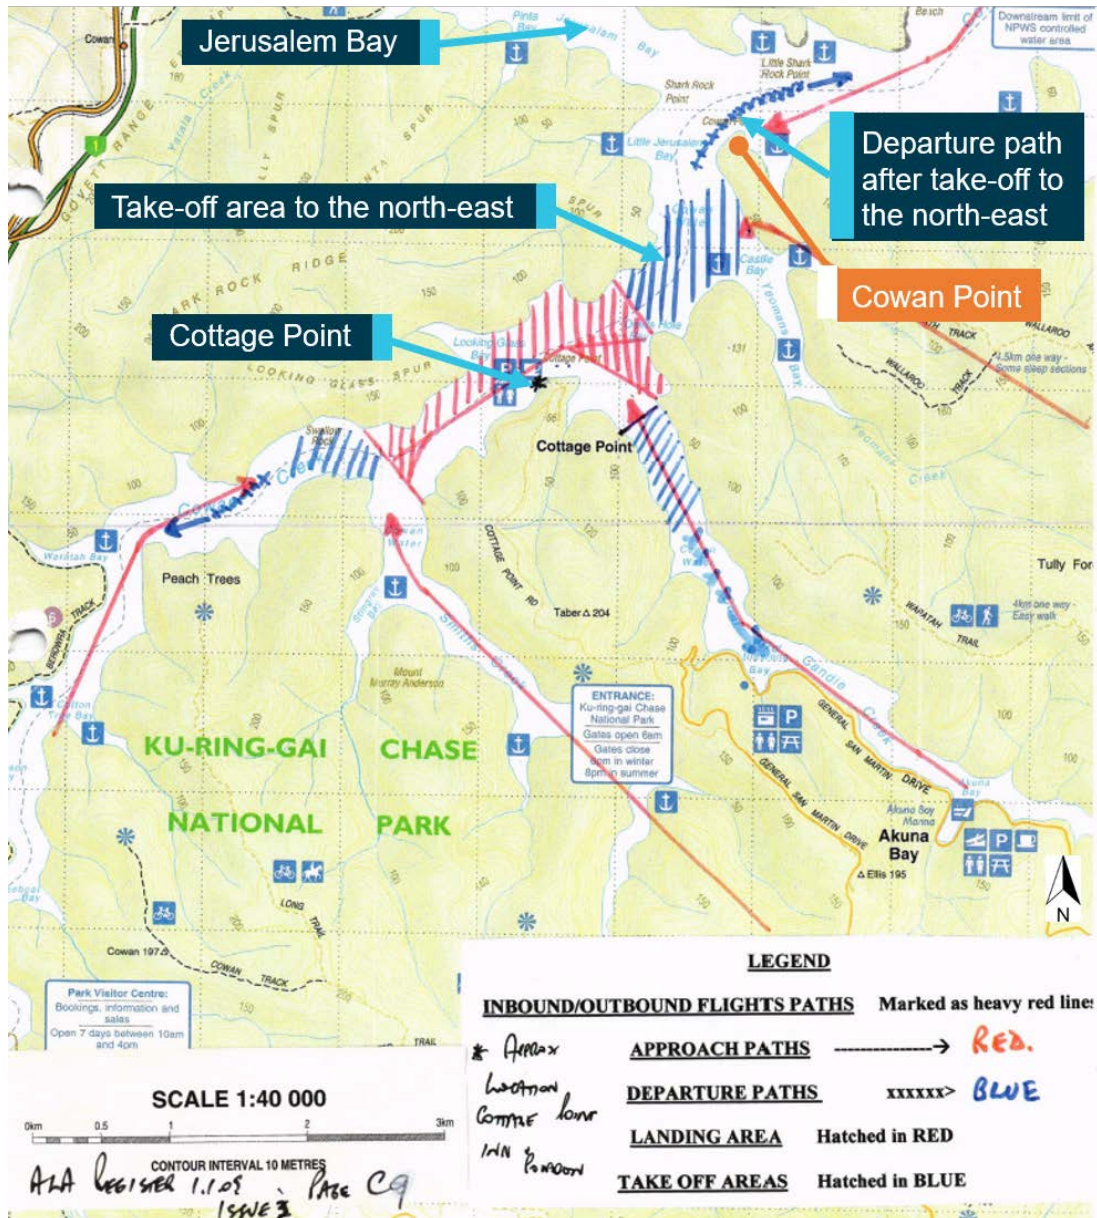
Figure 19 shows the recommended flight paths for Cottage Point. The blue hatching and crossed-lines respectively represent the take-off area and departure paths, while the approach paths and landing areas are shown in red. Specifically relating to the accident flight, the recommended take-off area was to the north-east of Cottage Point. After take-off, the departure path was to follow the river to the north-east passing Cowan Point.

The register also noted that there was limited very high frequency communications in the Cottage Point area due to terrain shielding. However, a relay of any radio broadcasts may be possible using overflying aircraft. In addition, it also stated that, if the wind conditions exceeded 30 kt, the ALA was considered unusable.

Figure 19: Cottage Point diagram of the recommended flight paths from the ALA register
