Hydraulic system failure involving Boeing 757, VH-TCA

Auckland International Airport, New Zealand | 5 February 2018

Aviation Occurrence Investigation AO-2018-014 Final – 1 May 2019 Released in accordance with section 25 of the Transport Safety Investigation Act 2003

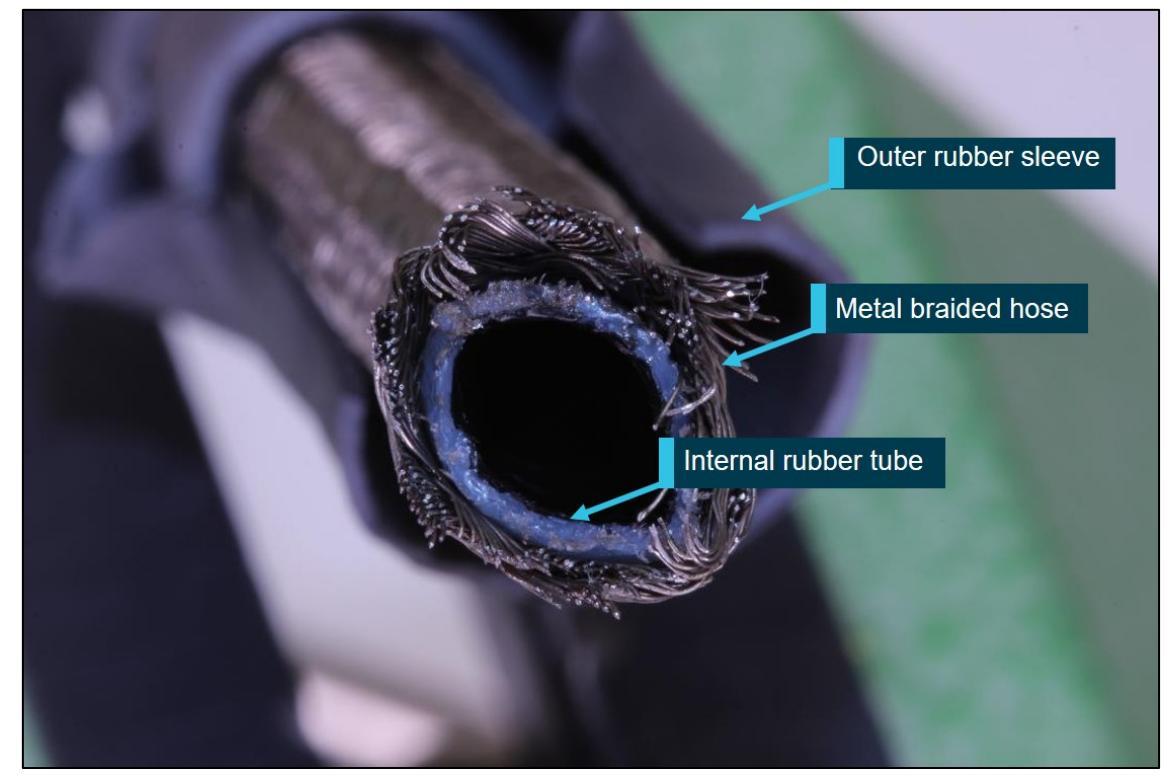
Figure 3: Hydraulic flex hose construction

The construction of the hydraulic flex hose consists of three layers; an internal rubber tube, housed in a braided metal hose³ and covered with a rubber sleeve (Figure 3).

The following observations were made during the analysis of the hose assembly:

- the chemical composition of the braid material fell within the required specifications
- the direction of the failed wires indicated that the braided hose failed under burst pressure
- the location of the rupture was not coincident with the maximum bend location on the hose, indicating the failure was not due to bending fatigue
- corrosion was limited to the rupture location, indicating that it was likely the wires corroded after the rupture (Figure 4)
- there was some evidence of ductile overstress on the individual wire filaments, but significant corrosion on the fracture surfaces made determination of the failure mode impossible
- no wear, cuts, abrasion or pinching on any of the layers of the hose was evident
- there was no evidence of manufacturing anomalies or kinking/twisting of the hose to indicate improper installation.
