Loss of engine power and forced landing involving amateur-built Europa Classic, VH-BWI

Near Bridport, Tasmania | 17 July 2016

ATSB Transport Safety Report

AO-2016-077

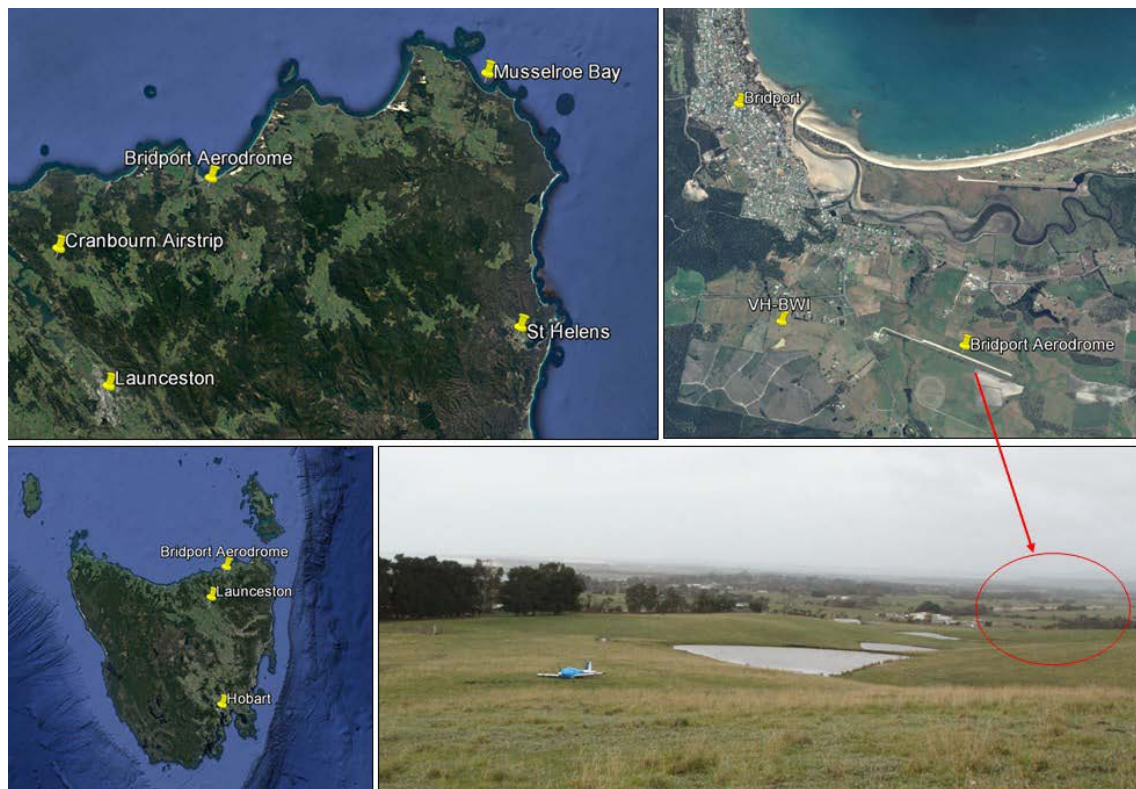
Figure 2: Google Earth map showing Bridport Aerodrome location and other locations mentioned in the report. VH-BWI forced landing location, about 1.5 km west of Bridport Aerodrome.

The engine initially appeared to recover a little before it and the propeller stopped completely, just prior to the forced landing. The aircraft bounced once, then slid for about 40 m before coming to a stop. BWI landed on an upward sloping paddock, about 1.5 km to the west of Bridport Aerodrome (Figure 2).
