Unreliable airspeed indication and stall warning involving Airbus A320, VH-FNP

near Perth, Western Australia, on 12 September 2015

ATSB Transport Safety Report
Aviation Occurrence Investigation
AO-2015-107
Final – 4 April 2019

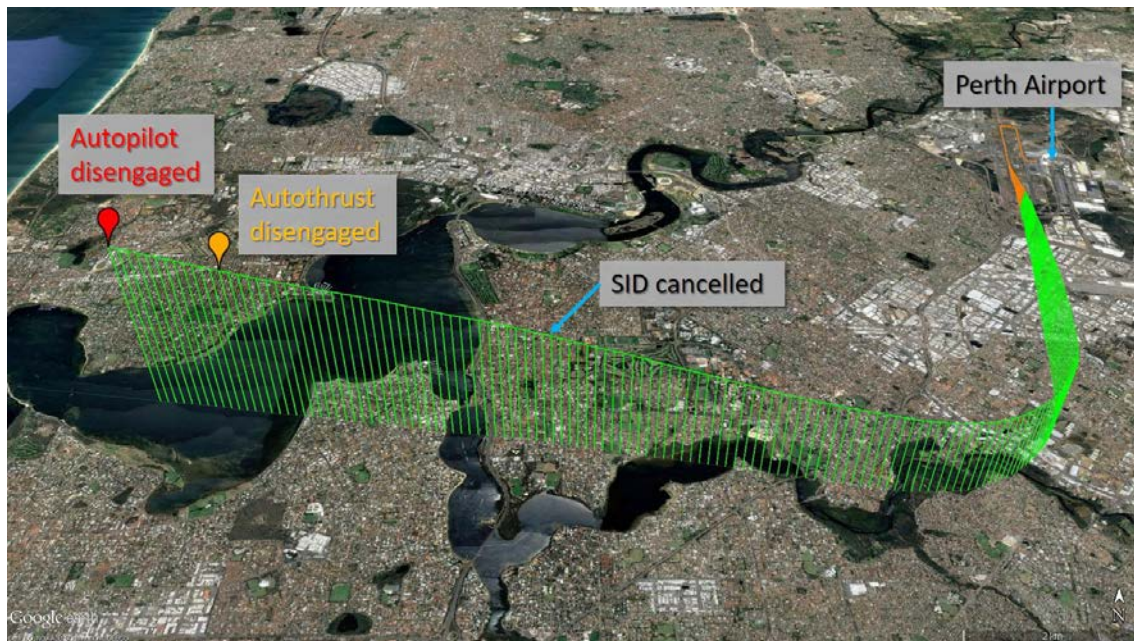
Figure 1: The flight path taken by VH-FNP when departing from Perth, up to the point that the autopilot disengaged

At 0654:39, as the aircraft was climbing through about 8,000 ft above mean sea level, the autothrust disengaged, generating an alert and locking the thrust at the current setting. Ten seconds later, the autopilot disengaged (Figure 1).

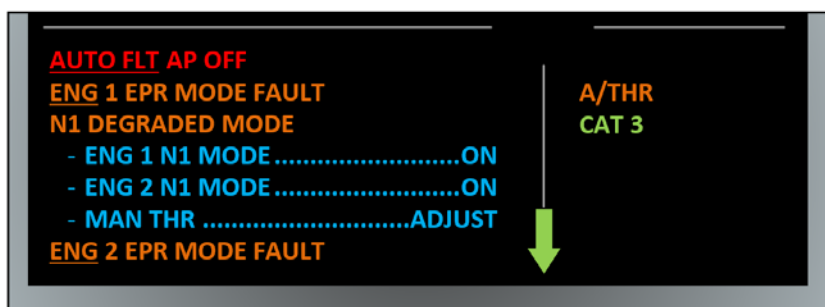
Figure 2: Representation of the ECAM messages presented to the flight crew when the autopilot disengaged⁹

The flight crew attempted to re-engage the autopilot, but without success. They then identified on the electronic centralised aircraft monitoring (ECAM) system an alert for engine 1 EPR mode⁸ fault (ENG 1 EPR MODE FAULT). At this point, the ECAM likely presented the following alerts to the flight crew (Figure 2).

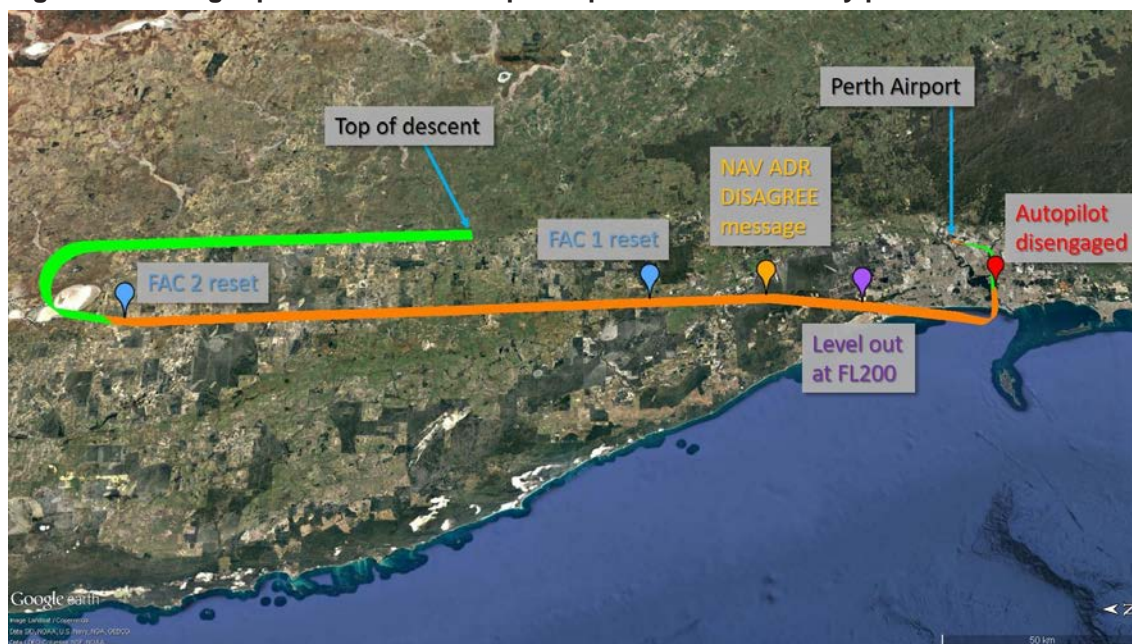
Figure 3: The flight path from take-off up to top of descent with key points identified

The flight from take-off to the top of descent, indicating where the key events took place is presented in Figure 3.

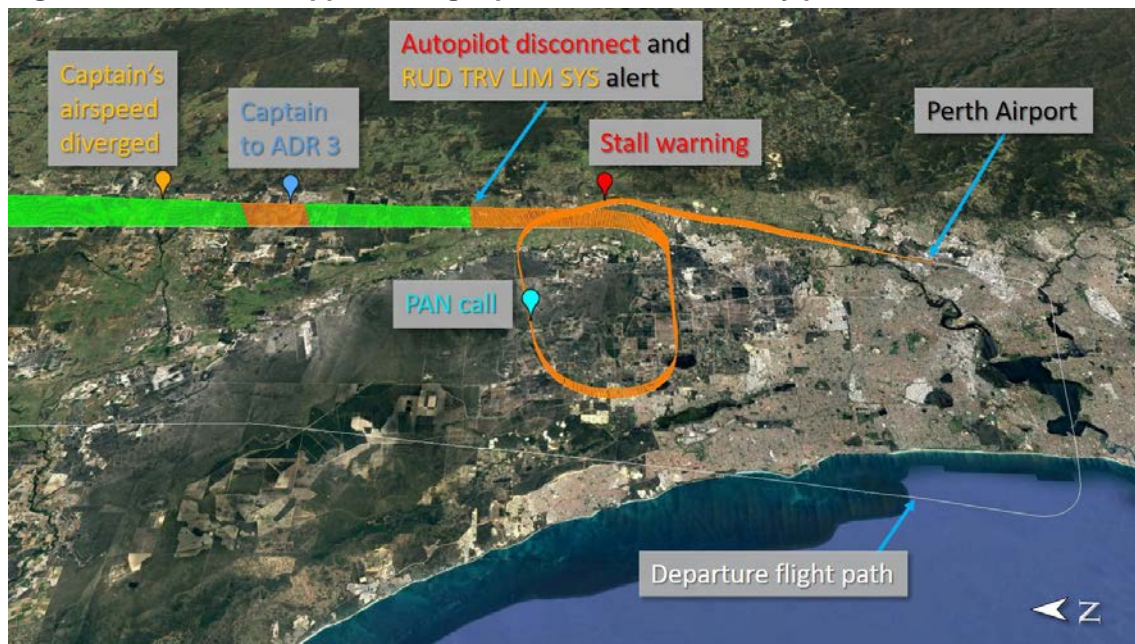
Figure 4: Descent and approach flight path into Perth with key points identified

The descent and approach flight path, with the key events identified, is presented in Figure 4.

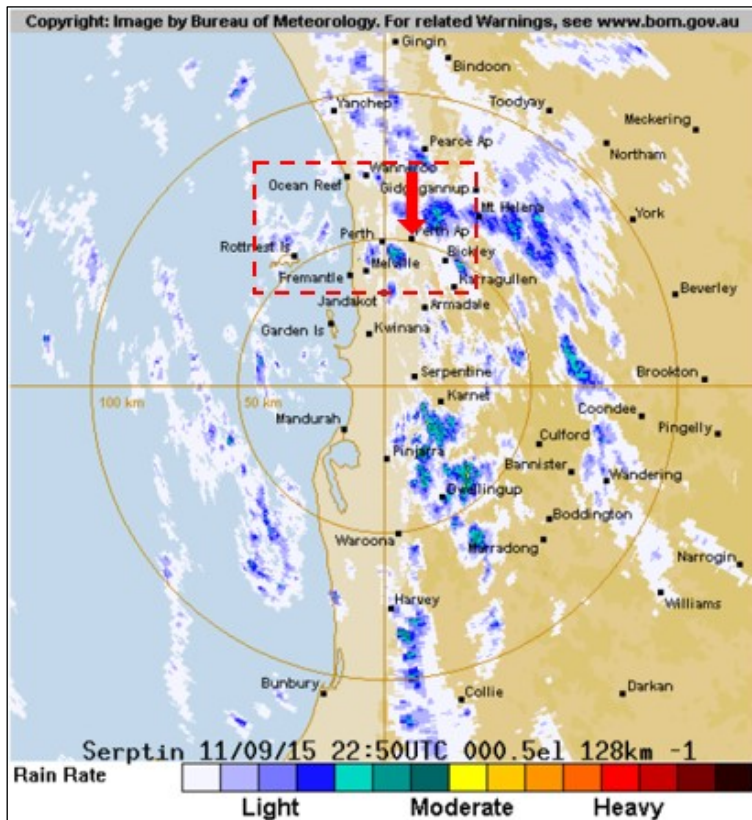
Figure 5: Perth weather radar image at 0650 (2250 UTC)

The weather radar for Perth showed that there were localised showers moving across the region. Figure 5 shows the rain showers in the area at 0650, the time that VH-FNP took off from Perth Airport. The showers were moving from the west towards the east.

The flight crew reported that the aircraft was in instrument meteorological conditions (IMC)³¹ during the climb, and about 10 seconds before the autothrust disconnected, the cockpit voice recorder (CVR) captured the flight crew discussing showers when delaying their turn to the north. Given the flight crew's reports and the proximity of the flight path to the rain on the weather radar, it was likely that VH-FNP passed through, or along the edges of, a rain cell before the autothrust and autopilot disconnected.

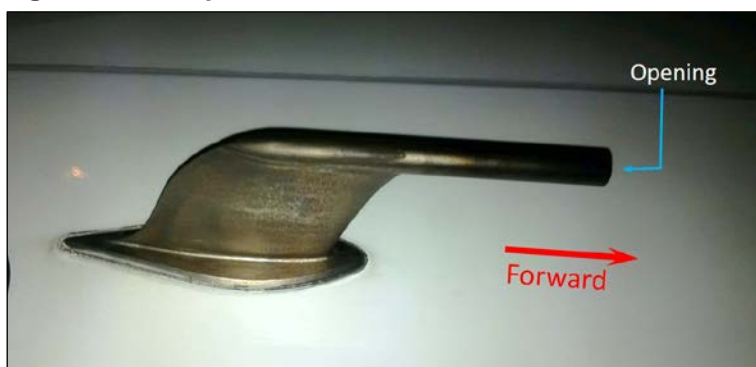
Figure 15: Pitot probe

The ATSB found that blocked drain holes in the pitot probes prevented water from being effectively discharged, resulting in erroneous airspeed measurements in all three systems at various times during the take-off and climb. The erroneous airspeeds were not detected by the flight crew, but had been detected by the system, resulting in the autothrust and autopilot disconnecting, and the generation of multiple alerts, including a NAV ADR DISAGREE alert. That alert required the flight crew to crosscheck the three airspeed indications and the result would indicate if they had an airspeed or angle of attack disagreement. Due to the limited space in the alert message area, the NAV ADR DISAGREE alert was initially pushed off the screen by engine related alerts that were programmed to have a higher priority.

The pitot probe is a tube with a forward facing opening mounted on the side of the fuselage (Figure 15). To ensure it has clean air, the opening of the probe is held away from the fuselage. To prevent water from blocking the probe, two small drain holes are drilled into the lower side of the probe.

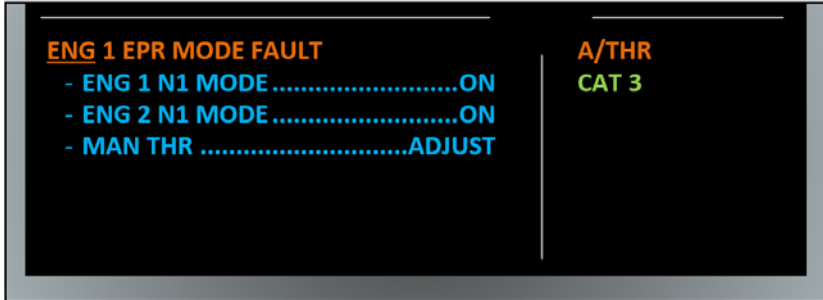
Figure 19: ECAM procedure – engine EPR mode fault

The flight crew discussions on the CVR indicated that the first ECAM message that they were aware of after the autopilot disconnected was the engine 1 EPR mode fault. The ECAM procedure required that the N1 mode be selected ON for both engines, and then the thrust be manually adjusted (Figure 19).

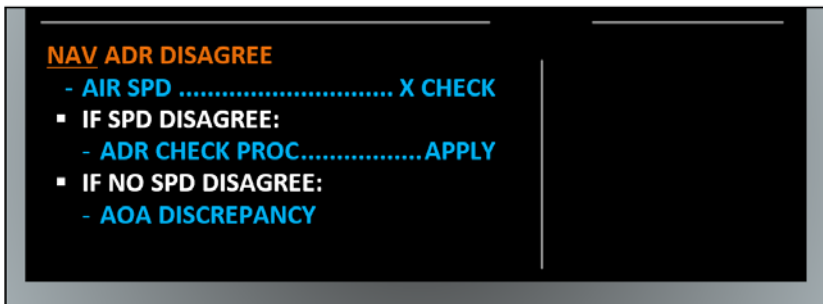
Figure 20: ECAM procedure – navigation ADR disagree

The ATSB also found that the NAV ADR DISAGREE alert and the associated procedure in the Airbus A320 may lead the flight crew to incorrectly identify the source of the alert (for example, angle of attack instead of airspeed) when there is a short-term disagreement in the airspeeds.

After the flight crew had cleared EPR mode faults for both engines 1 and 2, they were presented with an amber NAV ADR DISAGREE alert. The ECAM procedure for this alert first required the flight crew to cross-check [compare] the three airspeeds. If the airspeeds disagree, the procedure refers the flight crew to apply the ADR check procedure. If there is no airspeed disagreement, the flight crew are directed to an angle of attack (AOA) discrepancy (Figure 20).

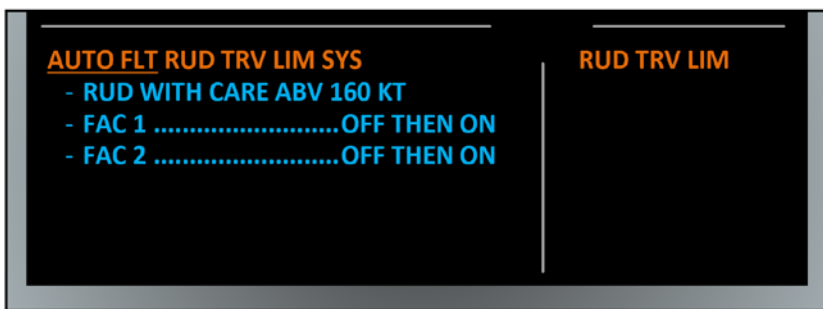
Figure 22: ECAM procedure – Auto flight rudder travel limiter system

After clearing the alternate law ECAM alert, the flight crew were presented with an amber auto flight rudder travel limiter system (AUTO FLT RUD TRV LIM SYS) alert. This alert is activated when both rudder travel limiter systems are inoperative. The ECAM message contains both advisory information regarding rudder use above 160 kt and flight crew actions associated with resetting the two FACs (Figure 22).

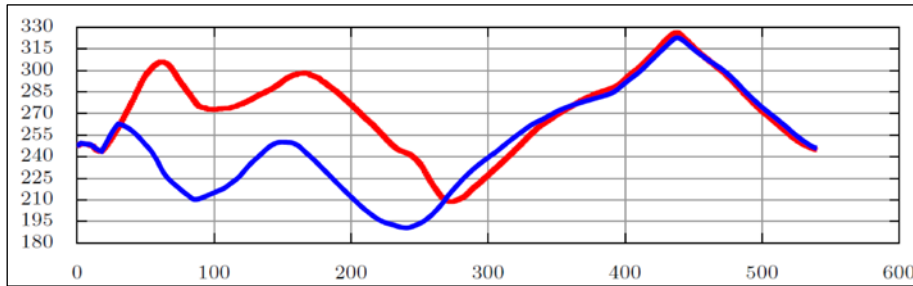
Figure 26: Airspeed estimation during the climb phase (recorded – red, estimated – blue)

The simulation showed that the recorded CAS 1 deviated from the actual airspeed for a period of about 4 minutes, before returning to the actual airspeed (Figure 26). The simulation showed that CAS 1 was overestimated by up to 60 kts. The estimated and recorded values reconverged at about 0700, shortly before the aircraft was levelled out at FL 200.

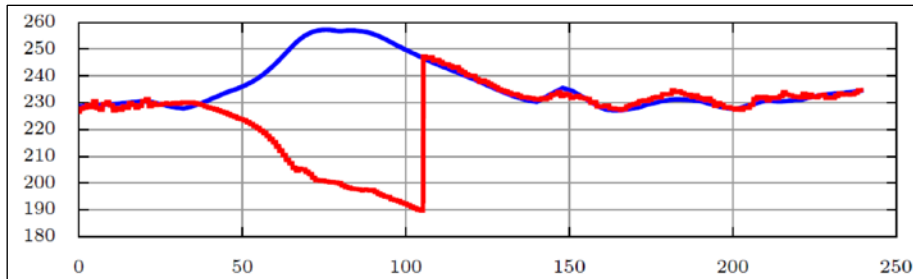
Figure 27: Airspeed estimation during the– descent phase (recorded – red, estimated – blue)

The simulation showed that CAS 1 deviated significantly from the actual airspeed (Figure 27). In this case, the recorded airspeed underestimated the airspeed by up to 60 kt, before the flight crew switched to ADR 3 at about 106 seconds. The correlation between the recorded and estimated airspeeds from this time onwards indicates that ADR 3 was correctly computing the airspeed.

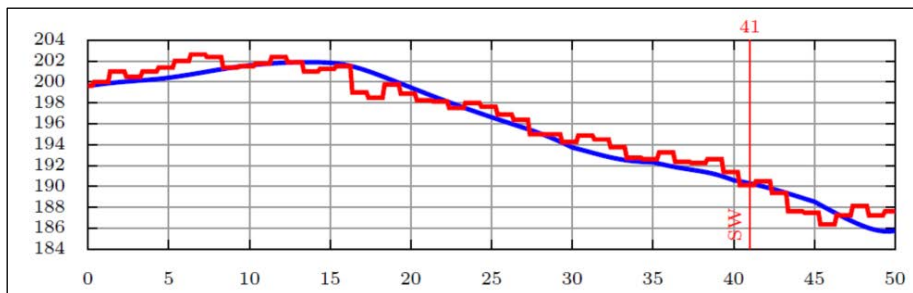
Figure 28: Airspeed estimation around the time of the stall warning (recorded – red, estimated – blue)

A period of 50 seconds, incorporating the stall warning at 0755:03, was simulated (Figure 28). This showed that, at this time CAS 3, which was the airspeed referenced on the captain's PFD, was consistent with the actual airspeed.

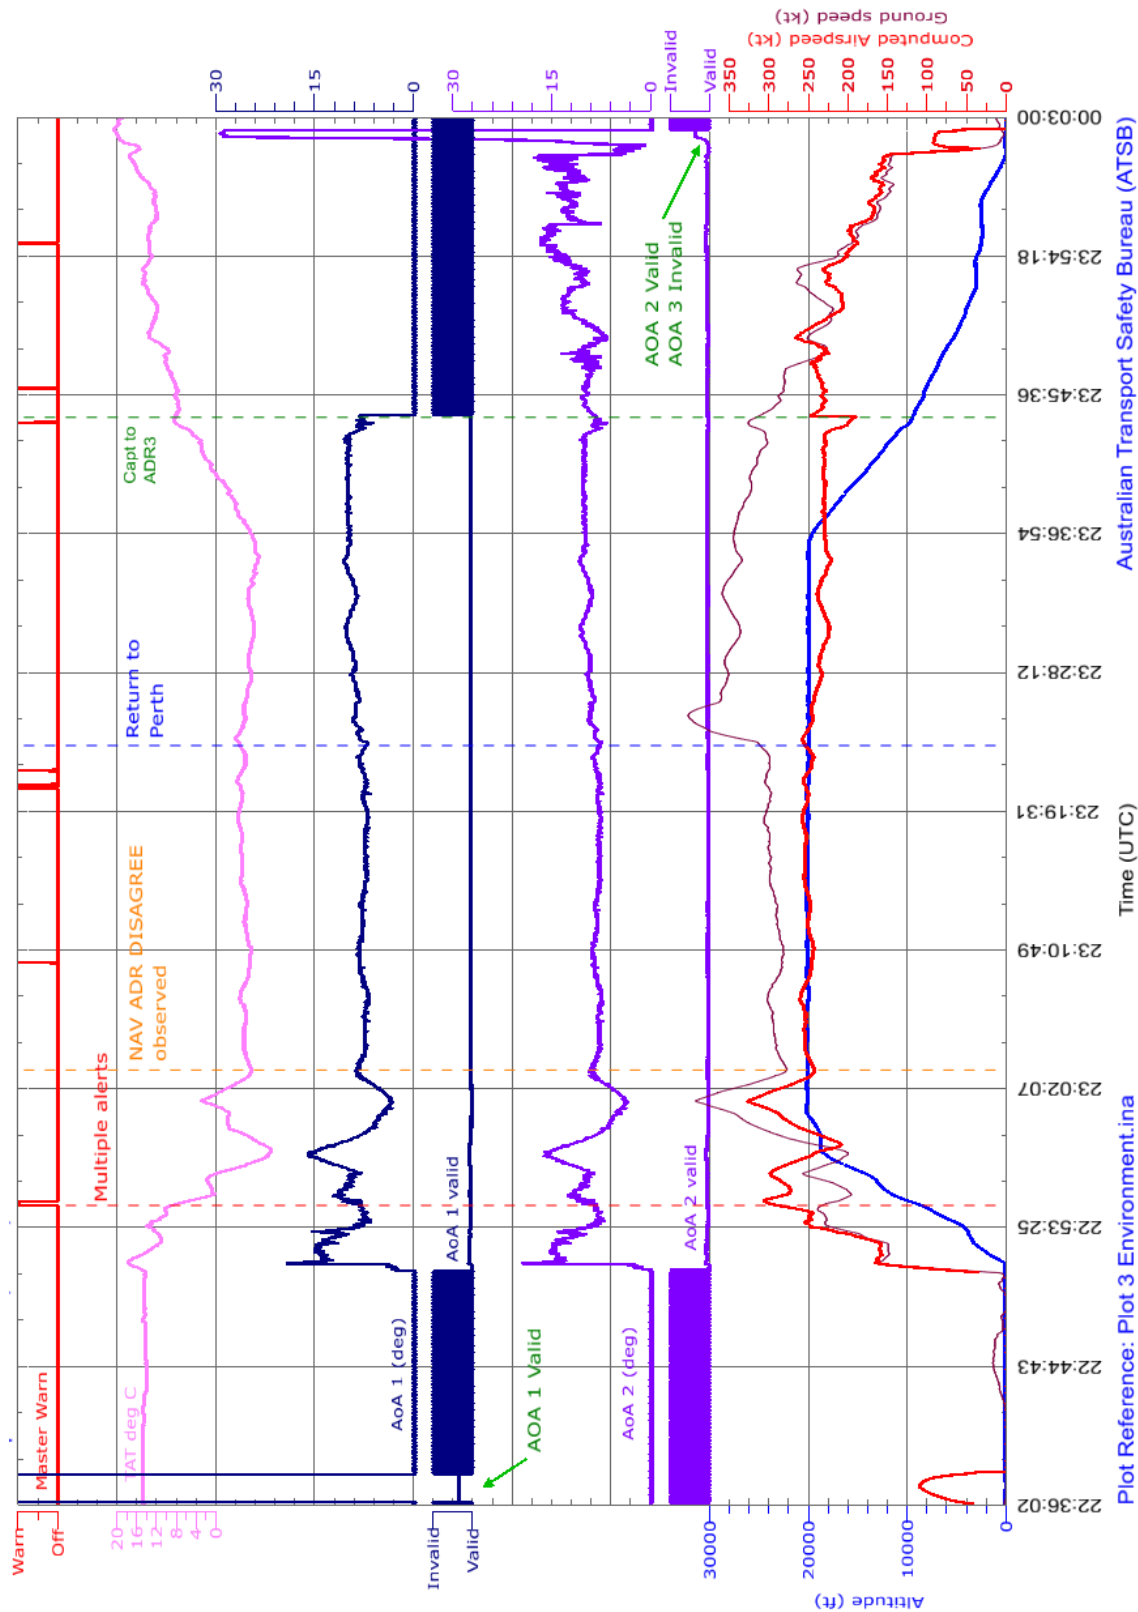
Figure C4: Flight data – environmental parameters (complete flight)

Note: The validity of the angle of attack (AOA) is inferred by its behaviour. When it cycles between maximum and minimum values, it is deemed invalid. Source: ATSB

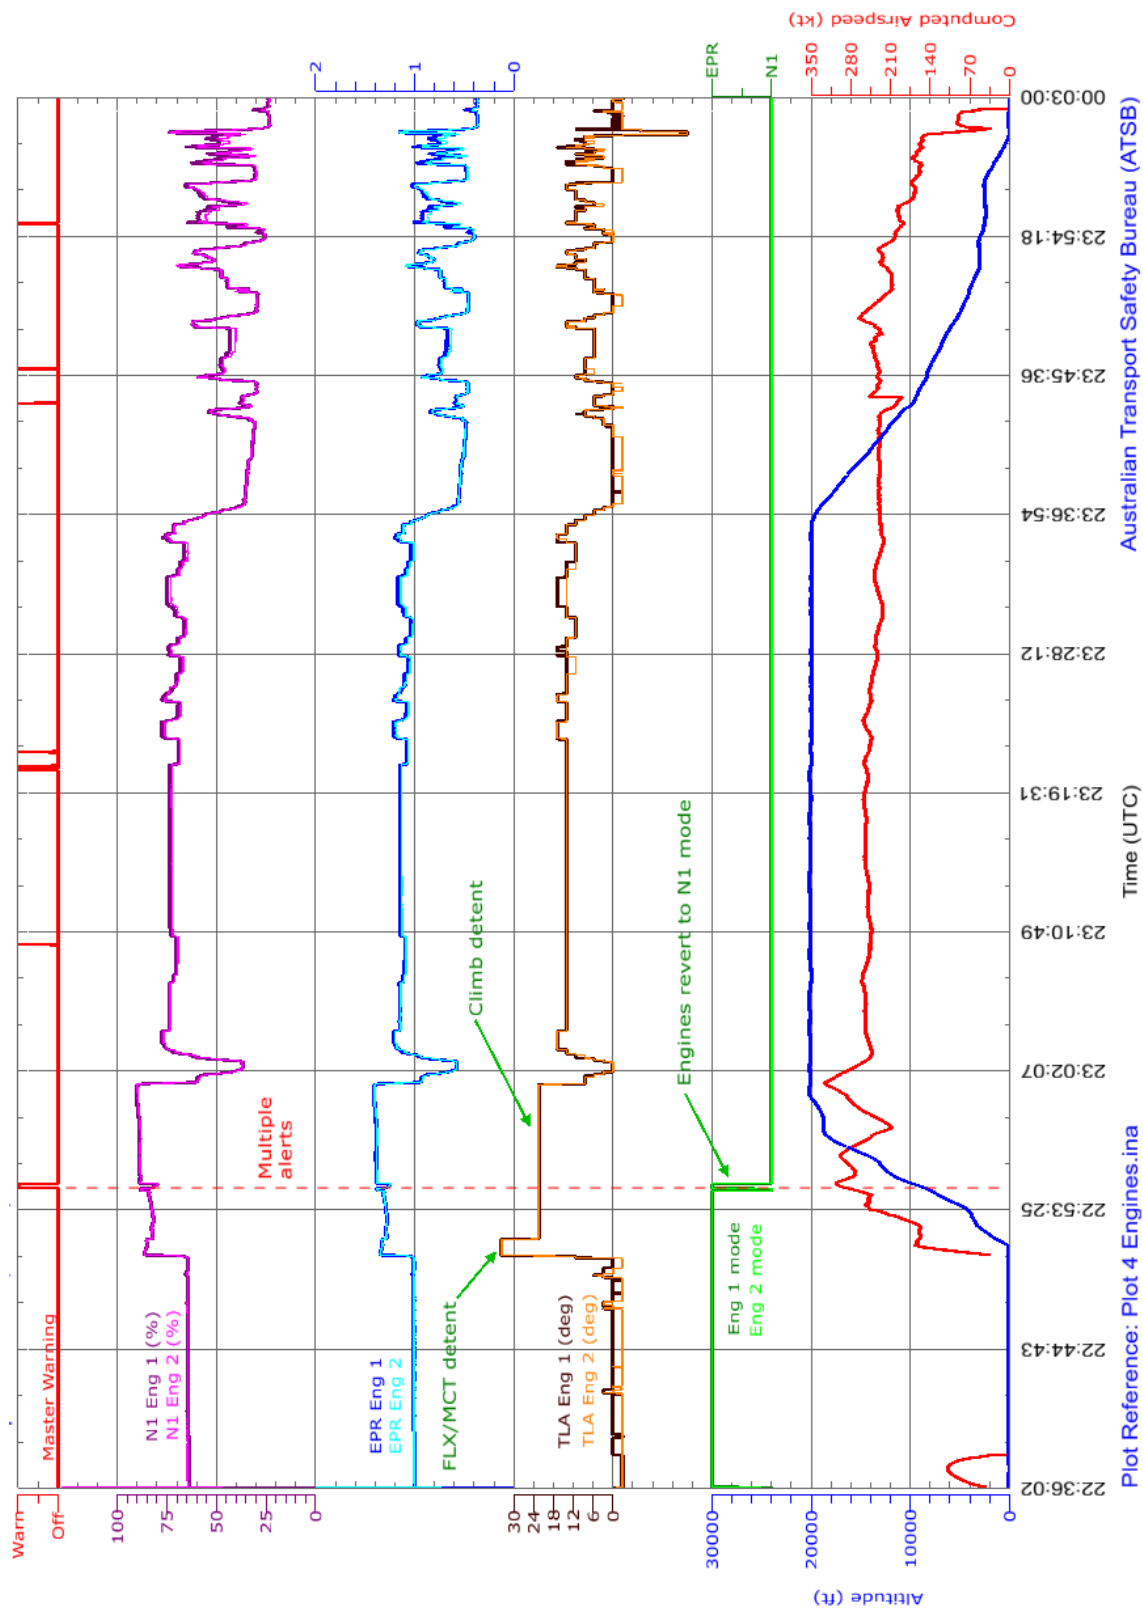
Figure C5: Flight data – Engine parameters (complete flight)

TLA = thrust lever angle. A measure of the thrust lever position. Source: ATSB

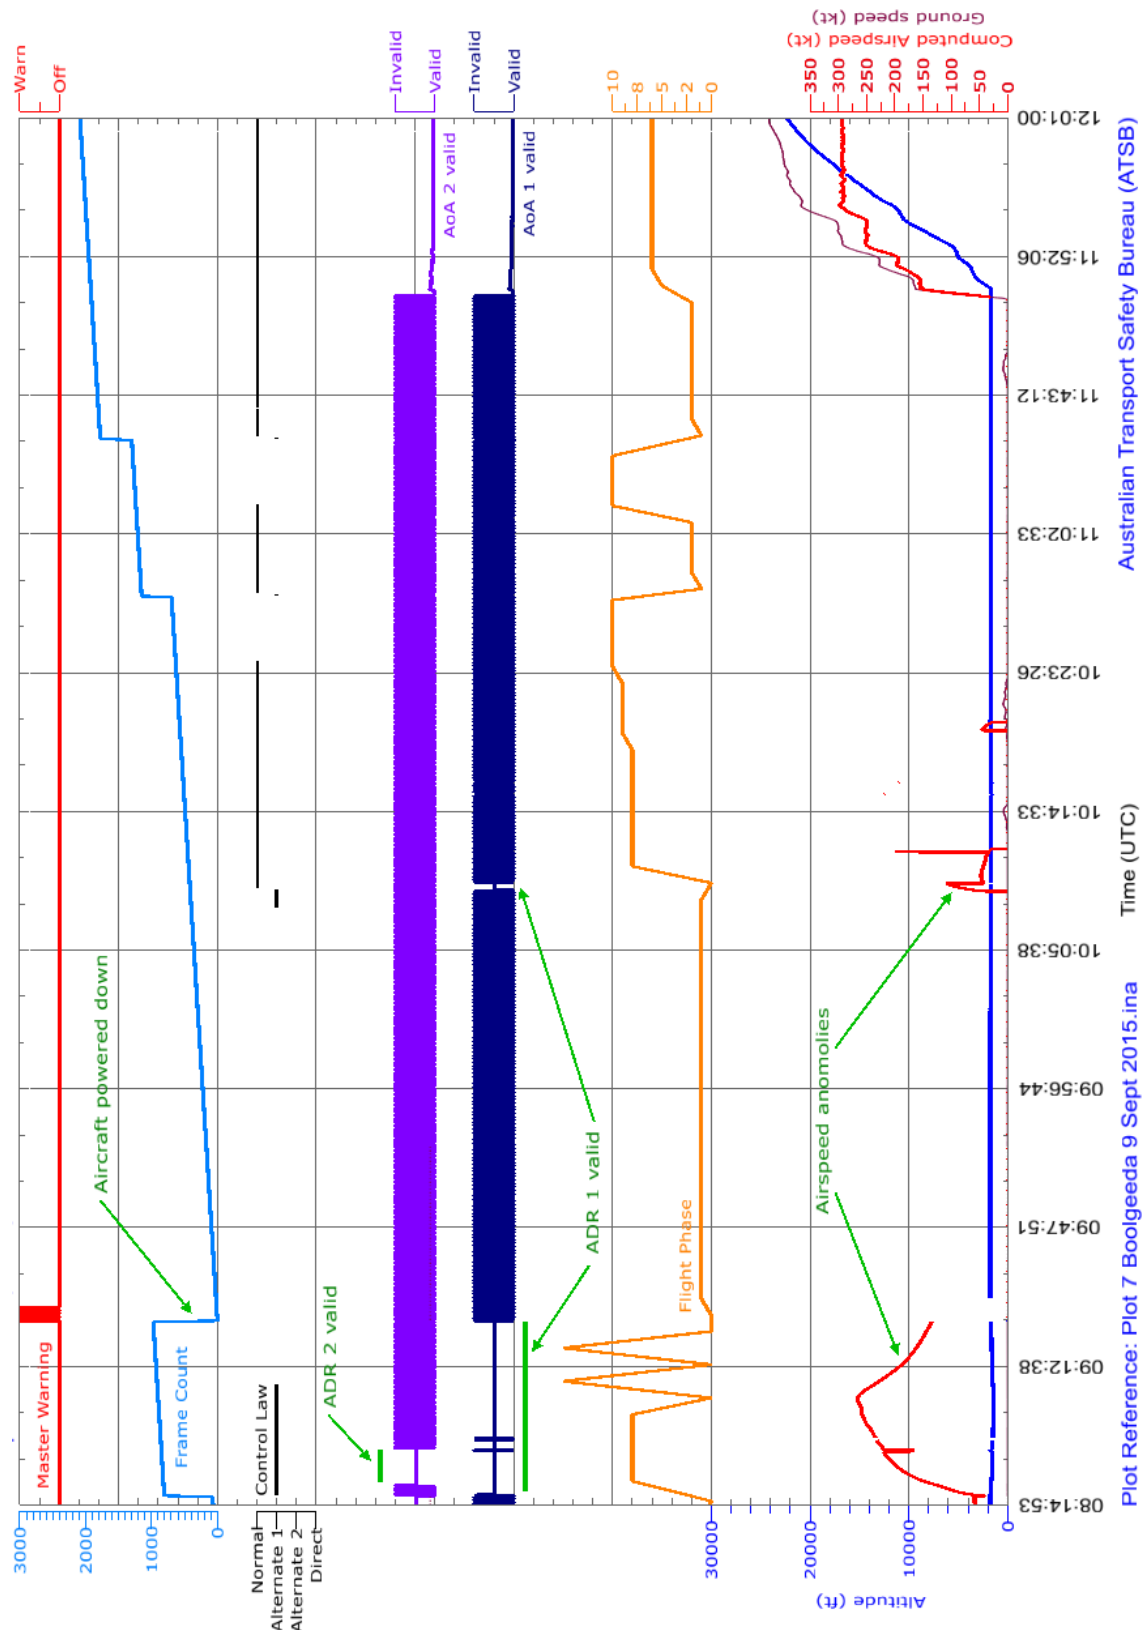
Appendix E – Recorded data from 9 September 2015 airspeed anomaly

Note: The frame count is a parameter recorded on the FDR that counts in seconds. This count is generated external to the FDR, so when power is removed from the FDR, but other systems have power, the count continues, but is not recorded by the FDR, resulting in steps in the count. If the aircraft is completely powered down, the count resets to zero. Such steps indicate some level of powering down of the aircraft. Source: ATSB
