# In-flight upset, inadvertent pitch disconnect, and continued operation with serious damage involving ATR 72 aircraft, VH-FVR

47 km WSW Sydney Airport, New South Wales | 20 February 2014

## **ATSB Transport Safety Report**

AO-2014-032

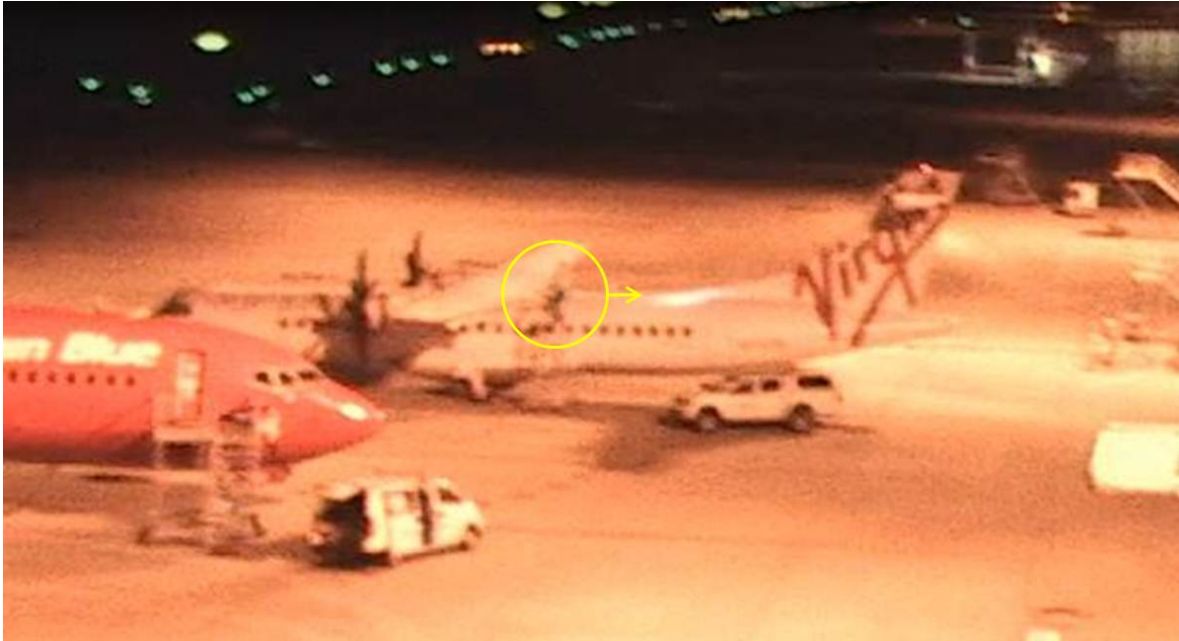
After attending to an arriving aircraft, LAME 2 returned to VH-FVR at about 2300. The engineer borrowed a nearby fixed-height stand to provide an elevated platform and positioned it to the rear of the left wing. That stand was described as the best he could get at that time and was of a height that provided a view of the top of the wing but not the top of the stabilisers. While on the stand, the engineer shone a torch over the upper surface of the wing, rear fuselage and tail (Figure 3). The engineer was on the stand for about a minute and the torchlight was directed to the rear fuselage and tail for a couple of seconds. No damage was identified.

**Figure 3: Aircraft visual inspection underway at 2306:44 with LAME 2 on the stand at the rear of the left wing. The circle and arrow indicate the location of the LAME and the direction of torchlight (still image copied from closed circuit TV footage)**

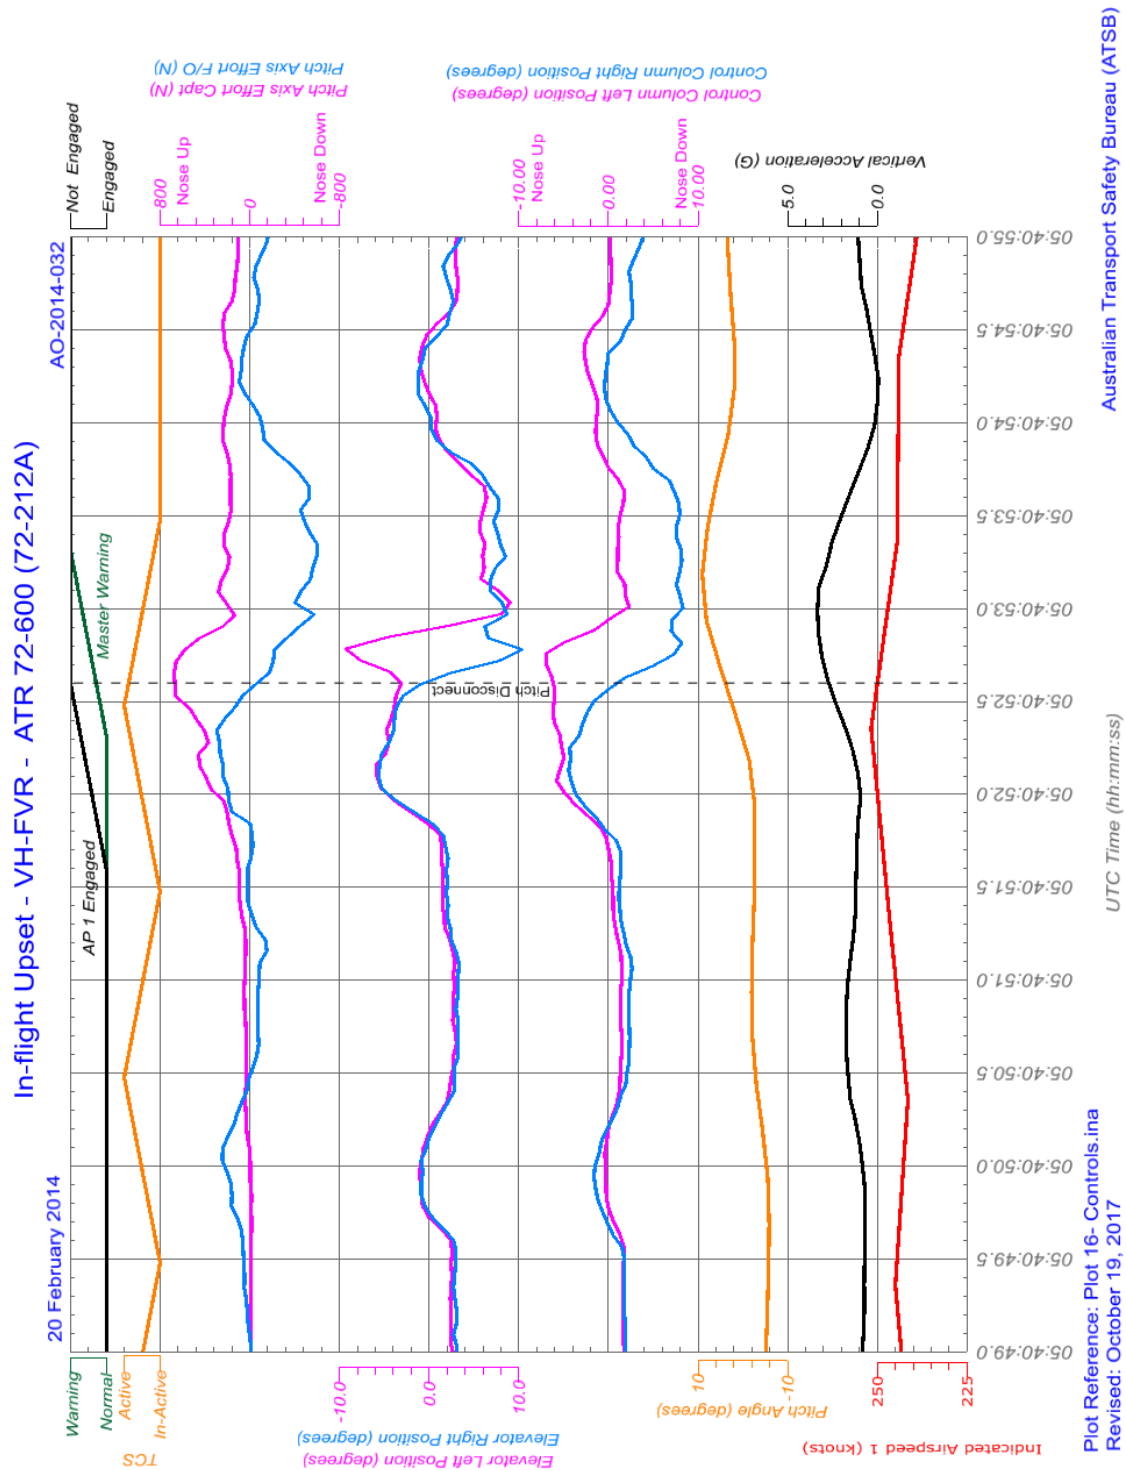
Figure 36: FDR information showing the relevant pitch parameters for the shaded 6-second period in Figure 35, during which the pitch disconnect took place. The estimated time of the pitch disconnect is shown with a black dashed line at time 05:40:52.6

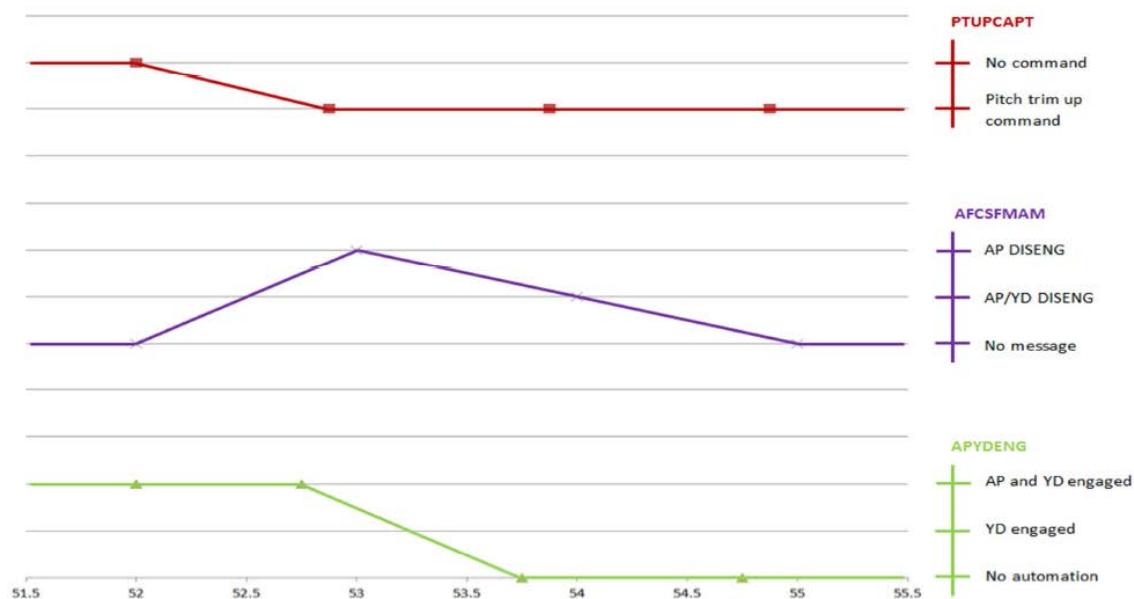
**Figure 39: FDR information showing the captain's pitch trim up command (PTUPCAPT), AFCS message (AFCSMAM) and autopilot/yaw damper engaged (APYDENG) parameters following the pitch disconnect event.**

The data indicates that the recorded autopilot/yaw damper engaged parameter changed directly from both engaged to no automation. However, the automatic flight control system message changed from no message, to autopilot disengaged and then to autopilot/yaw damper disengaged, before returning to no message. It was also observed that the captain made a nose-up pitch trim command at about the same time.

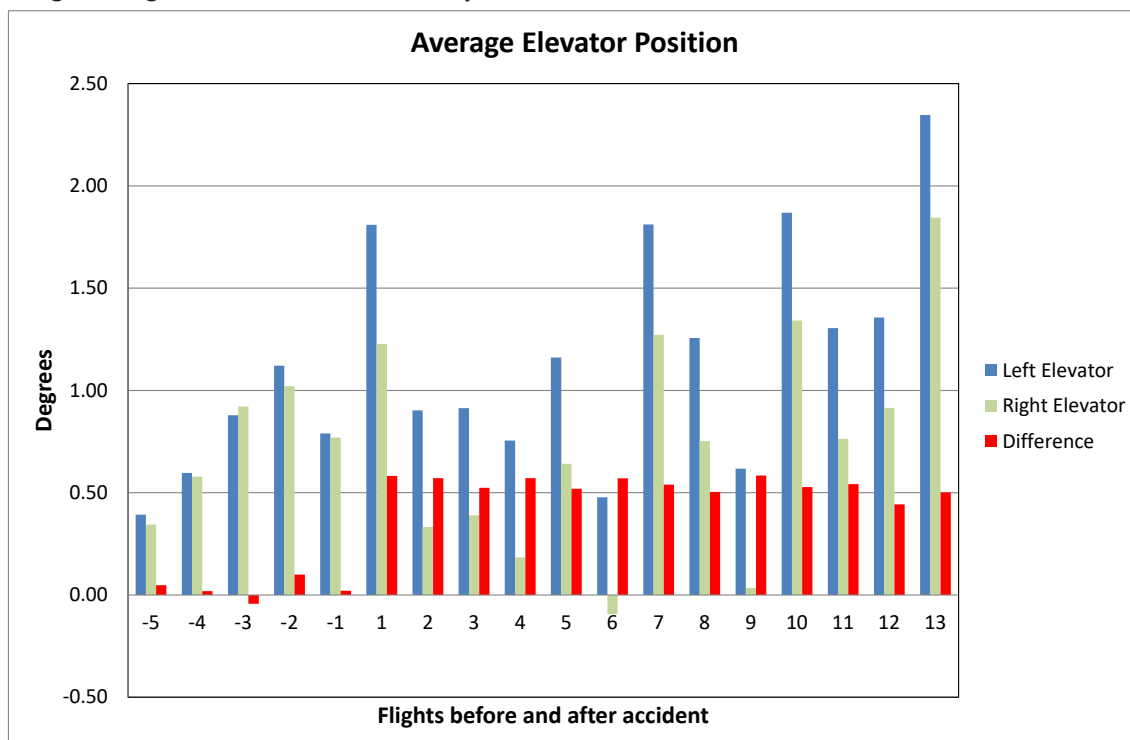
**Figure 40: Comparison of the average position for the left and right elevators over a range of flights before and after the pitch disconnect.**

Also included on the chart is the difference between the left and right elevator positions. Note: A negative flight number indicates that the flight was taken before the pitch disconnect.

The size and persistent nature of the difference between the elevator positions is an indication that the damage to the horizontal stabiliser was generated during the pitch disconnect event and that any further degradation of the structure was probably minimal.

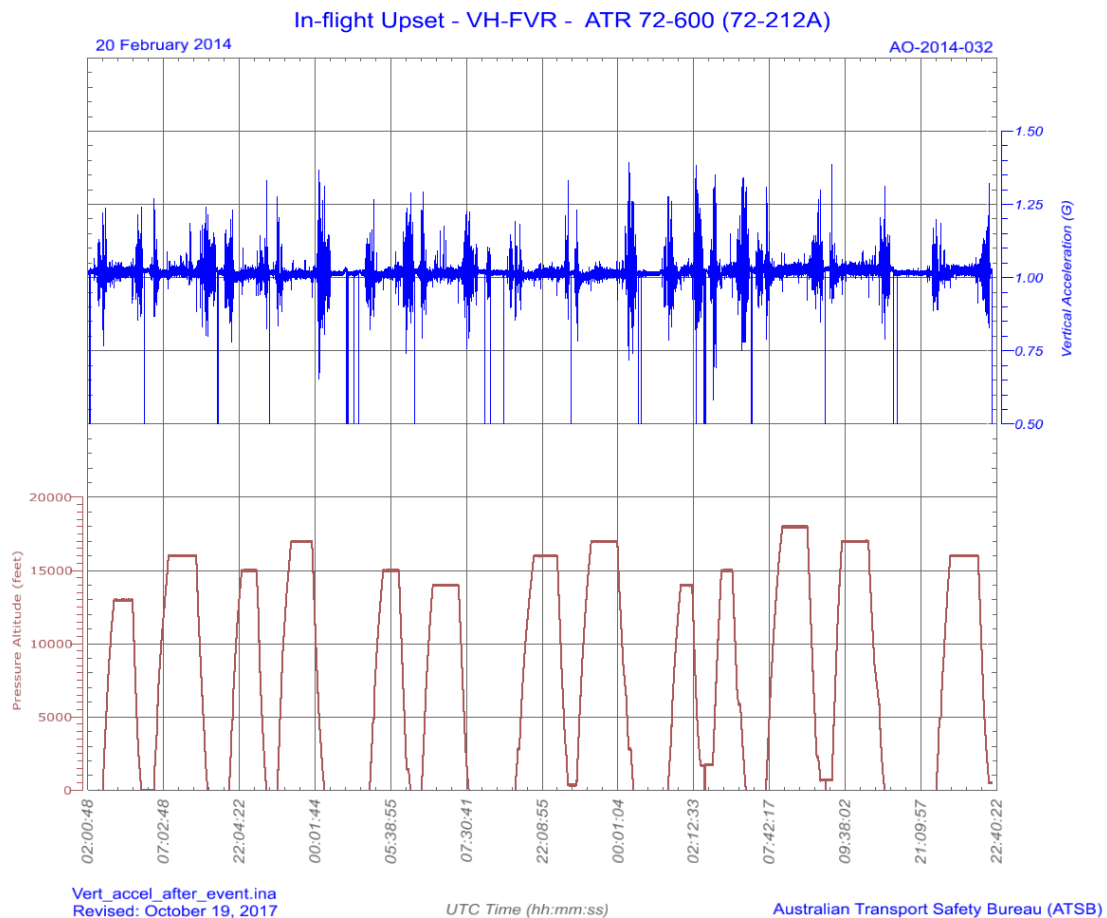
**Figure 41: Vertical acceleration recorded on flights between 20 February 2014 and 25 February 2014. The peak acceleration during the in-flight upset was 3.34 g. The maximum on the subsequent flights was 1.4 g.**

Note, the data spikes below 0.5 g are due to the system operation when the aircraft is powered down and do not indicate that the vertical acceleration was less than 0.5 g.

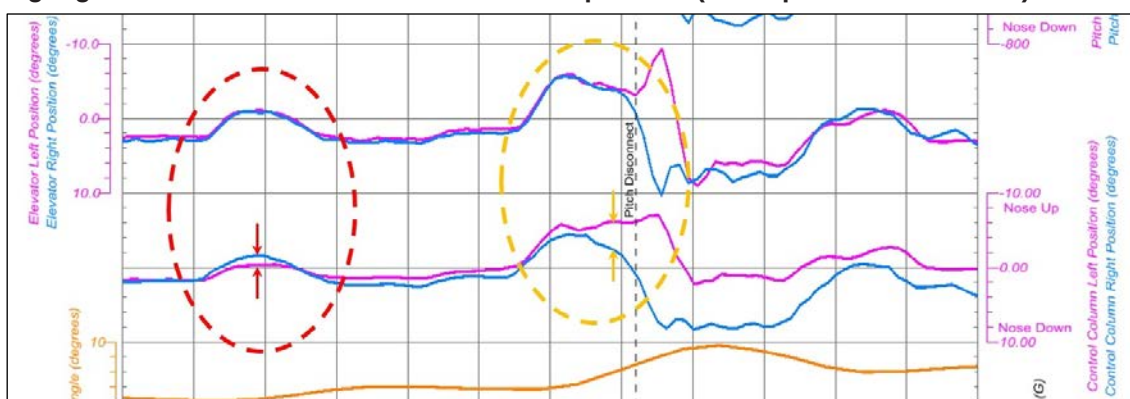
It was noted on the FDR data that when control inputs were made, prior to the pitch disconnect, the left and right elevator deflections were the same, but the left and right control column positions differed from each other (Figure 46). Given that the control column positions matched when there was no control input load, the differences in the recorded position was unlikely to have been a result of a recording or sensor error.

**Figure 46: Excerpt from the flight data recorder information around the time of the pitch disconnect. The circled areas highlight regions where there was a notable difference in the left and right control column positions before the pitch disconnect. The arrows highlight the difference in the control column position (lower pink and blue lines).**

Note, there is no corresponding difference between the position of the left and right elevators (upper pink and blue lines) until just before the pitch disconnect.

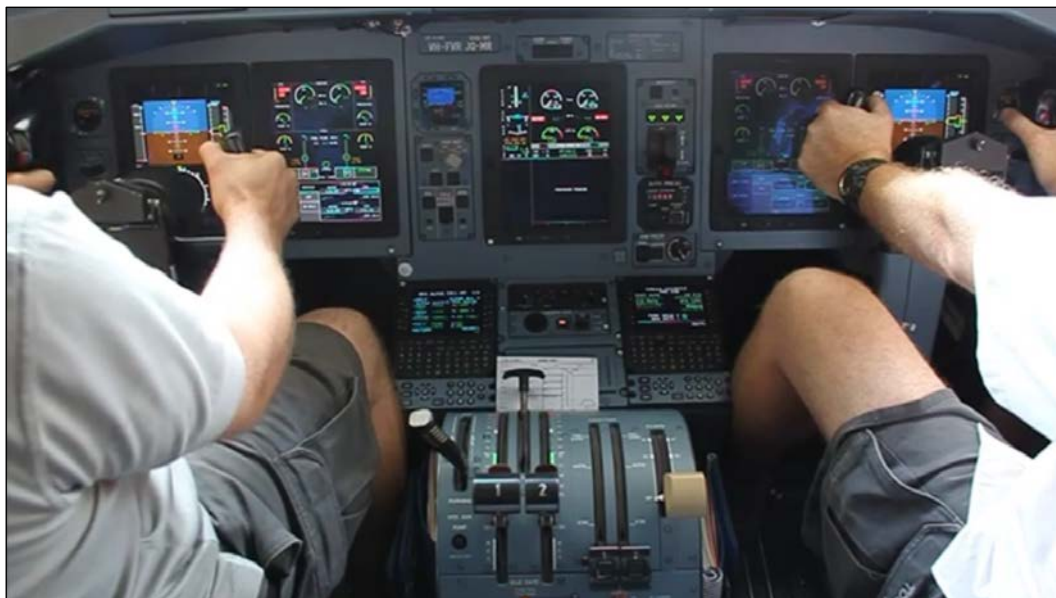
A difference in the control columns was also noted during the on-ground testing of the pitch disconnect system after the occurrence. When applying the control loads in order to intentionally activate the PUM, a significant difference in the control column positions was observed before the PUM activated (Figure 47).

**Figure 47: Still image from video of on-ground pitch disconnect testing carried out on VH-FVR following the occurrence. The right control column was held fully forward while the left control was pulled back. The image is just before the pitch uncoupling mechanism activated. Note the difference between the left and right control column positions. The left control column is about halfway through its full travel, while the right control column is at the forward limit.**

this point. During the ground testing carried out by the ATSB following the occurrence, it was noted that the arms of the person actioning the controls in the first officer's position had their arms fully outstretched when they were holding the controls in the forward position (refer to still image in Figure 47 taken from the video of that testing). Thus it is likely that the first officer's arms were also fully outstretched when the control column reached its maximum deflection.

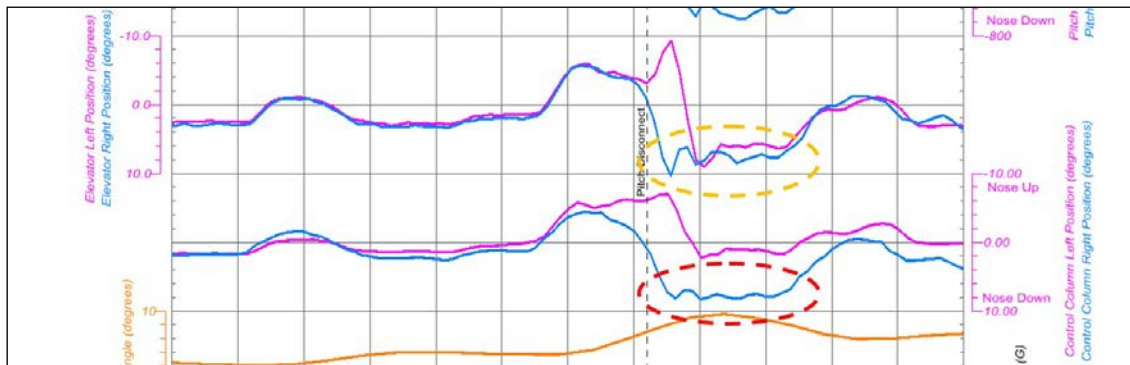
from the flight testing (Figure 48).<sup>60</sup> The captain's side also exhibited a rapid increase in the elevator position immediately following the pitch disconnect that was not commensurate with the change in the control column position during the same time. The captain's control column moved back by about 1°, but the elevator deflection increased by about 6°.

**Figure 48: Excerpt from the FDR data from VH-FVR during the pitch disconnect event. The underdamped oscillatory characteristic response of the elevator movement following pitch disconnect is circled in yellow. The region circled in red indicates that there was also some oscillation in the control column, but the amplitude was not commensurate with the elevator deflections.**

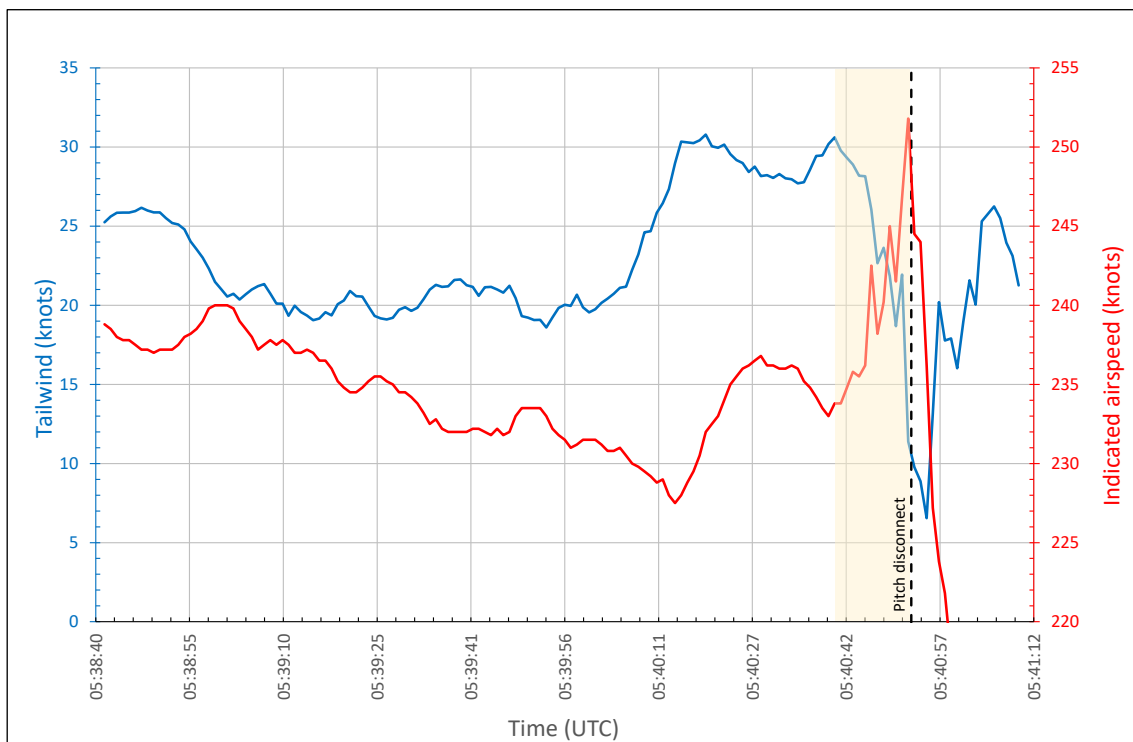
Similarly, in the seconds leading up to the pitch disconnect, there is a distinct correlation between the increasing airspeed and a corresponding rapid decrease in the calculated tailwind (shaded region in Figure 49). Thus, it is likely that there was a significant windshear that resulted in the indicated airspeed rapidly increasing toward VMO in 10 seconds before the pitch disconnect.

**Figure 49: Comparison of the variation in the calculated tailwind component (blue) with the indicated airspeed (red) for a period of approximately 2 minutes before and 30 seconds after the pitch disconnect.**

The shaded region shows a significant decrease in the tailwind component at the same time as the indicated airspeed increases.

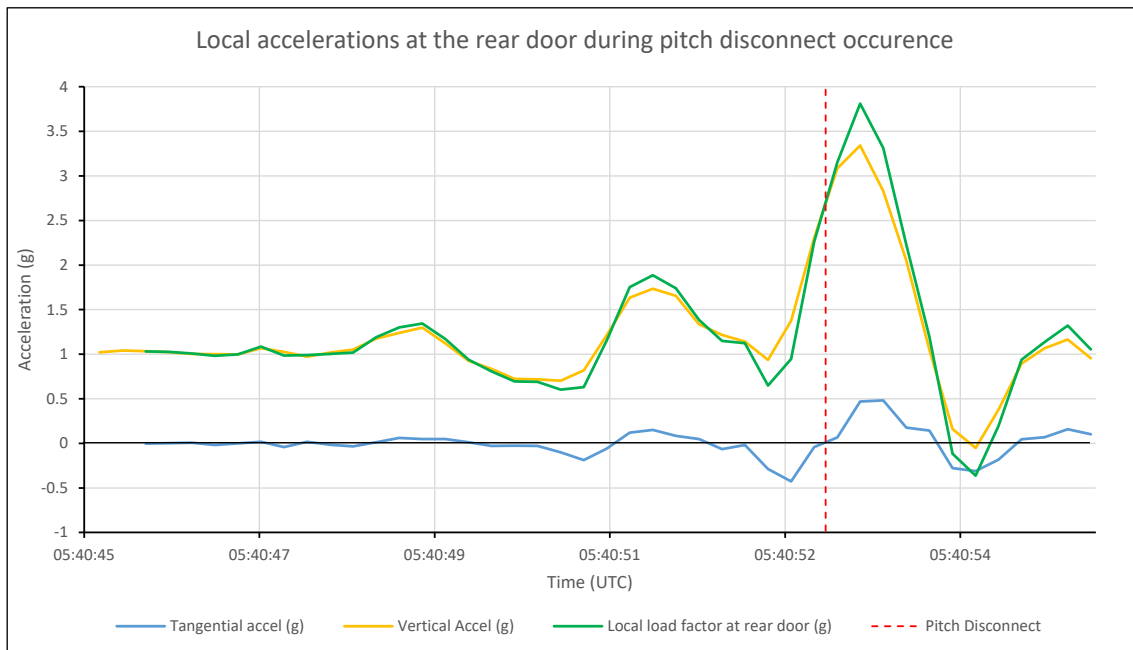
At the time, the first officer was the pilot flying, and his input alone should have resulted in a pitching manoeuvre that was only marginally greater than the previous two. It was also highly likely that the recovery from that pitch-up would have been similar. It was previously shown that the third, rapid, pitch-up was a result of the dual input. Thus, the recovery that resulted in the significant negative acceleration in the rear cabin was also a result of the dual control input and as such, the dual control input contributed to the SCCM's injury.

**Figure 51: Local vertical acceleration (load factor) at the rear door during the pitch disconnect event.**

The figure shows that an unrestrained occupant located at the rear door likely experienced a maximum load factor of about 3.8g followed by a dip to a minimum of about -0.4g, before returning to about 1g. The red dashed line indicates the time of the pitch disconnect.

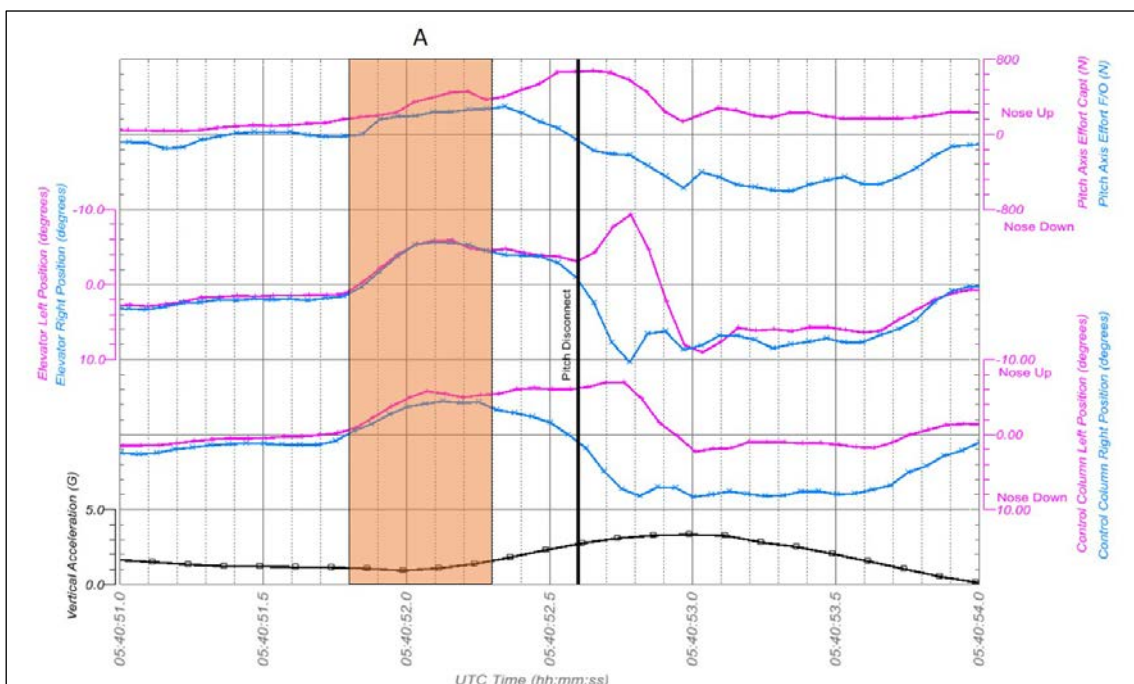
**Figure B3: Period A – The graph shows that the recorded pitch axis effort on both the captain and the first officer sides was from nose-up control column inputs by both pilots.**

The maximum effort on the captain's side during this period was about 45 daN (450 N, or 46 kg of force) and the first officer's side was about 27 daN. The respective nose-up control column movement indicates that the pitch axis effort was a result of both flight crew making inputs into the pitch system in order to raise the nose and slow the aircraft.

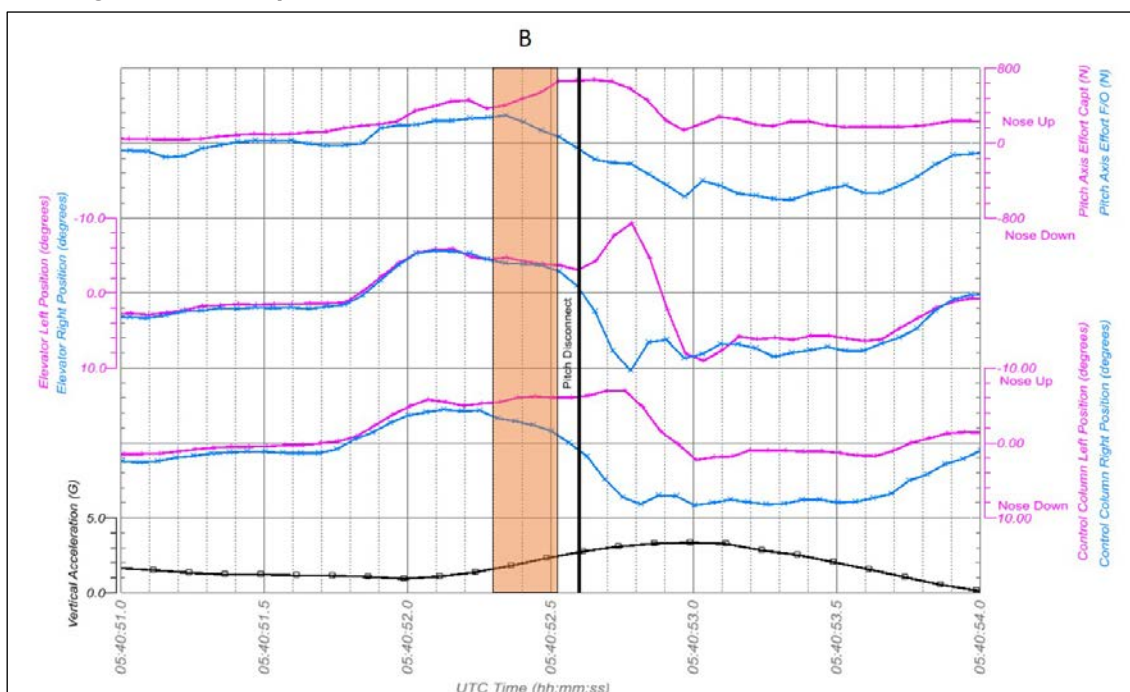
**Figure B4: Period B – The captain's side pitch axis effort increased while the first officer's decreased. The captain's control column movement was relatively small during this large increase in pitch axis effort.**

The first officer reduced the nose-up input on their control column, while the captain control column moved slightly further back. The increased control position was only slightly more than the position that resulted in a peak pitch axis effort of about 45 daN; however, the pitch axis effort continued to rise, even after the control column position remained steady. This was likely because, as the first officer reduced their input, the elevators remained deflected and the first officer's share of the aerodynamic loads was transferred to the captain's side.

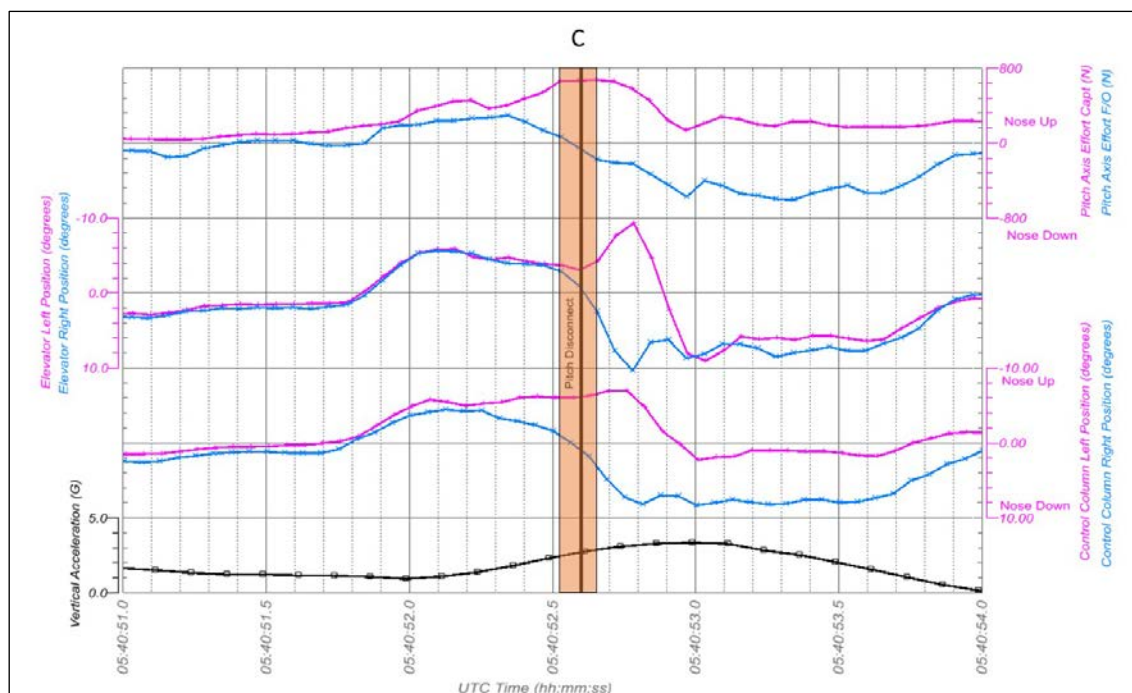
**Figure B5: Period C – During activation of the PUM, the elevators start to diverge, while the captain's input remained constant and the first officer's input became nose-down .**

The pitch axis effort recorded on the captain's side plateaued at about 67 daN and the first officer's changed from positive to negative, indicating that he had started to apply a nose-down load on the controls.

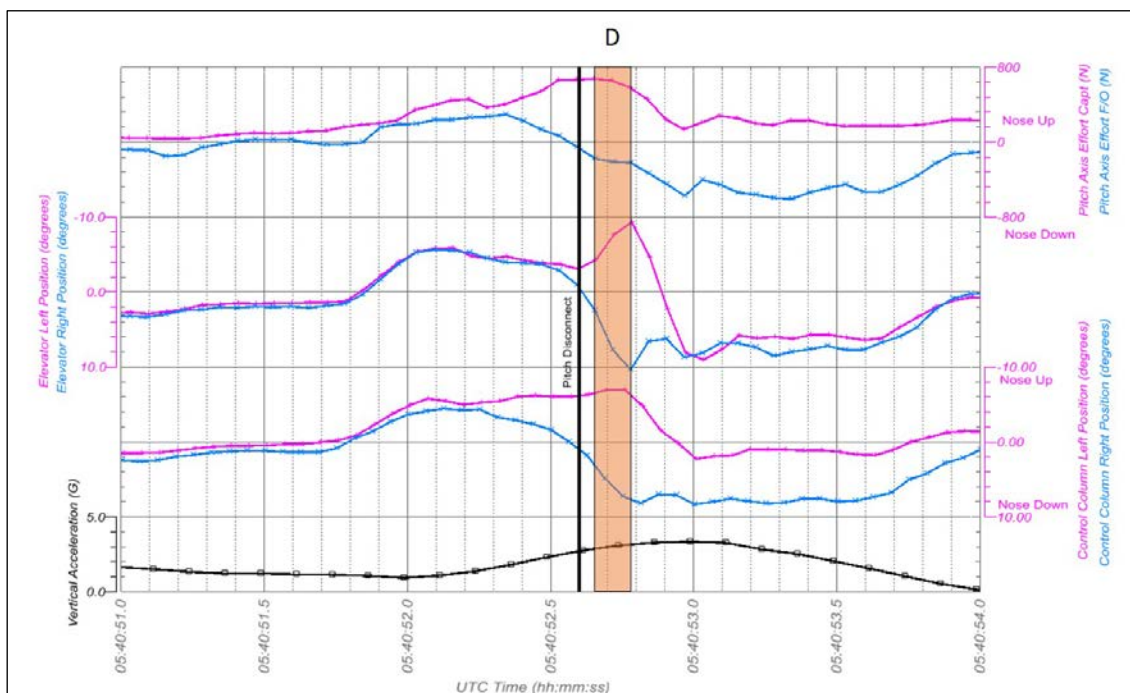
**Figure B6: Period D – After activation of the PUM, the elevators moved in opposite directions. The captain's and first officer's controls also moved in response to the change in the loads resisting the flight crew's input.**

When the PUM activated, the aerodynamic load from the elevators acting through the left control channel would have been halved. Consequently, the pitch axis effort on the captain's side decreased during this period, even though there was a small increase in the control column position.

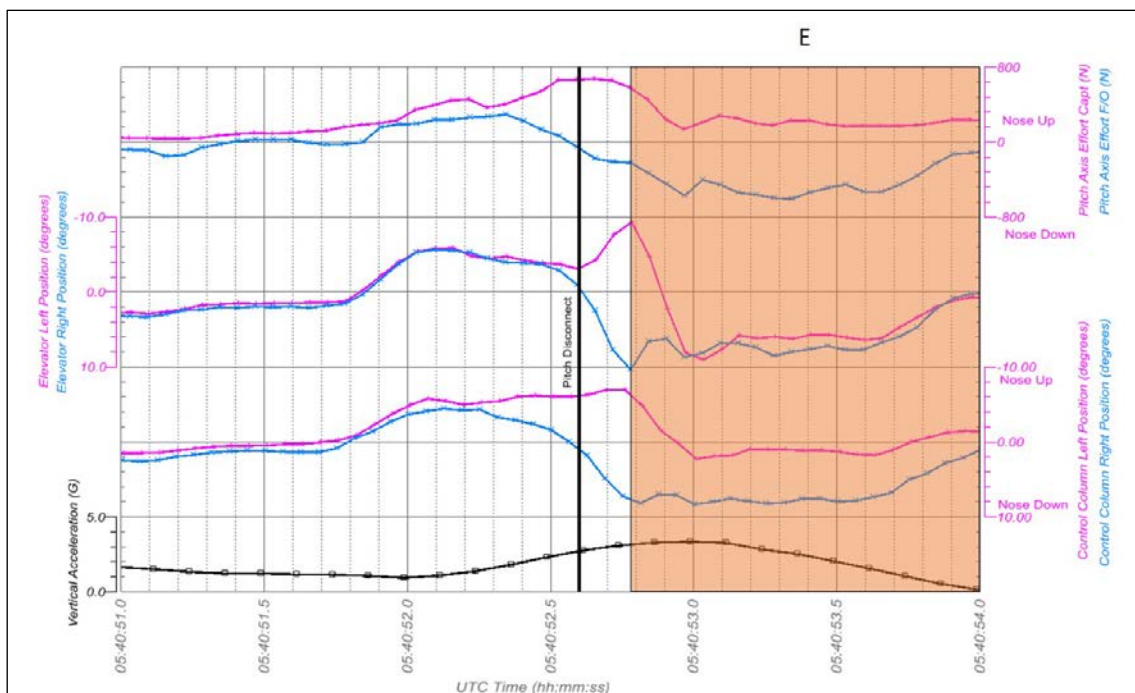
**Figure B7: Period E – After the elevators reached their maximum deflections, the captain's control is returned to neutral and the first officer's was held at the position reached after the pitch disconnect.**

Within about 0.2 seconds after the pitch disconnect, the captain's control column is moved forward, reducing the commanded input. Given how quickly this occurred in the context of human reaction time, it is unlikely to have been a conscious reaction to an unexpected pitch disconnect. It may have been an unconscious response to the change in the control feel, or an action that the captain was already in the process of performing, such as reducing the load factor, when the pitch disconnect occurred.
