Collision with terrain following an engine power loss involving Cessna 172M, VH-WTQ

12 NM (22 km) north-west of Agnes Water, Queensland on 10 January 2017

ATSB Transport Safety Report
Aviation Occurrence Investigation
AO-2017-005
Final – 17 October 2019

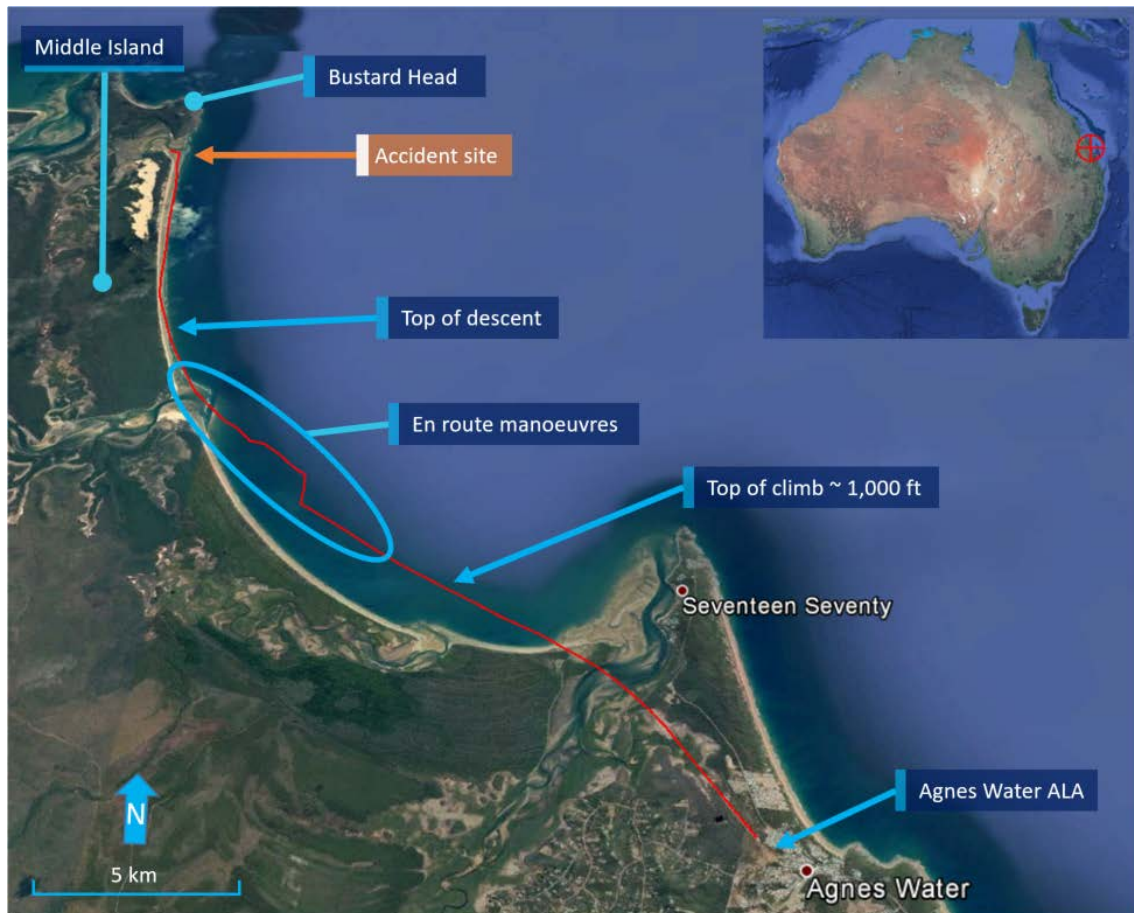
Figure 1: VH-WTQ's flight path between Agnes Water ALA and the accident location on Middle Island

Figure 1 shows the track of the aircraft for the whole flight, based on the GPS data.

The flight path was based on data downloaded from the GPS unit on the aircraft. The insert image shows the location of the accident on a map of Australia.

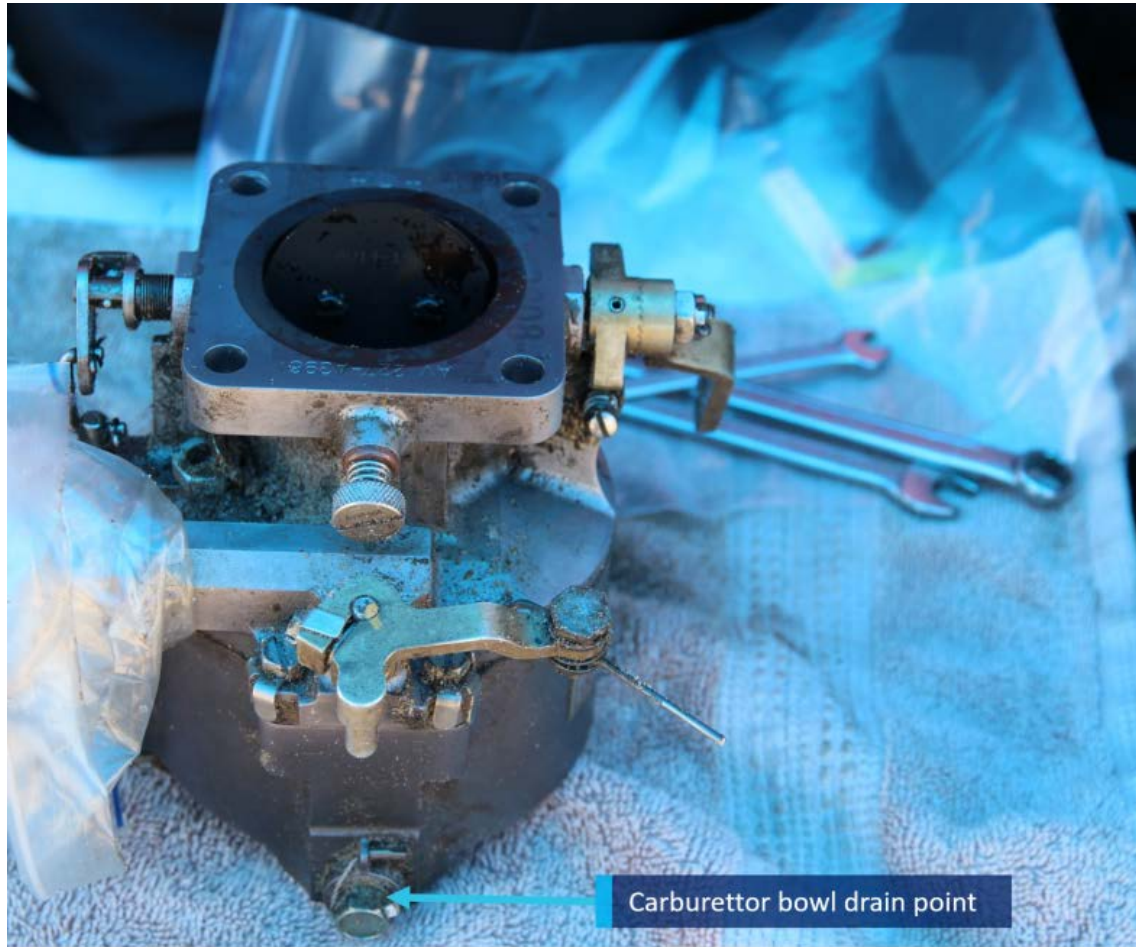
Figure 12: Carburettor showing drain point located at its base

As part of the removal process, care was taken not to invert the carburettor so as to prevent fuel draining out of the unit. With the carburettor in an upright position, the carburettor bowl drain was removed in order to ascertain if any fuel remained in the unit (Figure 12). No fluid of any kind was drained from the unit. It is possible that some fuel had leaked out of the unit while it was on its side; however the orientation of the unit meant that some fuel should have remained in the carburettor bowl.

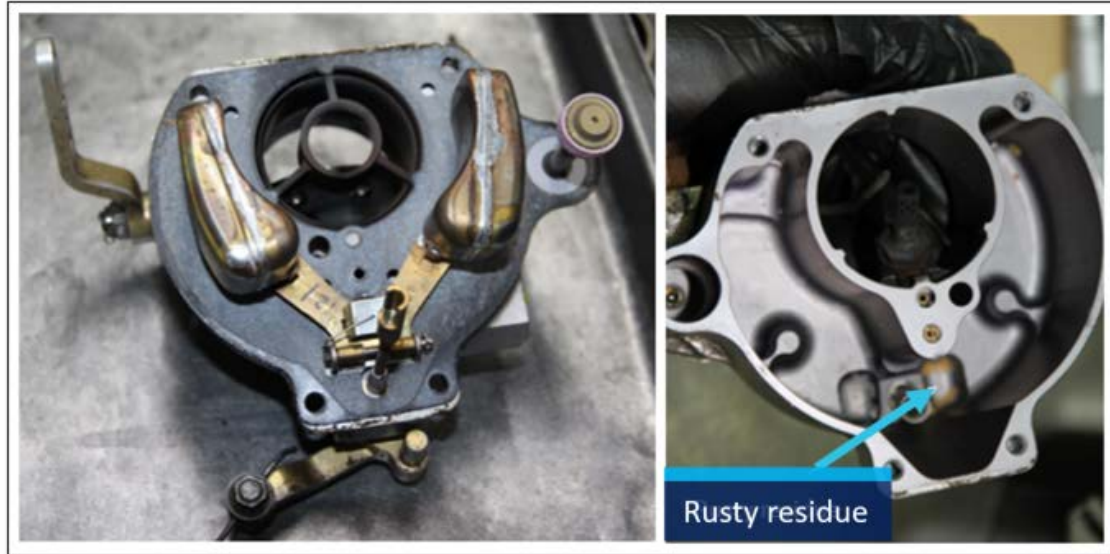
Figure 13: Disassembled carburettor showing internal components

- No pre-accident defects were identified with the mechanical components of the engine.
- The carburettor was disassembled and inspected, with no faults identified. There were no foreign particles and debris, apart from a small amount of rust-like residue at the drain point reservoir (Figure 13). The fuel metering orifice was also clean and free of foreign particles and debris. Given that no actual particles or debris were found in the carburettor, the presence of this rust-like residue was very unlikely to have contributed to the engine power loss.
- The magnetos were checked for correct timing and then removed for functional testing. Both magnetos functioned as designed with no faults identified.
- All the spark plugs were removed from the engine, inspected and tested. No faults were identified.

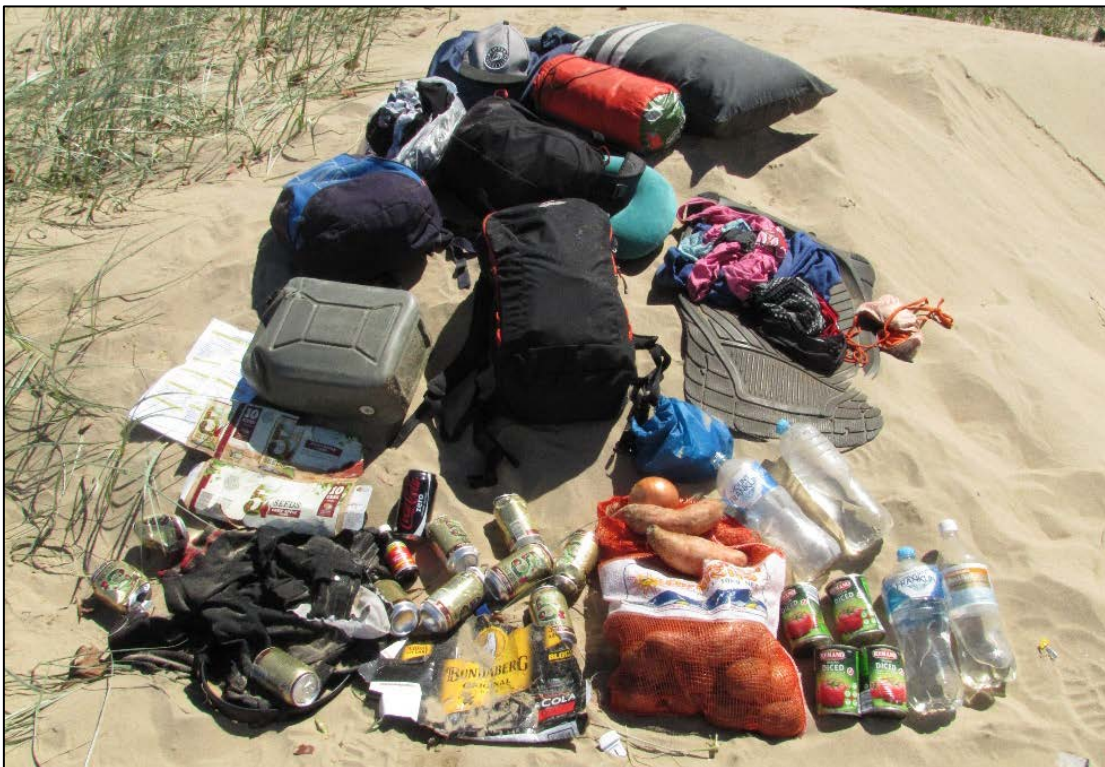
Figure 16: Some of the contents from VH-WTQ's baggage compartment at the accident site

During the on-site investigation, the ATSB recovered personal baggage and camping equipment from the baggage compartment of VH-WTQ. The ATSB also recovered camp food and drink supplies from the baggage compartment, as well as some of these supplies from the aircraft cabin and a small number of similar items from the surrounding area that were potentially on board the aircraft (Figure 16).

Some other items recovered by the ATSB from the wreckage are not included in this photograph. Those included cans of alcohol. It was reported that a full carton of rum and cola drink was on board but only 18 cans were recovered and included in the baggage weight. A large (3 kg) pumpkin was found close to the wreckage but not included in the final calculation. Only one of the 1.5 L water bottles shown in the photograph was included in the ATSB weight calculation (although others were found nearby and were potentially on board). The rubber mat was also not included in the ATSB calculations.

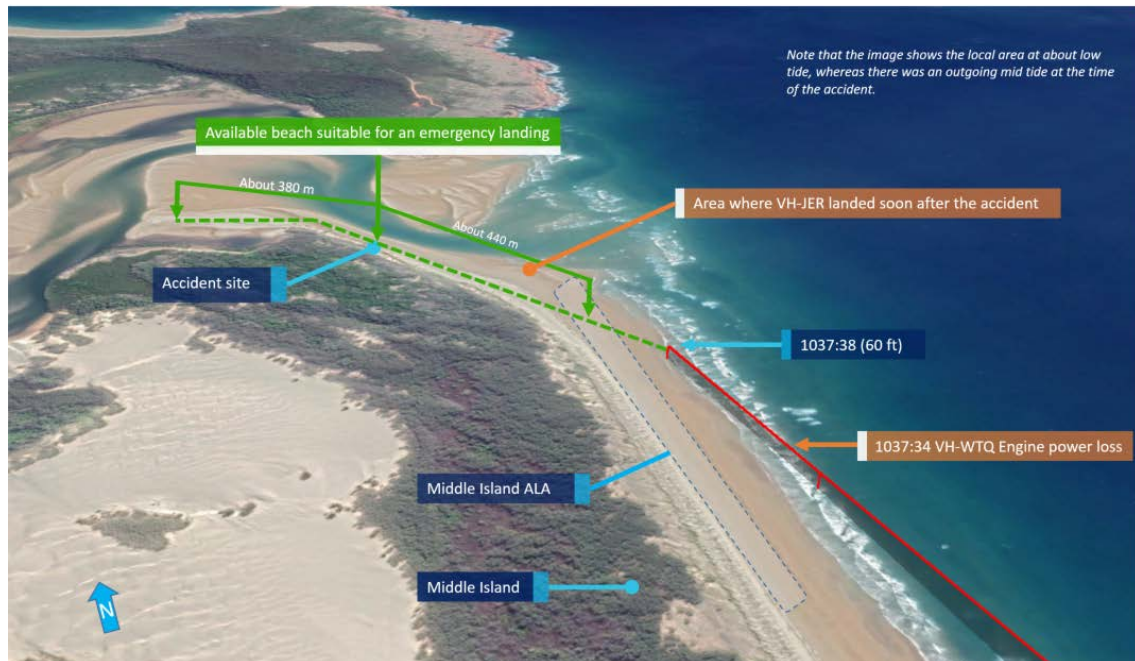
Figure 18: Image of Middle Island aeroplane landing area and the beach area to the north

Figure 18 shows a Google Earth image of the landing area and beach north of the landing area. This image was taken in May 2016, and it was the Google Earth image that most closely represented the conditions at the time of the accident flight. Based on reviewing video footage taken from the accident flight, and the following flight in VH-JER, there was significantly less beach area around Jenny Lind Creek inlet at the time of the accident compared to this Google Earth image. The width of the beach near the landing area was also slightly narrower. However, there was still a substantial amount of beach surface north of the landing area at the time of the accident.

Note; Actual location of the ALA was not documented and the ATSB's estimation of the ALA's location is based on GPS locations of previous landings and take-offs. Source: Google earth, modified by the ATSB.

In summary, most of the beach area north of the ALA indicated in Figure 18 was present at the time of the accident flight. More specifically, as indicated in the video footage from VH-WTQ, the aircraft was almost over the beach at the time of the engine power loss (1037:34). Figure 18 compares this location with the estimated touchdown point of VH-JER (heading south) a few minutes after the accident (see also Figure 6). Based on a review of video footage from VH-JER, from 1037:38 (just after the pilot commenced a right turn), there was about 440 m (1,440 ft) along the beach until abeam where the aircraft wreckage was located. In addition, there was about

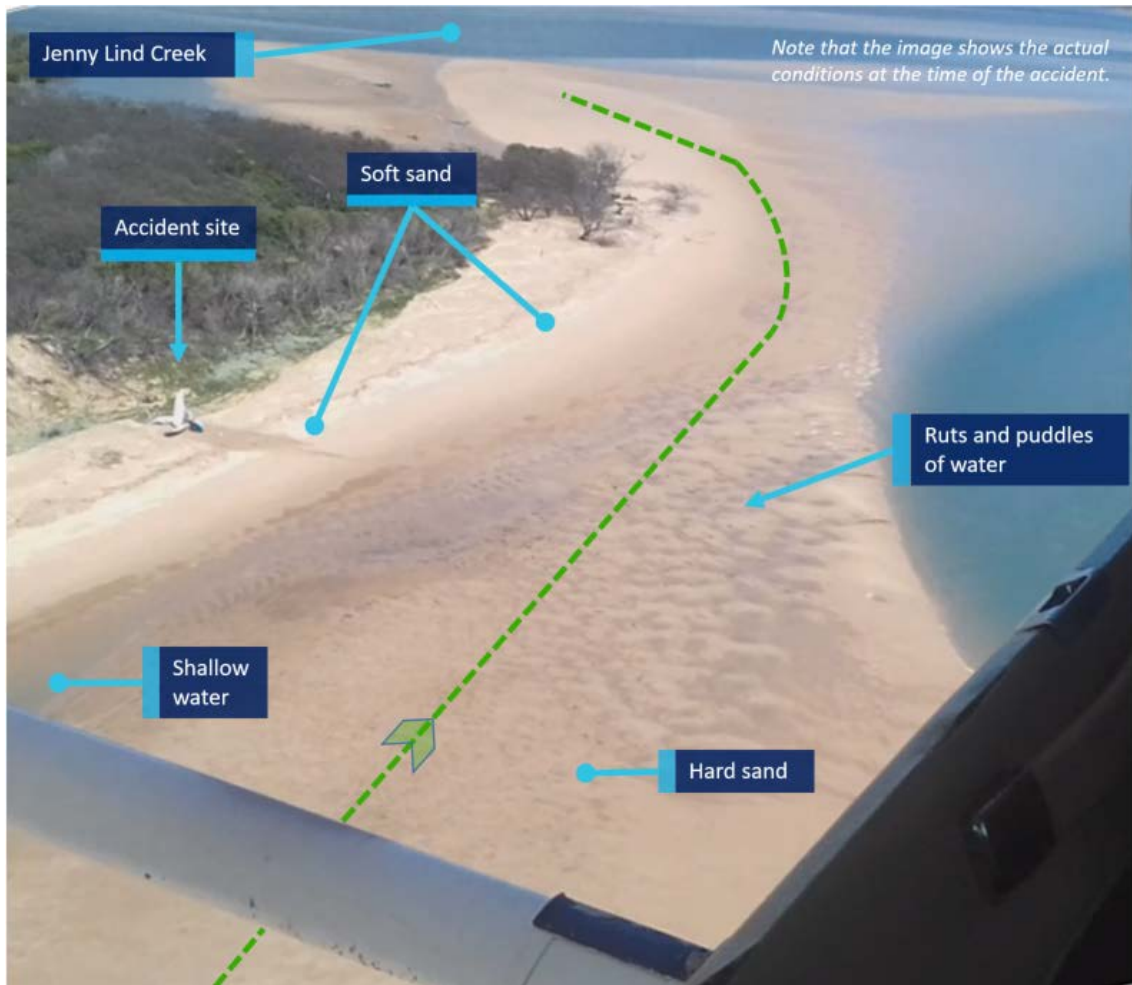
Figure 19: Image taken from VH-JER soon after the accident showing area of beach to the north of the landing area

Figure 19 shows the beach area to the north of the accident site as seen just after the accident. As indicated in this image, most of the sand area shown in Figure 18 was present at this time. The beach included an area of shallow water just south of the accident site, areas of hard sand, areas of hard sand with ruts and very shallow puddles and areas of soft sand. Figure 20, also taken from VH-JER just prior to it landing, shows the beach from the accident site up to the camp site.

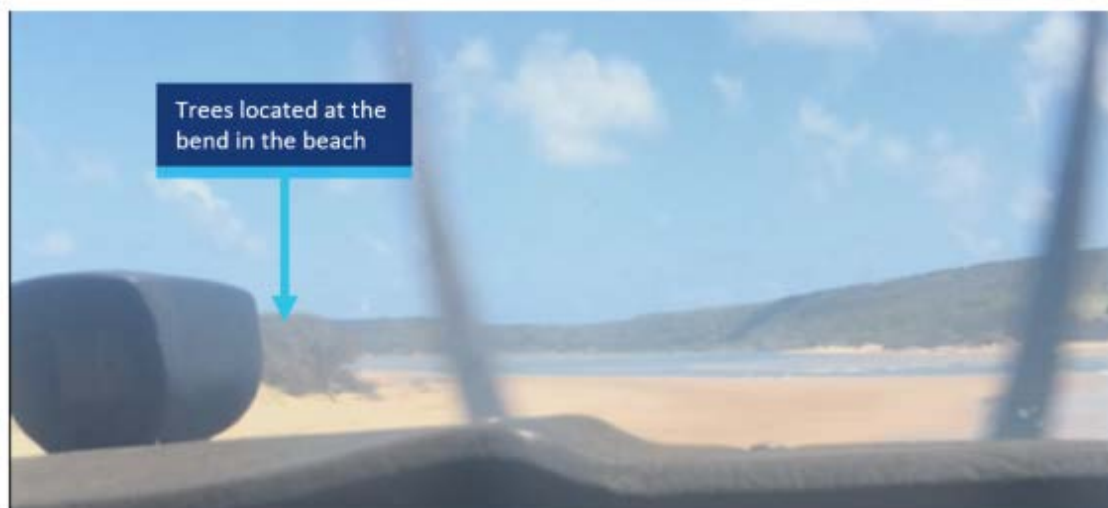
Figure B1: A still image taken from the video footage 2 seconds after engine power loss (1037:36)

- At 1037:36, 2 seconds after the engine power loss, the video footage showed that the aircraft was still a significant distance south of the bend in the beach on Middle Island (see Figure B1 and the location of the bend in Figure 2). Given the aircraft's groundspeed was about 124 kt (or 64 m/s) at that time, the image shown in Figure B1 was taken about 130 m north of the engine power loss. If the engine power loss had occurred at the position reported by the pilot, then the area of beach north of the bend should have been visible in Figure B1. Instead, this image is consistent with what would be expected if the engine power loss occurred at the position indicated in Figure 2 (based on the recorded GPS data).

At the time this image was taken the phone camera was oriented to the left of the aircraft's heading. The image shows an area of sand on Middle Island beach, just prior to a bend to the left with further beach beyond.
Source: Queensland Police Service.

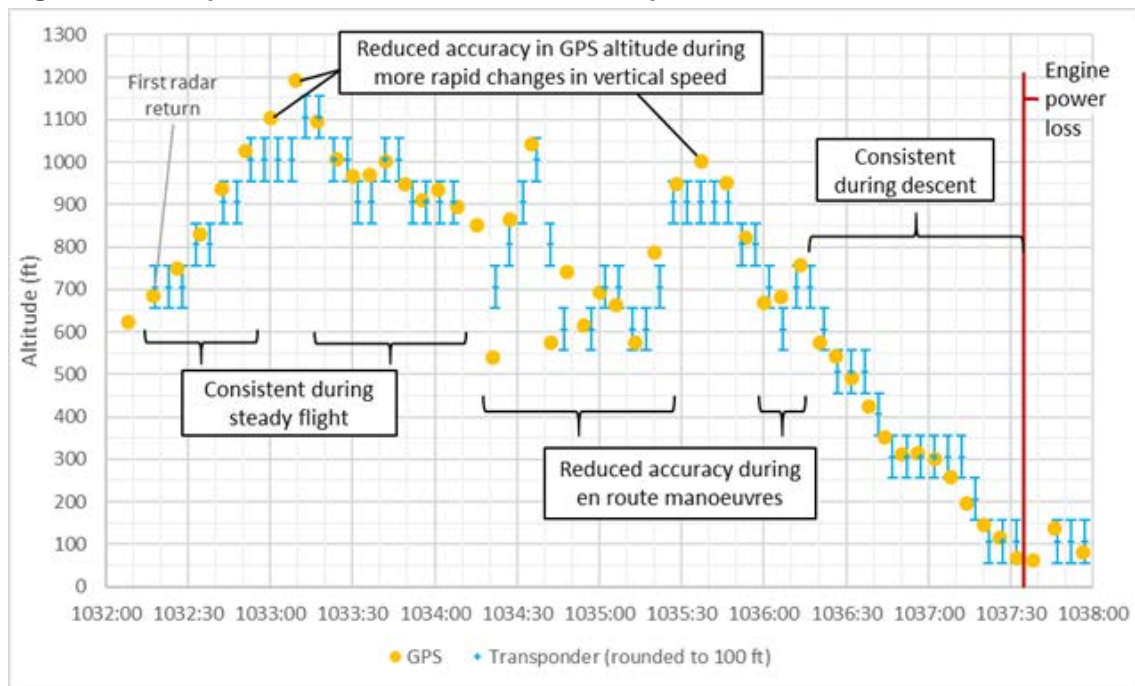
Figure B2: Comparison of recorded GPS and transponder altitudes

⁷⁰ 'QNH' refers to the altimeter barometric pressure subscale setting used to indicate the height above mean seal level. Transponder altitude data is based on a standard QNH of 1,013.2 hPa, which was very slightly below the QNH measured at a nearby town (Seventeen Seventy) at 0900 (1,013.4 hPa). This would result in the transponder altitude reading about 6 ft too low. The ATSB corrected the transponder altitude for this analysis.

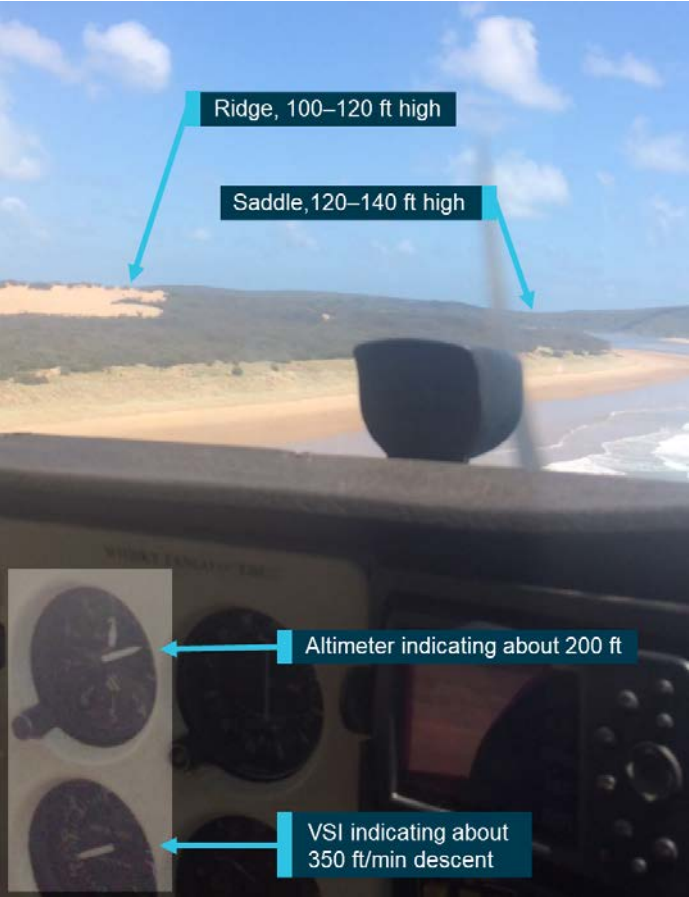
Figure B3: Still image from mobile phone video at 1037:26 (altimeter enhanced)

The image shows nearby terrain features: a ridge 100–120 ft high on nearby Middle Island, and a distant saddle 120–140 ft high. An enhanced section of the image shows the altimeter indication at that point, which is about 200 ft and the vertical speed indicator (VSI) showing a 350 ft/min descent.
Source: Queensland Police Service.
