# Runway excursion and collision with terrain involving Van's RV-6A, VH-OAJ

Somersby (ALA), New South Wales, on 18 March 2018

**ATSB Transport Safety Report**  
Aviation Occurrence Investigation  
AO-2018-025  
Final – 22 October 2019

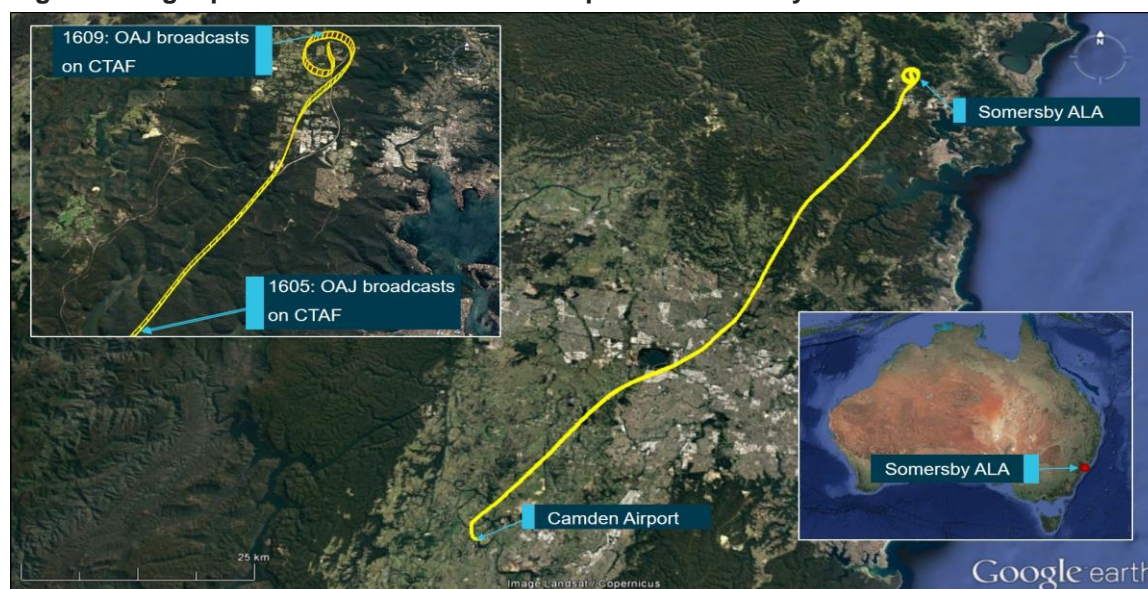
**Figure 1: Flight path of OAJ from Camden Airport to Somersby**

At 1543, the pilot filed a flight plan<sup>3</sup> for the return flight to Somersby. Several minutes later OAJ took off from runway 28 at Camden Airport and tracked to Somersby at around 2,000 ft. At 1605, the pilot made a broadcast on the common traffic advisory frequency to nearby traffic that he was 7 NM south of Somersby and estimated being overhead the airfield in 3 minutes. Approaching from the south, the pilot overflew the airfield before descending for a landing to the north on runway 35. At 1609, the pilot made a second broadcast on the frequency when he was downwind (Figure 1).

Image shows OAJ's flight path in yellow. The approach to the Somersby ALA and landing flight path are inset.
