# Engine inlet cowling failure involving Airbus A330, B-6099

Sydney Kingsford Smith Airport, New South Wales | 11 June 2017

**ATSB Transport Safety Report**  
Aviation Occurrence Investigation  
AO-2017-059  
Final – 20 November 2019

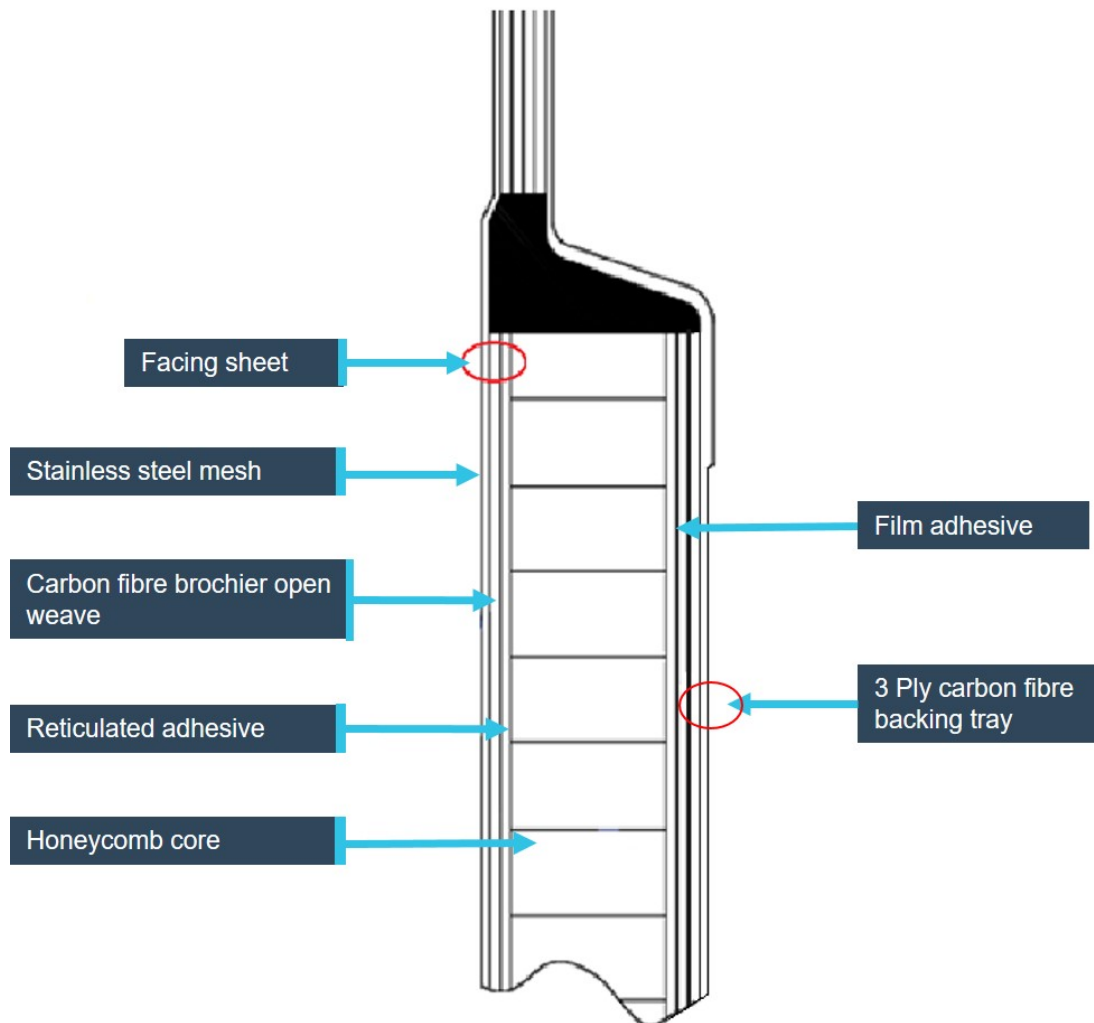
**Figure 4: Diagram showing the construction of the 3/4 inch 1.5 lbs/ft<sup>3</sup> density honeycomb core acoustic panel**

The upper inlet cowling acoustic panels, No. 1 and No. 3 fitted to B-6099 were manufactured from 3/4 inch honeycomb cell with a 1.5 lbs/ft<sup>3</sup> density core. The panel consisted of a backing tray, manufactured from three layers of carbon fibre weave (Figure 4). This was then adhered to the 3/4 inch honeycomb with film adhesive. A facing sheet, consisting of a carbon fibre brochier and stainless steel mesh, was then adhered to the other side of the honeycomb with reticulated adhesive.

- if the facing sheet or backing tray is damaged
- a disbond between the honeycomb core and facing sheet or backing tray
- a blockage of the facing sheet weave that resulted in pressure variation across the facing sheet (leading to pressure across the honeycomb cell being unable to equalise).
