# Pressurisation event involving AirAsia Indonesia Airbus A320, PK-AXD

160 NM north of Perth, Western Australia, on 15 October 2017

**ATSB Transport Safety Report**  
Aviation Occurrence Investigation  
AO-2017-098  
Final – 26 November 2019

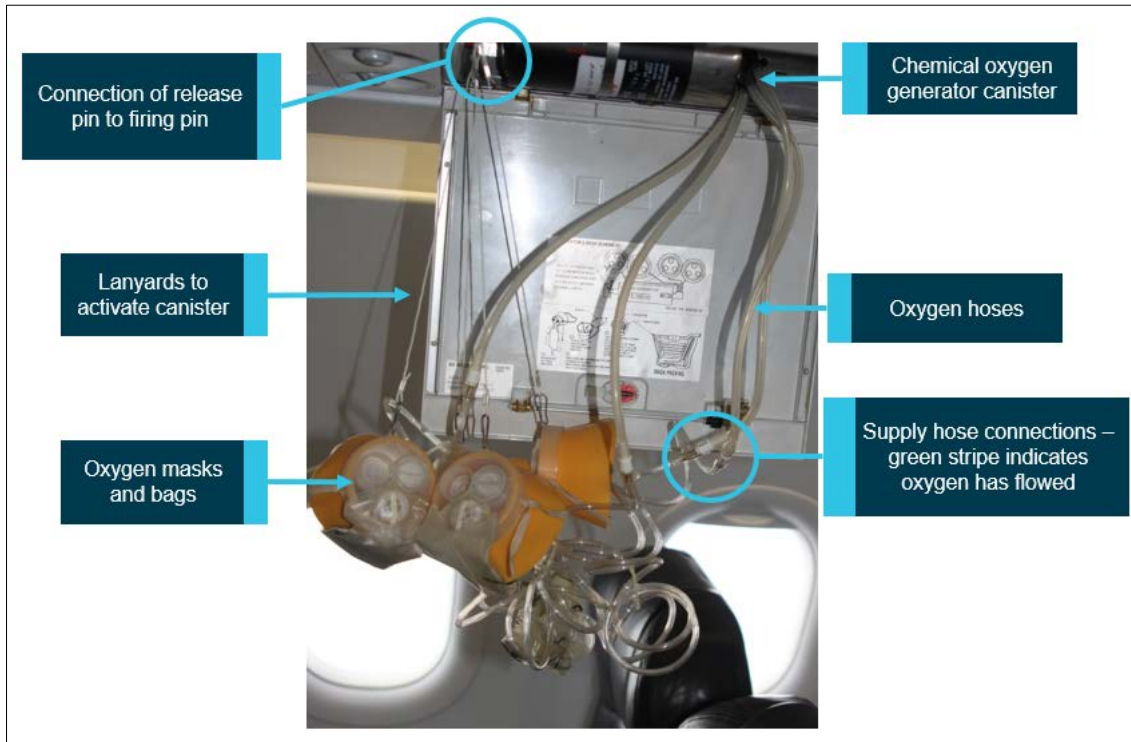
**Figure 3: Deployed oxygen unit**

Each row of seats in the passenger cabin had an emergency oxygen container installed above it. The container doors open automatically when the cabin altitude reaches 14,000 ft, or manually by flight crew selection. Each container had one chemical<sup>18</sup> oxygen generator canister, four masks with lanyards and associated supply hoses (Figure 3).

All four lanyards were attached to one release pin, which, when removed, allowed a spring-loaded firing pin to strike a percussion cap and initiate the chemical reaction (Figure 3 & 4). Only one lanyard was required to be pulled to remove the release pin and drop all four masks for the unit. Oxygen gas was released as a product of the chemical reaction. A thermal indicator on the canister will turn black to indicate the chemical has burned, and a green stripe will appear in the supply hoses to indicate oxygen has flowed (Figure 4).
