# Engine failure involving Airbus A330, 9M-XXD

445 km south-east of Alice Springs, South Australia, on 16 August 2016

**ATSB Transport Safety Report**

AO-2016-101

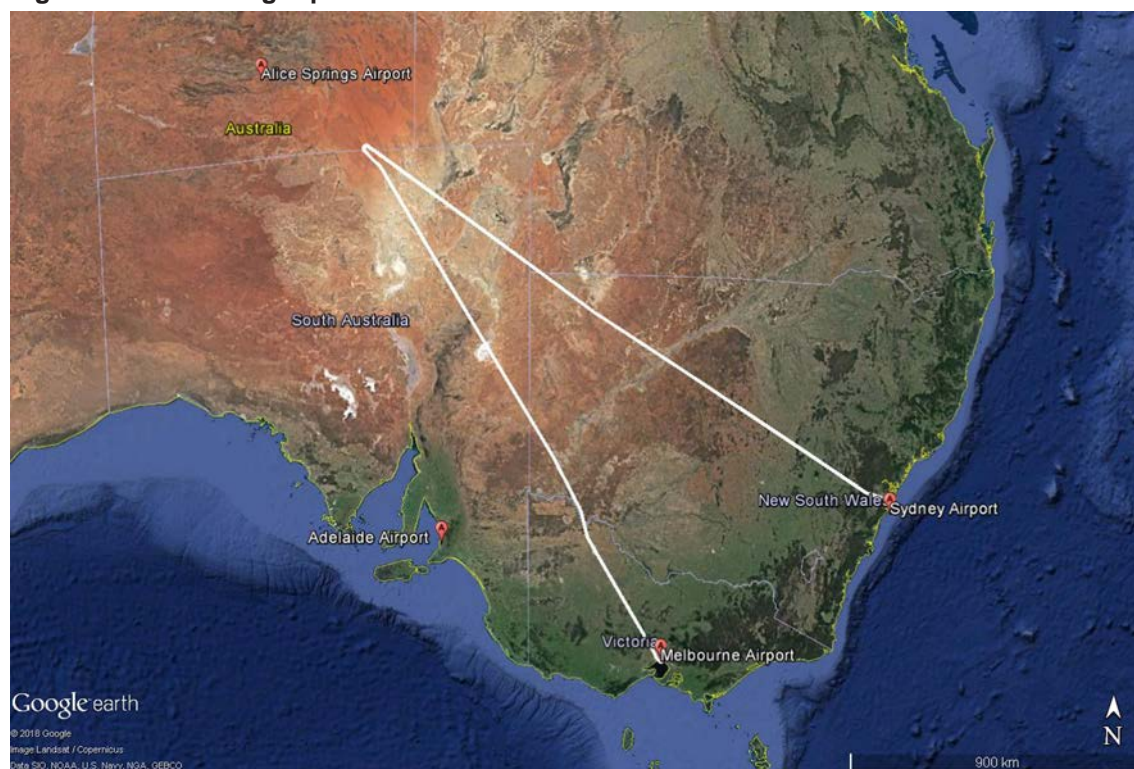
**Figure 1: XAX221 flight path**

As the aircraft approached Alice Springs (Figure 1), the right engine's (engine 2) oil pressure pump failed, and shortly thereafter, the engine failed. The aircraft descended and diverted to Melbourne. During the diversion, the flight crew attempted two restarts of the failed engine. The aircraft landed at Melbourne at 0159 on 17 August 2016.

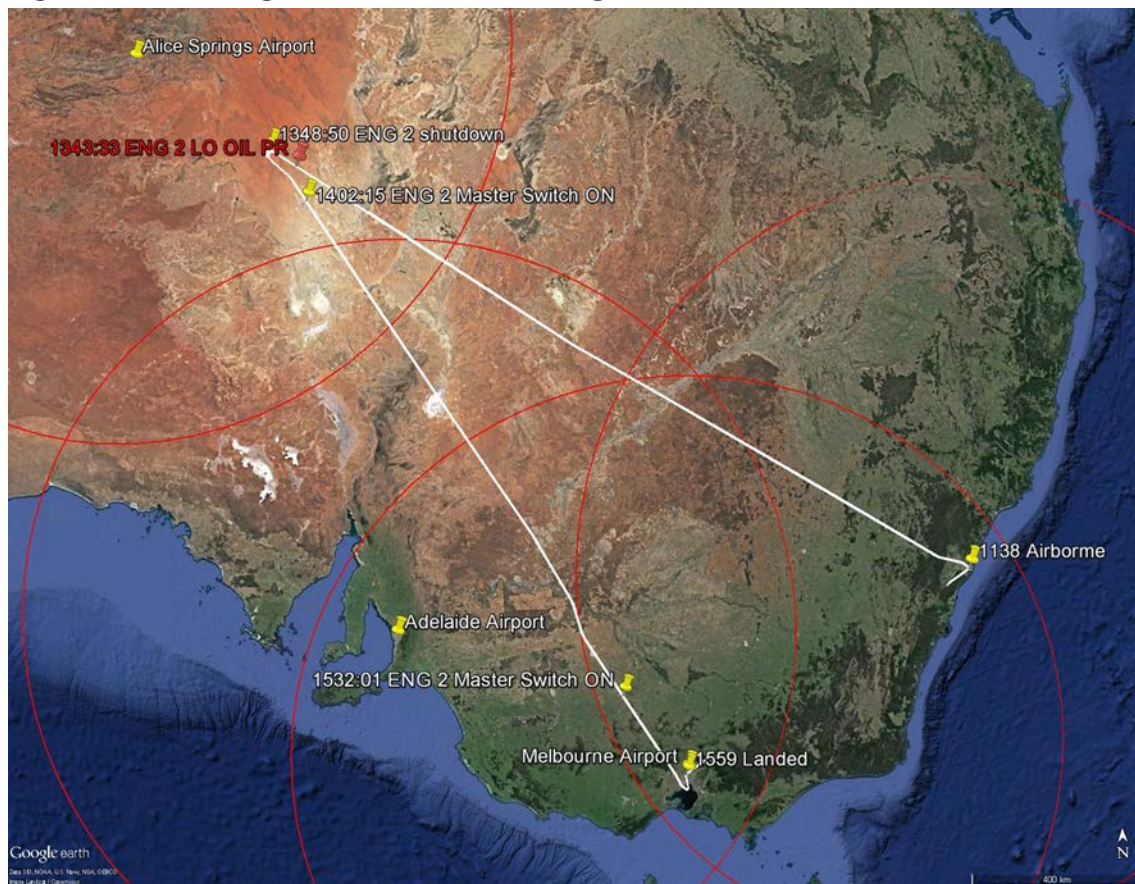
Figure 5: XAX221 flight track, with 430 NM range circles.

The flight track of XAX221 is displayed, as are 430 NM range circles from the company preferred alternates of Melbourne, Adelaide and Alice Springs aerodromes. The positions of the ENG2 OIL LO PR warning and the two engine relight attempts are also shown.  
Source: Google earth, modified by ATSB.
