In-flight break-up involving Cicaré S.A. CH-7BT, VH-JEW

near Roy Hill Station, Western Australia | 28 July 2015

ATSB Transport Safety Report

Aviation Occurrence Investigation AO-2015-089 Final – 20 December 2019 Cover photo: Andrew Miles

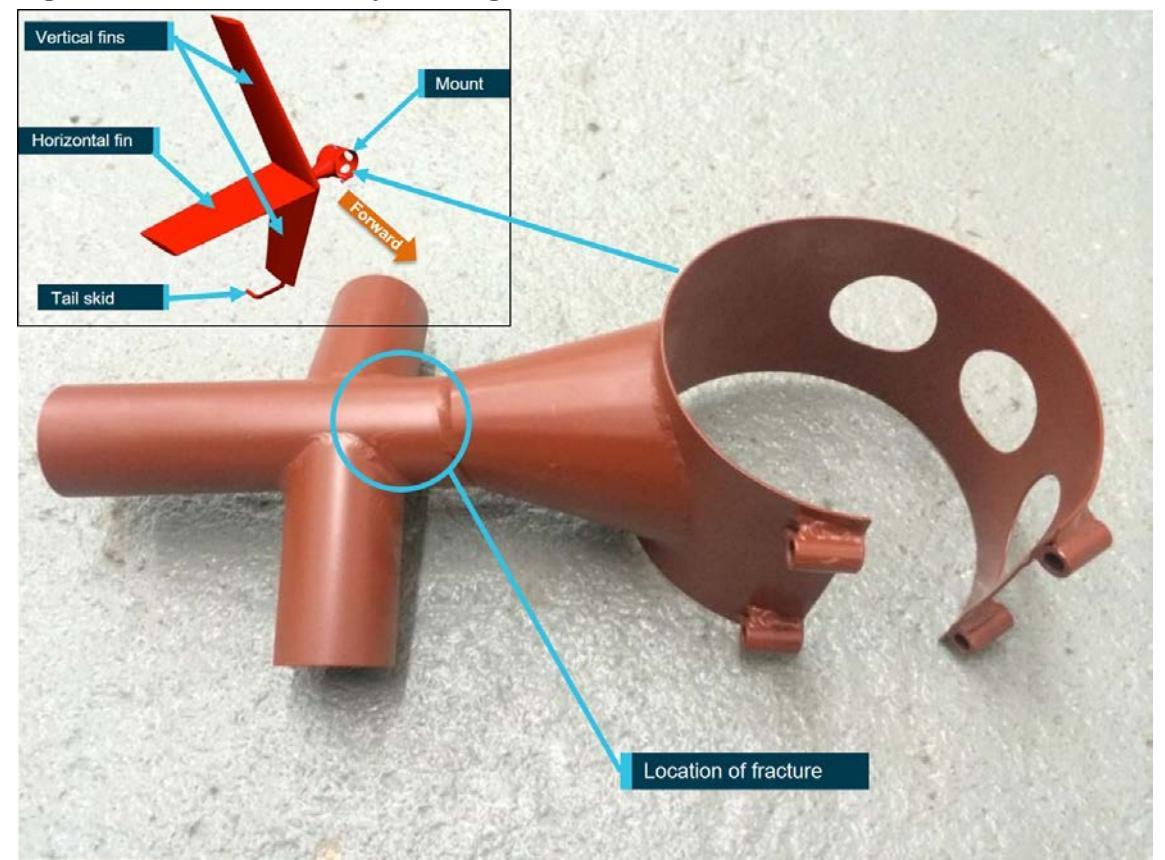
While the build manual provided instructions for manufacturing this component, the kit manufacturer and Australian distributor advised that the CH-7B kits for Australia were supplied with the stabiliser assembly as a pre-assembled component (inset, Figure 3).

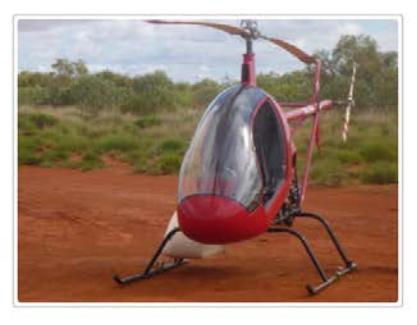
Preliminary technical examination at the ATSB's facilities in Canberra, indicates that in both instances the stabiliser failed due to cracking associated with metal fatigue. In the most recent accident, the crack propagated in a circumferential manner through approximately 75 per cent of the welded structure prior to failure.

The examination showed cracking in the stabiliser attachment outboard of the tail boom, coincident with the welded intersection of the conical and tubular sections of the attachment. The location of the cracking in the attachment cannot be easily inspected as they are obscured by the upper and lower vertical stabiliser fairings.

The ATSB recommends that owners of CH-7B series helicopters ensure the integrity of the stabiliser prior to further operation and on an ongoing basis. While the ATSB is working to establish the factors leading to the two failures, owners are advised to exercise extreme caution in the operation of their helicopters.

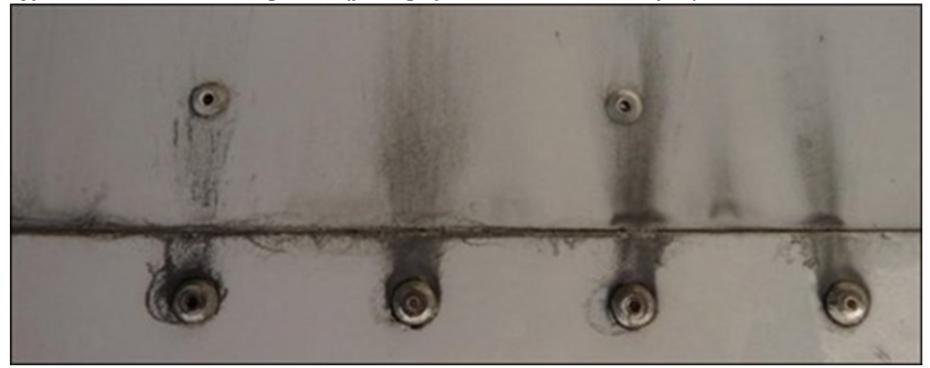
Typical indication of 'working' rivets (photograph not of a CH-7B helicopter)
