Loss of power on take-off and forced landing involving Cessna 182, VH-DGF

Tooradin Airfield, Victoria | 6 January 2019

ATSB Transport Safety Report
Aviation Occurrence Investigation
AO-2019-002
Final – 31 January 2020

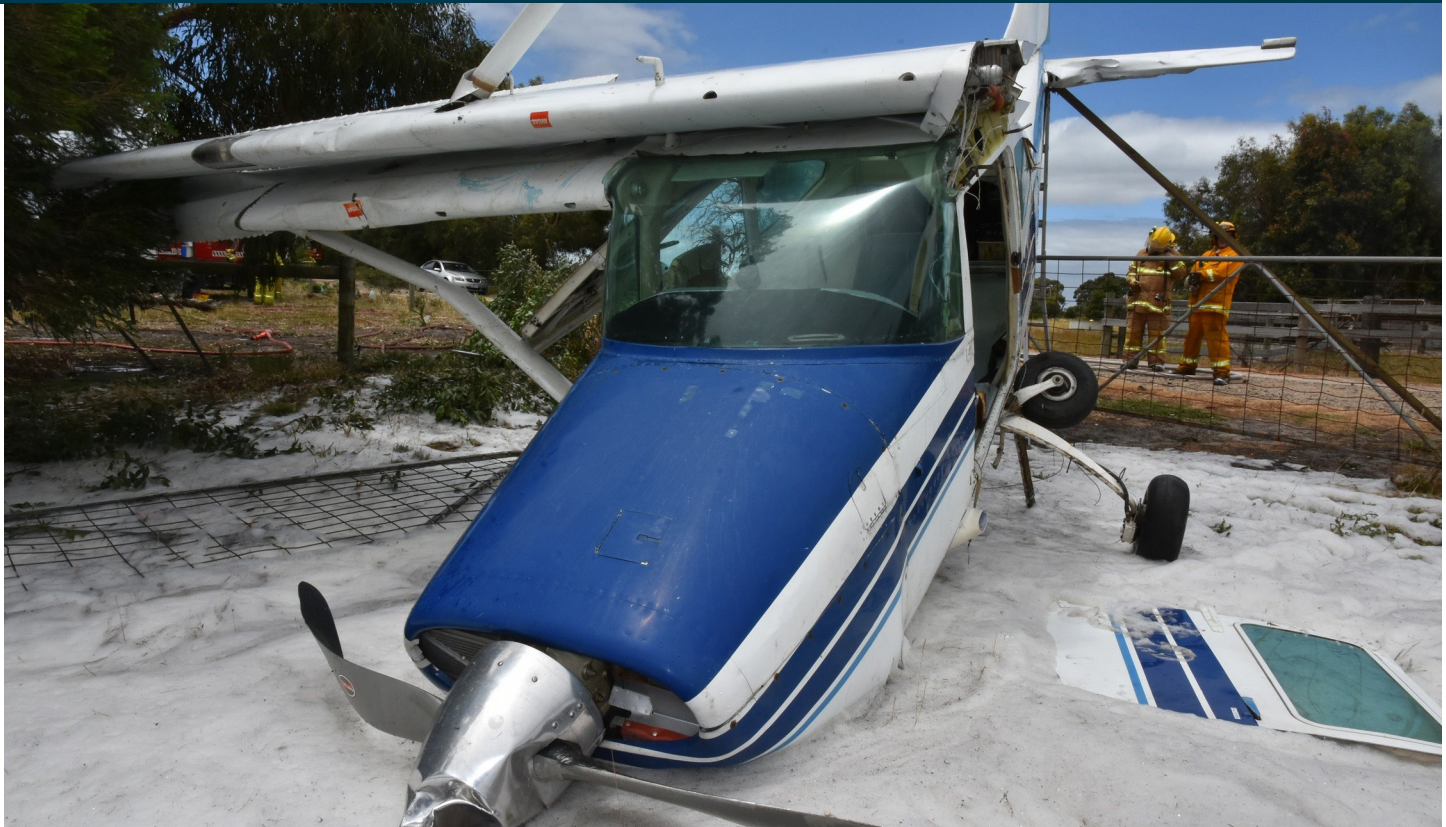
Cover: Victoria Police.

The aircraft touched down in a relatively flat, open paddock. It initially bounced on the unprepared surface before settling on the ground and passing through two boundary fences. The pilot attempted to slow the aircraft and manoeuvre to avoid trees. As the aircraft passed through a gap in the trees, the left wing strut collided with a tree, which resulted in the left wing folding over on top of the right wing and fuel leaking from it onto the fuselage. The aircraft further collided with a third fence, crossed a private road, and collided with a fourth fence, which collapsed the nose landing gear (Figure 1).

The aircraft was substantially damaged and there were no injuries.
