Engine failure involving Airbus Helicopters AS355F-1, VH-SEV

Bankstown Airport, New South Wales on 12 March 2018

ATSB Transport Safety Report
Aviation Occurrence Investigation
AO-2018-021
Final – 12 March 2020

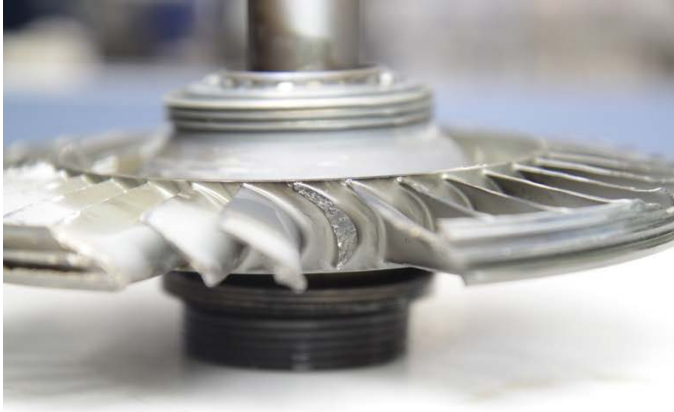
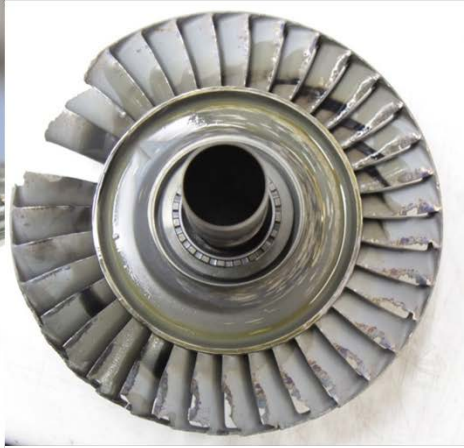
The incident resulted in substantial damage to the right-hand engine and minor heat damage to the surrounding structure on the aircraft.

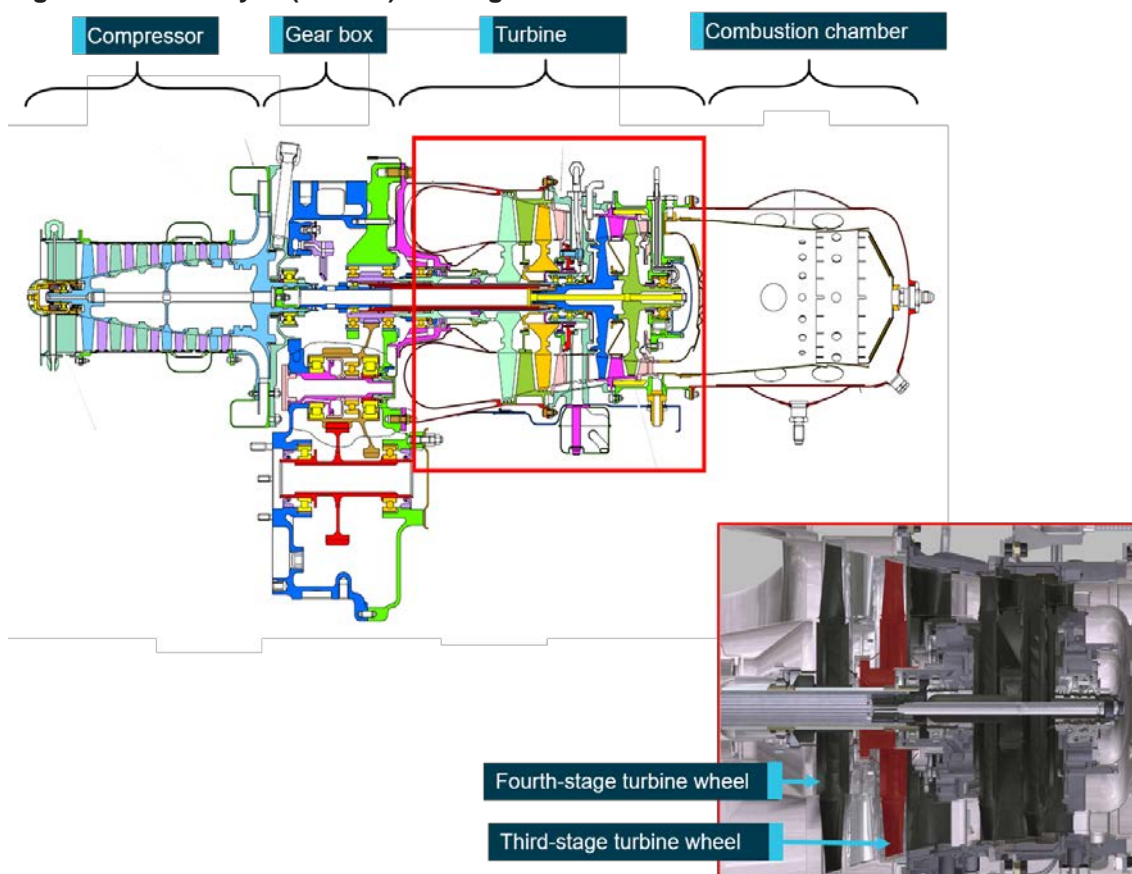
Figure 2: Rolls-Royce (Allison) 250 engine cross section

On 31 January 2018, a heavy maintenance inspection was conducted on the engines installed on SEV. The maintenance included actions required for compliance with the relevant airworthiness directive (AD) and commercial engine bulletins (CEB) (see the section titled *Aircraft safety alerts*). Some of the maintenance items on the turbine section (Figure 2) of the right-hand engine included:

- replacement of the first-, second- and fourth-stage turbine wheels
- fluorescent penetrant inspection (FPI) on the third-stage turbine wheel (there were no crack indications identified during the inspection).
