Uncontrolled flight into water involving Cessna 208B, VH-FAY

260 km north-east of Narita International Airport, Japan, on 27 September 2018

ATSB Transport Safety Report Aviation Occurrence Investigation AO-2018-065 Final – 18 March 2020 Released in accordance with section 25 of the Transport Safety Investigation Act 2003

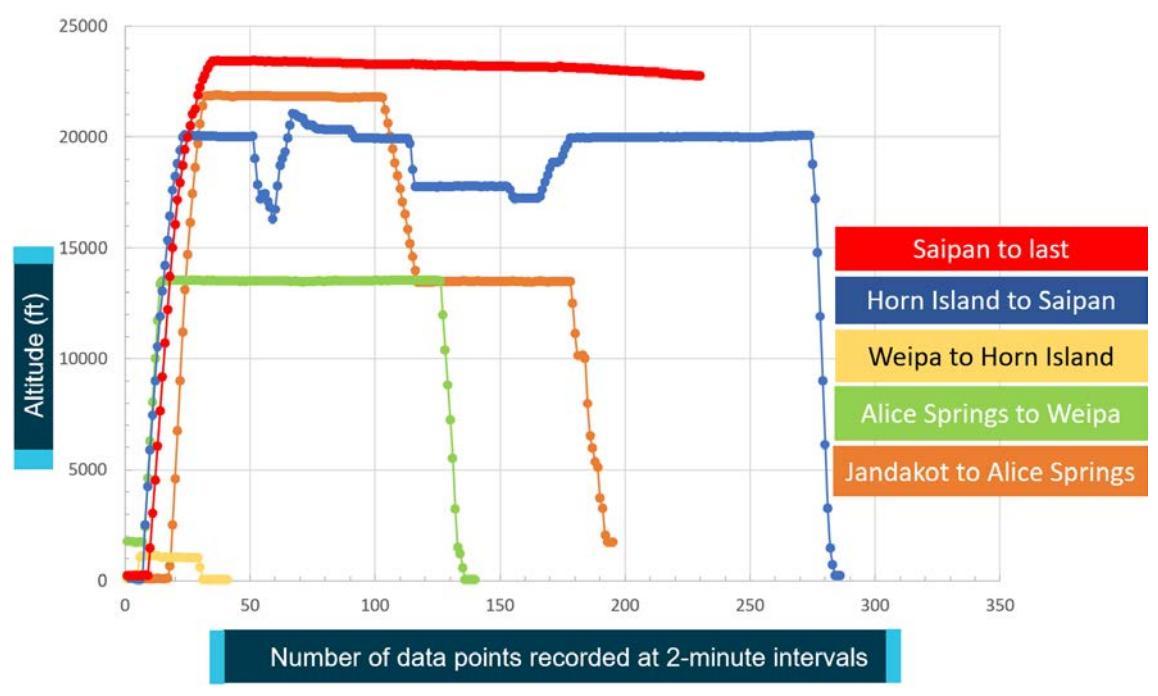
The geometric altitude for the occurrence flight from Saipan showed a gradual descent from top of climb at 23,412 ft to the last recorded position at 22,770 ft. This was consistent with the aircraft flying into reducing temperature and barometric pressure. The corresponding radar data recorded pressure altitude at intervals of about 10 seconds and showed a constant altitude at 22,000 ft AMSL.

The pilot sent several messages from the Garmin device after departing Saipan and before the aircraft reached reporting point TEGOD. The last position recorded by the Spidertracks and Garmin devices was at 0626 UTC at FL 220. The aircraft took less than 2 minutes to descend from FL 220 to the ocean and there were no GPS recorded points below that altitude.
