# Loss of control and collision with terrain involving Cessna 441, VH-XMJ

4 km west of Renmark Airport, South Australia on 30 May 2017

**ATSB Transport Safety Report**  
Aviation Occurrence Investigation  
AO-2017-057  
Final – 30 April 2020

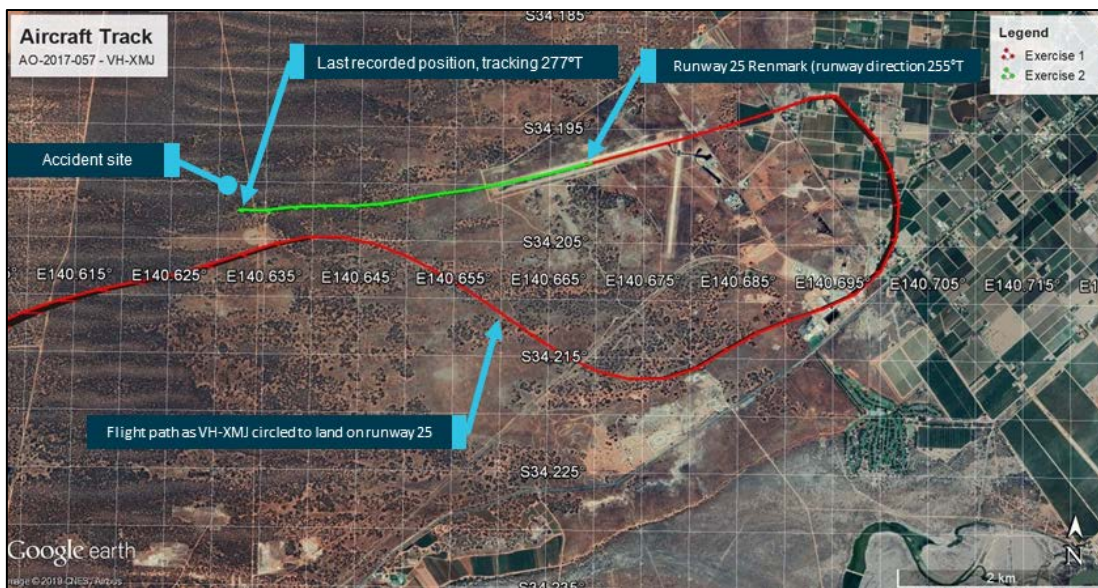
The aircraft maintained the runway heading until reaching a height of between 300-400 ft above the ground (see the section titled *Recorded flight data*). At that point the aircraft began veering to the right of the extended runway centreline (Figures 1 and 15). The aircraft continued to climb to about 600 ft above the ground (700 ft altitude), and held this height for about 30 seconds, followed by a descent to about 500 ft (Figures 2 and 13). The information ceased 5 seconds later, which was about 60 seconds after take-off.

**Figure 1: Position information of VH-XMJ as the aircraft circled and landed on runway 25 (depicted in red), before backtracking and departing (depicted in green).**

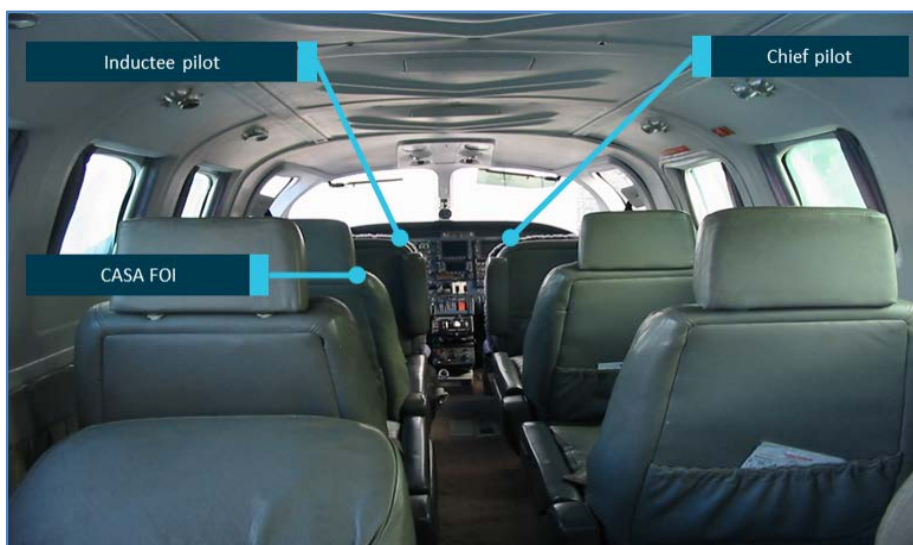
There is no jump seat<sup>15</sup> in a Cessna 441 aircraft, so the CASA FOI sat in the first row passenger seat, on the left side of the aircraft, behind the inductee pilot (Figure 18). From the seated position, he should have had some visibility of the chief pilot, and the controls and instruments, but was not likely to be able to read the instruments precisely.

**Figure 18: Exemplar Cessna 441 in a similar configuration to the accident aircraft**
