Pitch trim runaway (uninterrupted) and partial loss of control, Pilatus PC-12/47E, VH-OWJ

4 km west of Merredin, Western Australia on 14 April 2019

ATSB Transport Safety Report
Aviation Occurrence Investigation
AO-2019-019
Final – 13 May 2020

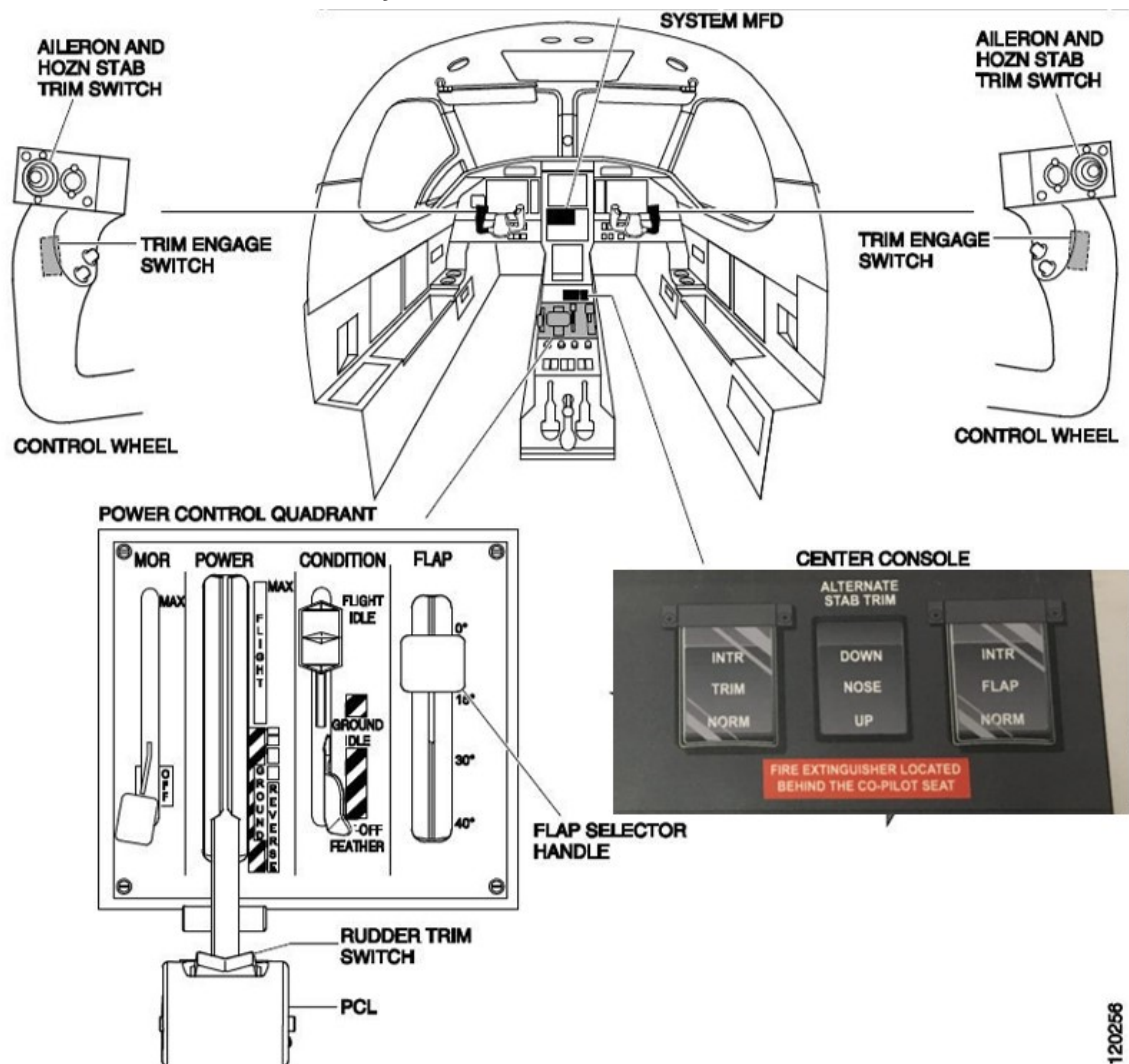
Figure 4: Pilatus PC-12/47E trim system features

The wing flap system is electrically actuated and controlled by a selector handle on the centre console to the right of the engine control quadrant. Located forward of the flap selector handle is a Flap Interrupt switch (Figure 4) that disables normal operation of the flap system and generates a 'Flap' caution message on the CAS if the switch is selected to INTR. Irrespective of subsequent switch selections, the flaps will not operate until reset on the ground.

The ATSB notes that, as can be seen in Figure 4 (bottom right), the Flap Interrupt switch and Trim Interrupt switch appear to be the same type of switch and are located on the same panel, either side of the Alternate Stab Trim switch (refer to the following *Safety analysis* section).

The Trim Interrupt switch and Flap Interrupt switches were both located in the centre console and appeared to be the same type of switch with a similar function (Figure 4 bottom right). Although the switches were differentiated by being located either side of the Alternate Stab Trim switch, and the Flap Interrupt switch was located forward of the Flap Selector Handle, the similarities increased the risk of mis-selection.

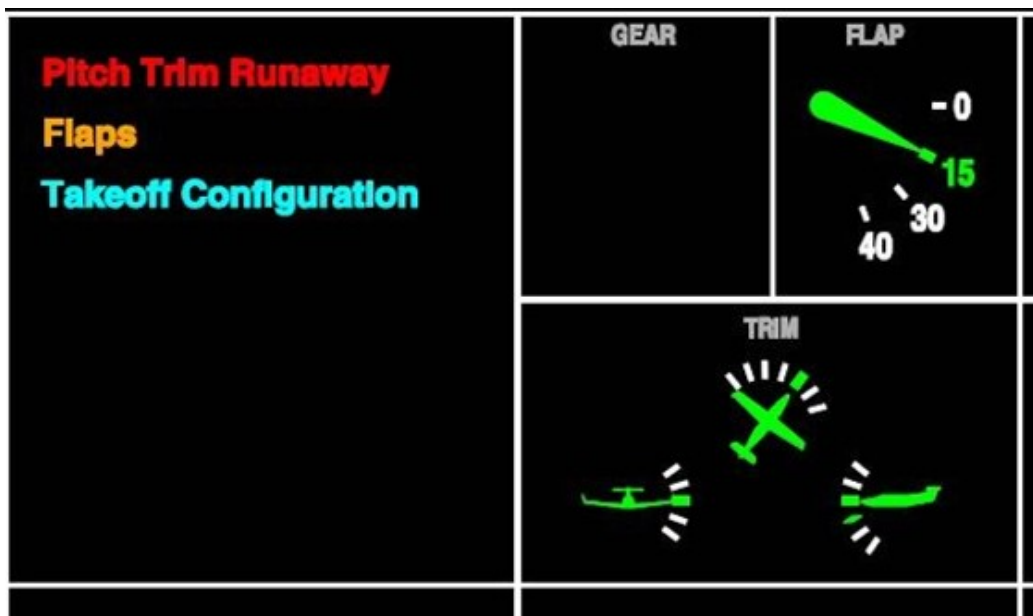
Figure 5: Sample multi-function display showing acknowledged CAS messages

The ATSB notes that conditions 2 and 3 will cancel the message and stop a related runaway but condition 1 will only cancel the message without any effect on a runaway condition. The recorded data showed that the pitch trim runaway warning was cancelled and reactivated three times in the 32-second period after the initial warning. This was consistent with the pilot attempting to use the manual trim, which was ineffective in resolving the runaway.
