# Loss of control and collision with terrain involving FU24 Stallion, VH-EUO

40 km north-east of Bathurst, New South Wales, on 16 June 2017

**ATSB Transport Safety Report**  
Aviation Occurrence Investigation  
AO-2017-062  
Final – 19 May 2020

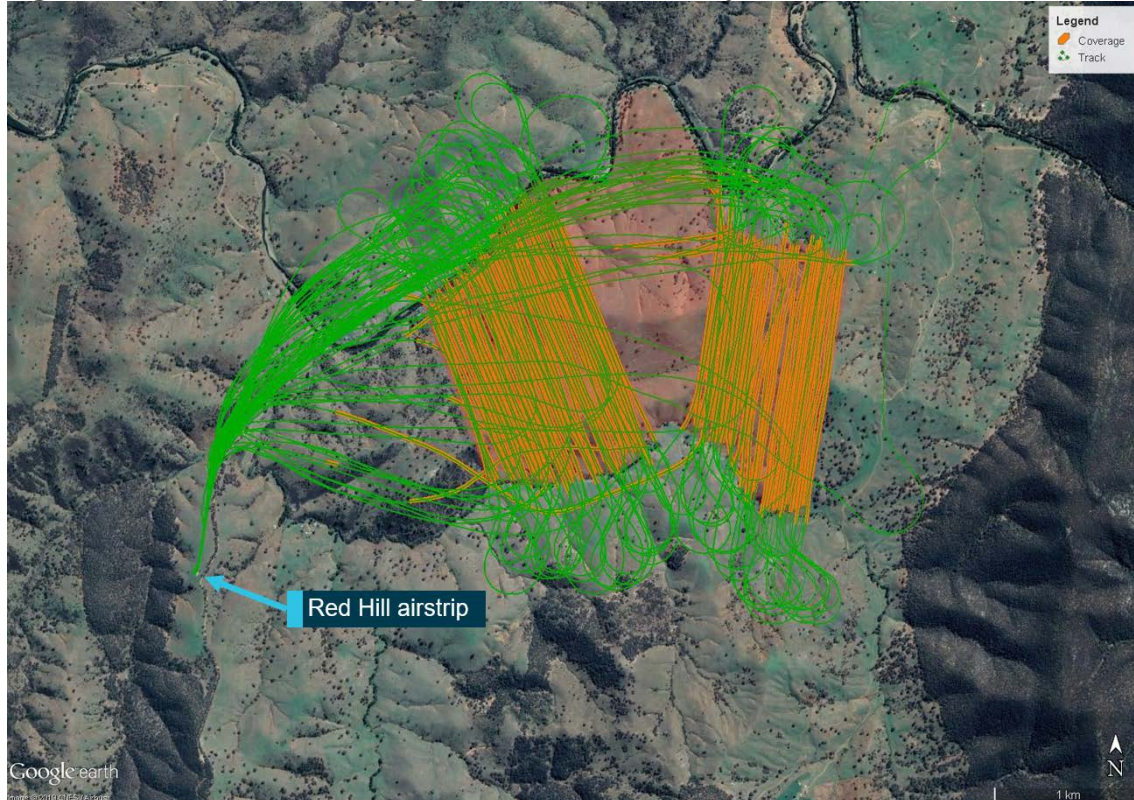
**Figure 6: TracMap data of the flights involved in the first job on 16 June**

Figure 6 shows TracMap data for the flights involved in the first job on 16 June. Work on this job started at about 0900 and continued until about 1350. During this time, two hot refuels<sup>15</sup> were conducted, one at 1048 and one at 1250. Approximately 40 tonnes of fertiliser was applied during this job.

Figure 6 shows the aircraft's flight track (shown in green) as well as the areas where fertiliser was applied (shown in orange). The red shaded area shows the approximate area of application for this job. Also shown by the annotation is the location of the Red Hill airstrip. Source: Google, annotated by ATSB.

Analysis of the TrackMap data of the procedure turn conducted on the penultimate flight (Figure 7), as well as a number of standard procedure turns conducted on the previous job (Figure 6), indicated that it took the pilot between 30 and 35 seconds to reposition the aircraft safely onto a reciprocal track using a procedure turn. Additionally, analysis of a number of previous flights by the pilot that day indicated that application runs were conducted at an average speed of 100 kt.
