Grounding of the bulk carrier *Orient Centaur*

Weipa, Queensland | 6 November 2017

ATSB Transport Safety Report
Marine Occurrence Investigation
MO-2017-010
Final – 14 November 2019

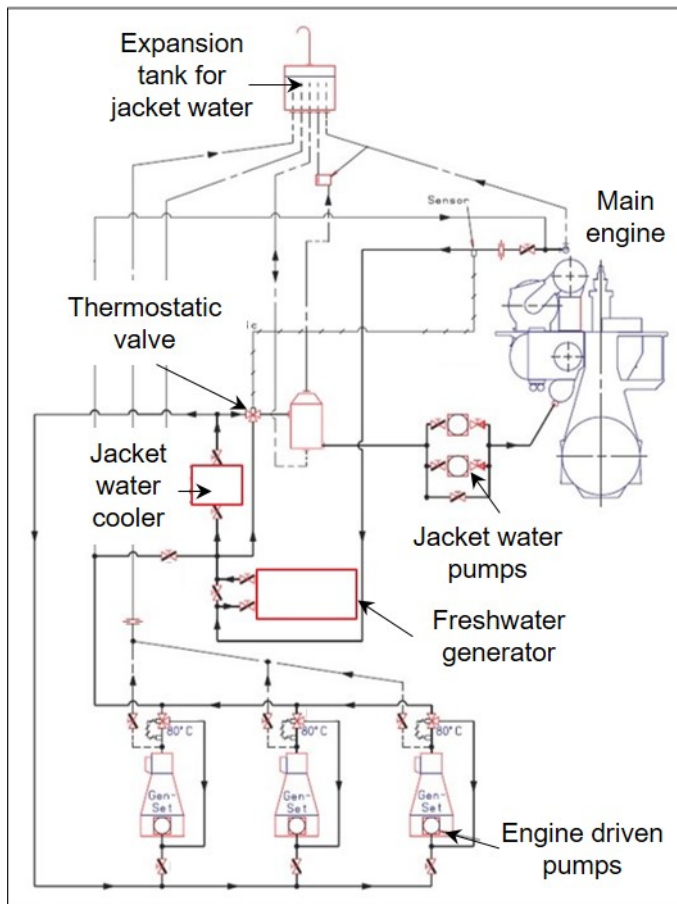
Figure 6: Jacket water cooling diagram

At 1716, as the ship passed SC13 and SC14, the ship's main engine jacket water header tank went into low-level alarm, followed by low-pressure and high-temperature alarms. The chief engineer phoned the bridge and asked the master to stop the main engine for repairs, as there was a cooling water issue. The conning pilot advised the master that half ahead was acceptable and the master moved the telegraph to half ahead. He then advised the chief engineer, the main engine could not be stopped as the ship was in a narrow channel.

The jacket cooling water system (Figure 6) is used for cooling the cylinder liners, cylinder covers, and exhaust valves of the main engine, and for heating the fuel oil drainpipes.

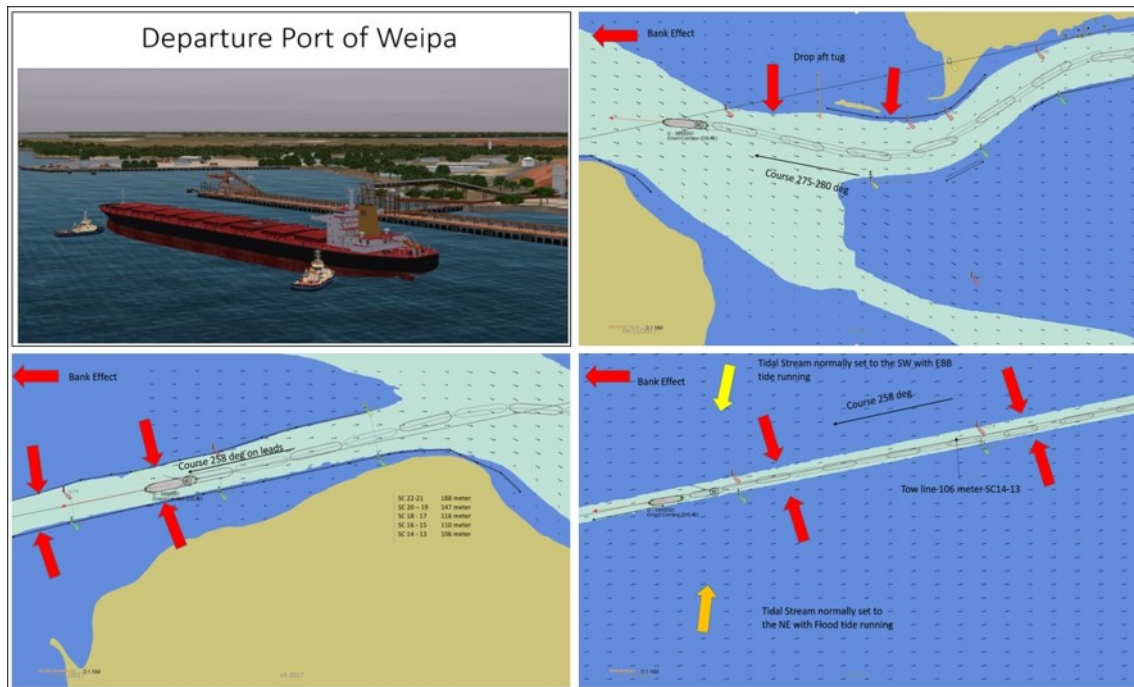
Figure 8: Port simulation exercise report

In 2017, Rio Tinto Marine submitted a written application to the RHM for mini cape-size ships that were 255 m in length with a 43 m beam to export bauxite from Weipa. As the ships exceeded the port's size limits, Full Mission Bridge Simulation (FMBS) exercises were required. In May and July 2017, the RHM, pilot manager, several senior pilots and a Rio Tinto shipping specialist, attended the MSQ Smartship simulator in Brisbane, Queensland, to conduct the FMBS exercises. The exercises (Figure 8) used a model of the mini cape-size bulk carrier for arrivals in a ballast condition and departures in a fully laden condition, to a maximum draught of 12.8 m.

Red arrows show areas of bank effect, yellow arrows show flood tide, other annotations show ship's course, past positions and tidal information.

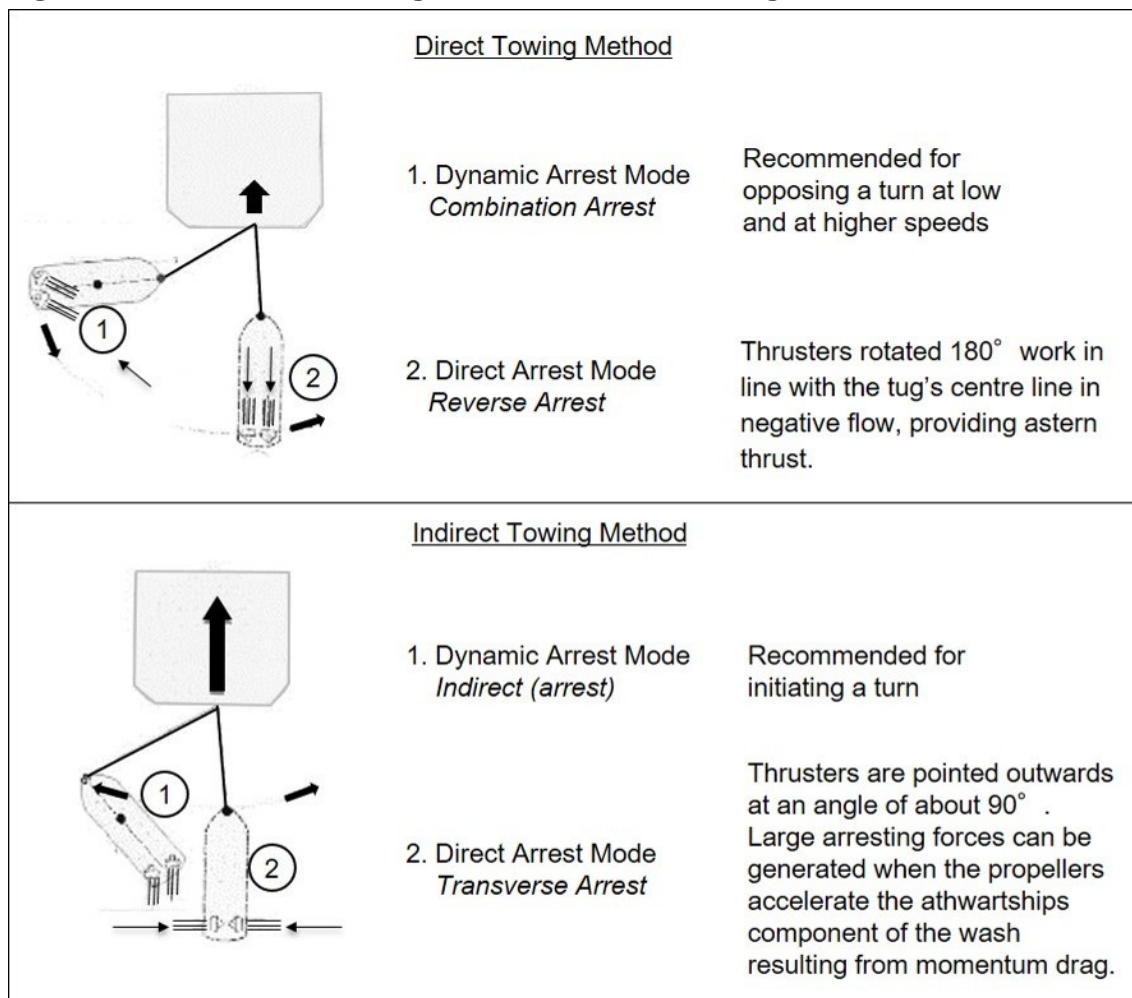
Figure 9: Azimuth stern drive tugs - direct and indirect towage methods

ASD tugs can be operated in either direct or indirect towage methods (Figure 9). The method used in the Port of Weipa was direct towage, as the tugs were predominantly used for harbour work and assisting ship berthing and un-berthing manoeuvres. Direct towing is performed at low speeds from about 0- 5 knots. The tug uses its engines and propellers to generate the tow force (directly), which is governed by the conventional bollard pull of the tug.

The effectiveness of the towage methods is also dependent on the availability of safe water to work in. In a narrow channel, the ability to work around the radius of the towline is restricted. Therefore, with the ship at speed (about 8 knots) in the South Channel (106 m) it was prohibitive for a tug to effectively steer it using dynamic arrest mode. However, direct arrest mode remained an effective option when retarding (braking assistance) forces were required.
