Loss of control and collision with terrain involving Eurocopter AS350BA helicopter VH-BAA

Hobart Airport, Tasmania, on 7 November 2017

ATSB Transport Safety Report

AO-2017-109

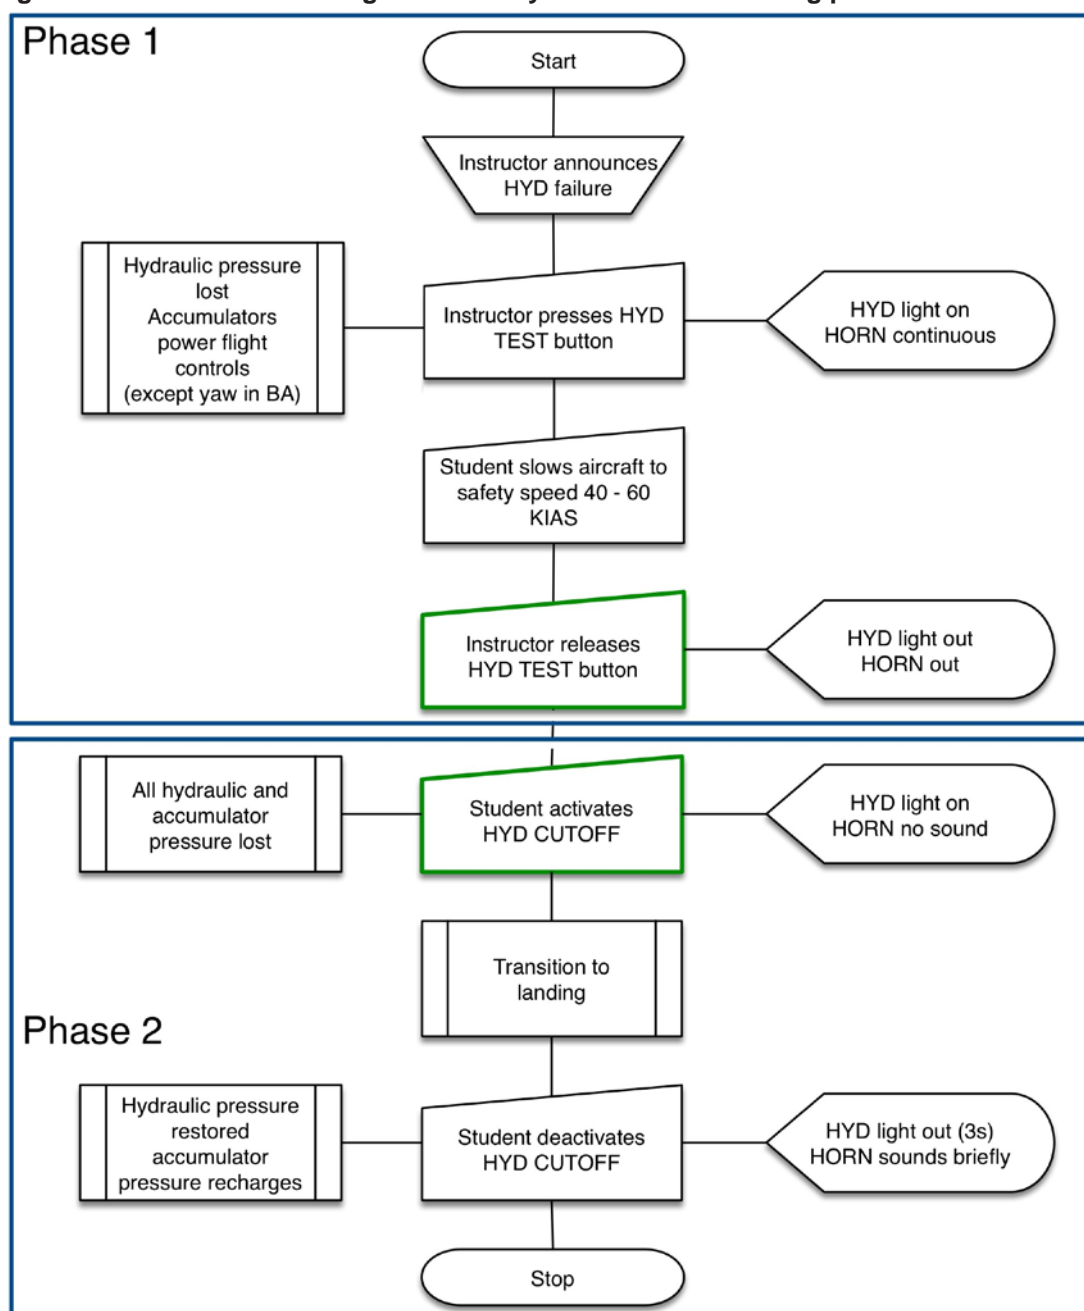
Figure 2: AS350 Rotorcraft flight manual hydraulic failure training procedure

Supplement 7 of the AS350 RFM was incorporated in 2003; it carried specific instructions for hydraulic failure training. The sequence was divided into two distinct phases, and the hydraulic cut-off (HYD CUTOFF) switch and hydraulic test (HYD TEST) switch would not be engaged at the same time. This prevented depletion of tail rotor hydraulic pressure accumulators (not fitted in VH-BAA), and ensured only one switch would be required to restore hydraulics at any time. Figure 2 illustrates the two phases of the procedure.

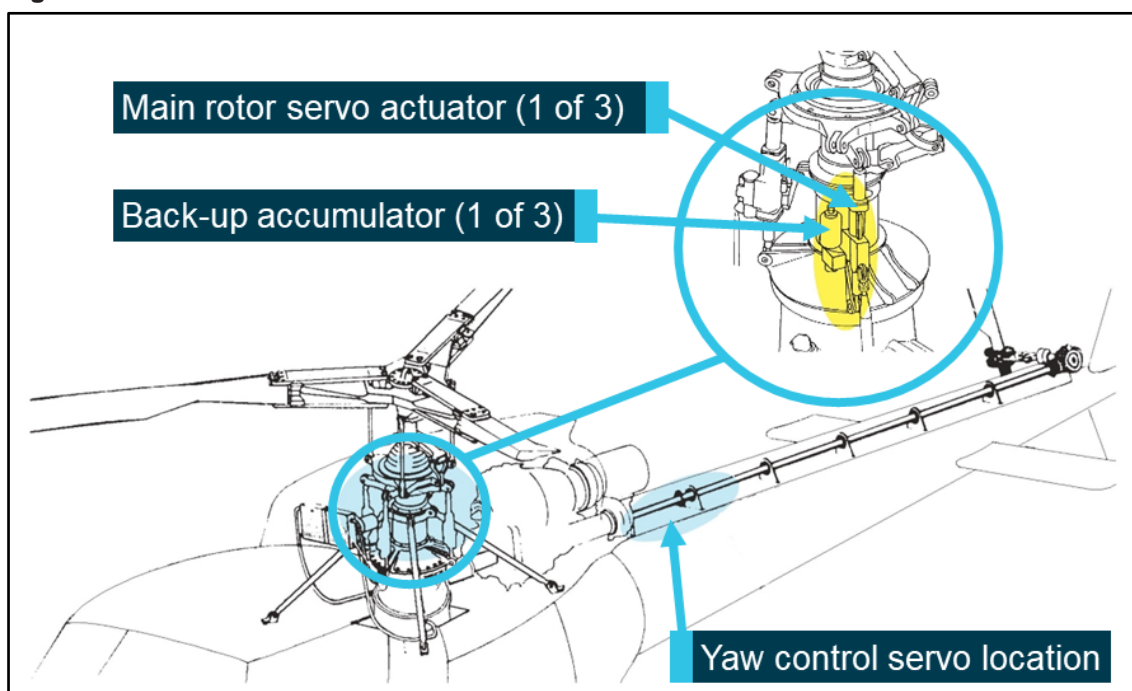
Figure 4: AS350 servo locations

There were three Dunlop servo actuators for control of the main rotor and one Dunlop servo actuator for control of the tail rotor (Figure 4). With hydraulics operating, the input force required to move the rotor blades, at the cyclic,⁵ is less than or equal to 0.3 kgf. For that cyclic input, at 40 bar, the system provides an output of 183.5 kgf.

A yaw load compensator was fitted to later iterations of the aircraft in order to overcome excessive forces in yaw control in the absence of hydraulic assistance. VH-BAA was not fitted with a yaw load compensator, and did not have an accumulator on the yaw control. In the AS350BA, in the absence of hydraulic assistance, yaw control loads are felt directly and immediately.

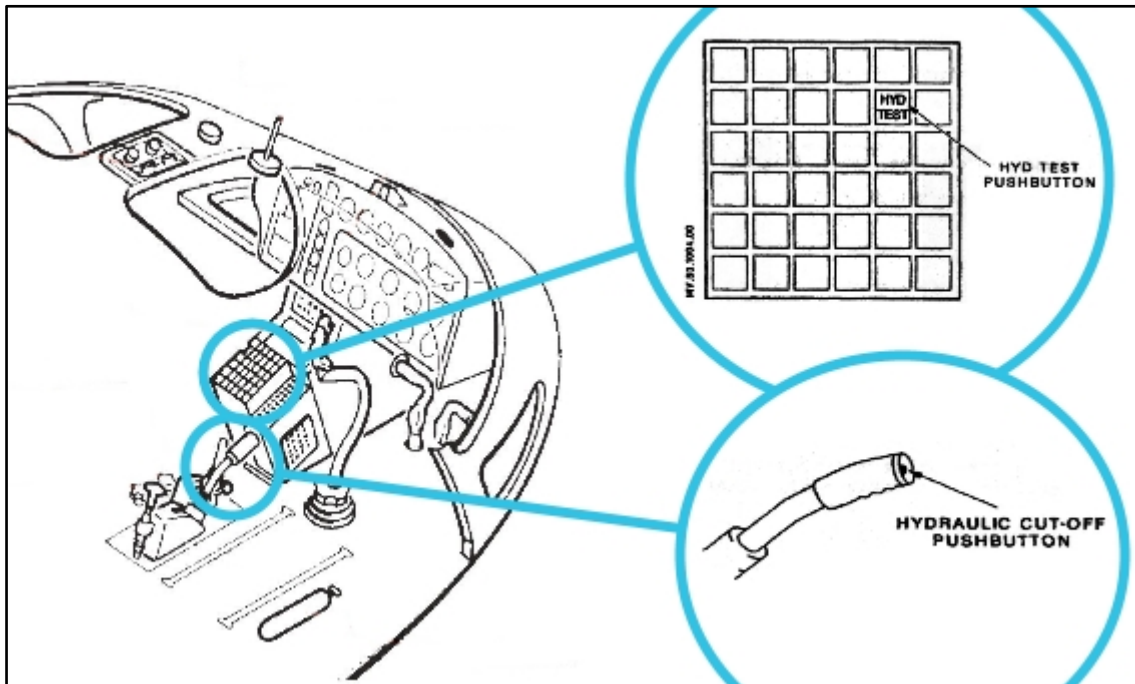
Figure 5: HYD TEST switch and HYD CUTOFF switch locations

The hydraulic system is managed via two switches. The guarded, console-mounted push-button HYD TEST switch, and the recessed, collective-mounted⁶ HYD CUTOFF switch (Figure 5).

The HYD CUTOFF switch is ON (out) in normal operation. Pressing the HYD CUTOFF switch OFF (in) bypasses the servos by connecting the pressure inlet and return outlet in each one. The effect is to depressurise the servos and the back-up accumulators of the main rotor servo actuators. It is used in the event of an in-flight emergency, once the safety speed of 40-60 kt has been established, to ensure that residual accumulator pressure causes no asymmetry in forces across the flight controls.

In emergency procedure training, the HYD TEST switch is used to induce hydraulic failure in flight and the HYD CUTOFF switch is used to conduct hydraulic off landings. If either switch is in, the system will not provide hydraulic pressure to the controls. As previously detailed in the section titled *Hydraulic failure training*, they should not be activated together in the AS350BA, so hydraulics can be restored with one switch.

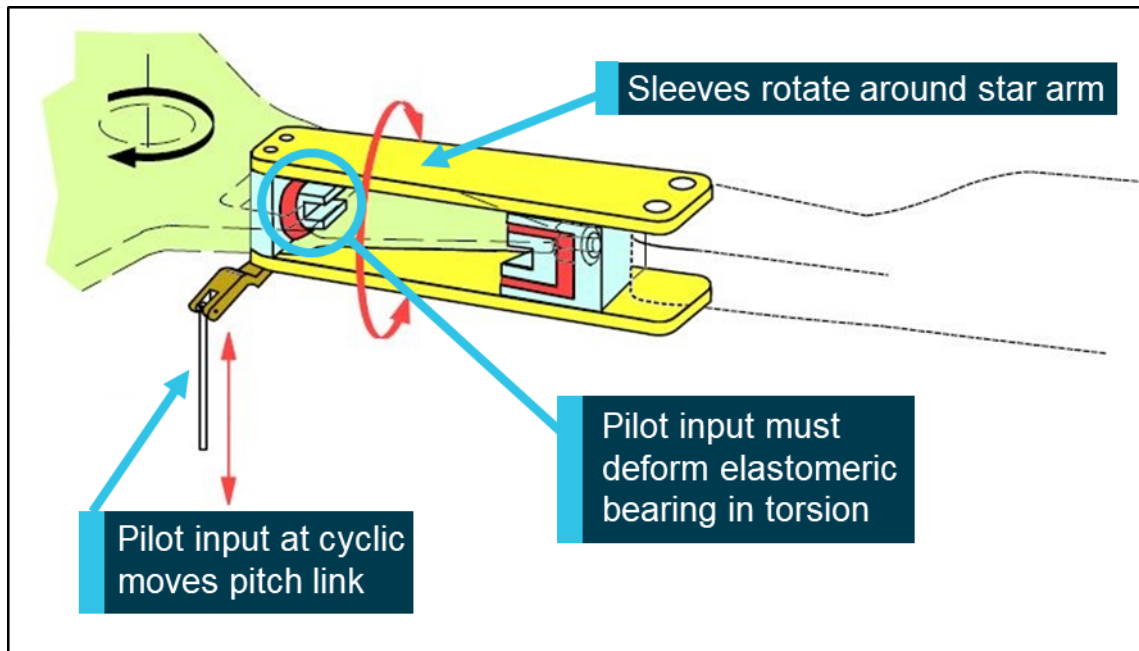
Figure 6: AS350 main rotor pitch change mechanism

The AS350 was fitted with a starflex hub (Figure 6). This design replaced hinges with elastomeric (rubber type) bearings. Without hydraulic assistance, the pilot must exert significant effort to push or pull the flight controls to deform the elastomeric bearings, change the pitch of the blades, and control the helicopter.

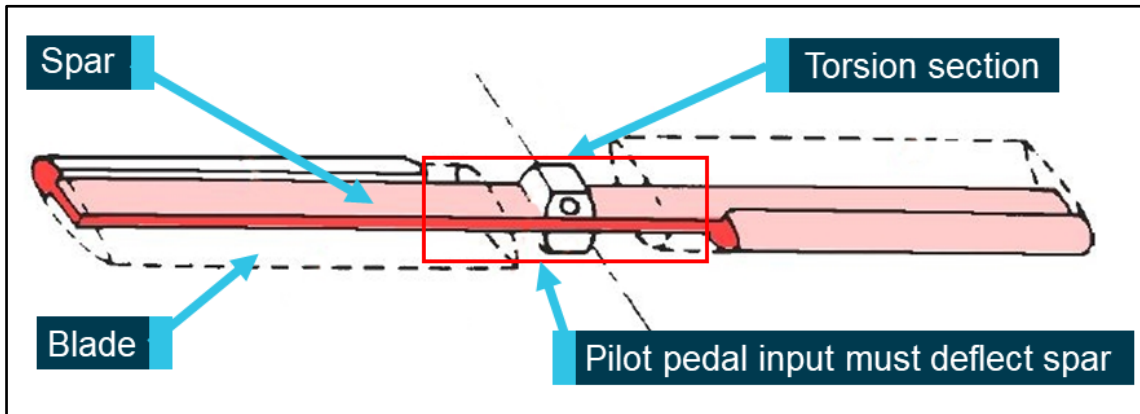
Figure 7: AS350 Tail rotor

The AS350 tail rotor is built on one continuous composite spar (Figure 7). Without hydraulic assistance, the pilot must push the pedals and twist the spar to change the pitch of the tail rotor blades. While helicopter weight and speed affect pedal force, the Royal Australian Air Force (RAAF) Aircraft Research and Development Unit (ARDU) (see section titled *Research*) found that a tail rotor pitch change requires a force of up to 50 kgf. Airbus Helicopters advised they were able to demonstrate significantly lower required forces in flight tests while observing flight manual limitations.

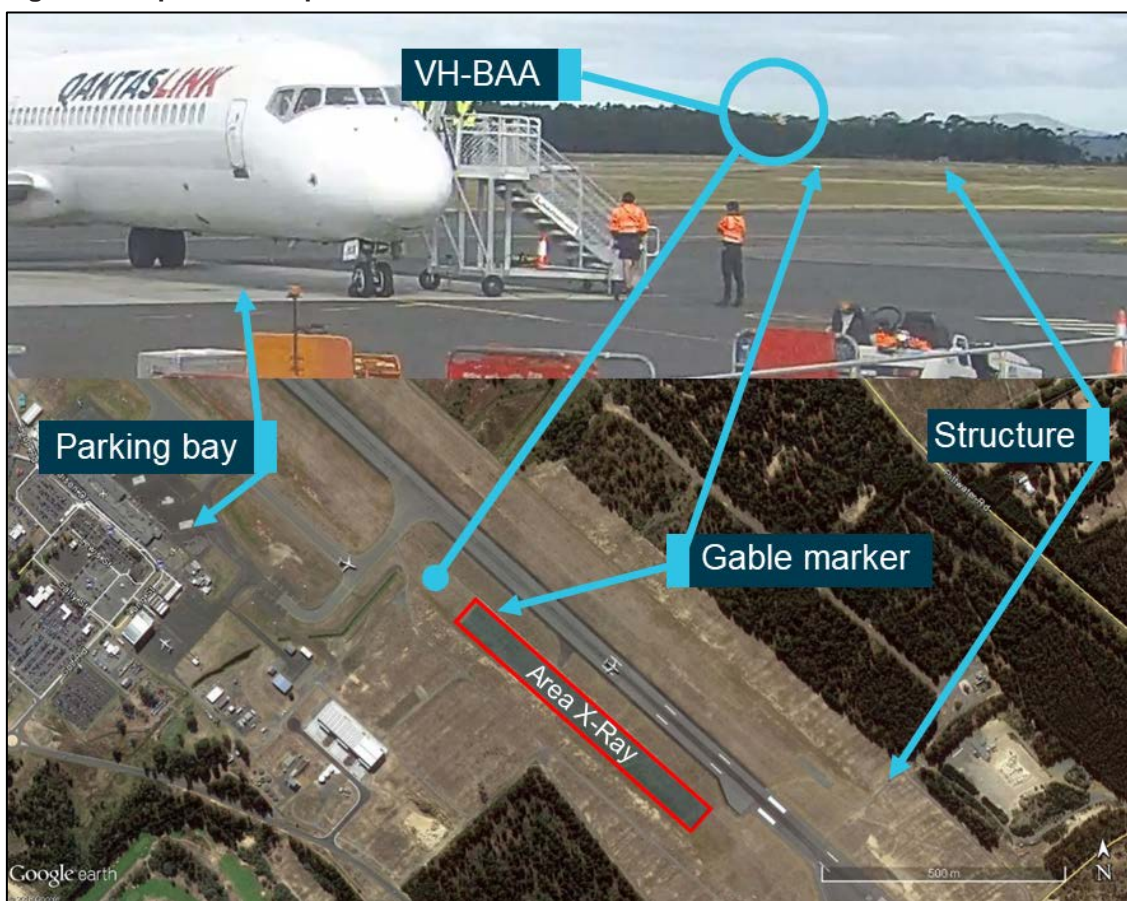
Figure 14: Apron CCTV point of view

Closed circuit television (CCTV) from the regular public transport apron of the Hobart Airport captured VH-BAA during approach, loss of control and impact. Figure 14 shows the point of view from the apron CCTV.
