# Loss of cyclic control and in-flight break-up involving Robinson R22 helicopter, VH-HGU

7 km north-north-west of Cloncurry Airport, Queensland, on 2 August 2017

ATSB Transport Safety Report Aviation Occurrence Investigation AO-2017-078 Final – 21 July 2020 Released in accordance with section 25 of the Transport Safety Investigation Act 2003

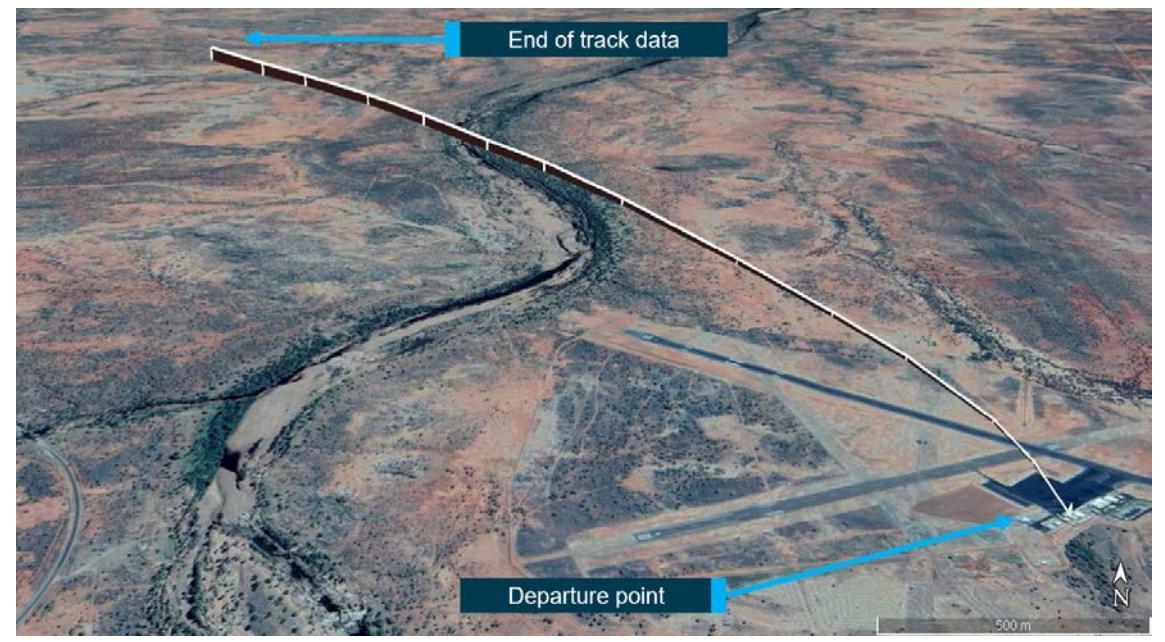
Figure 3: Accident flight GPS track

powerlines. Table 1 provides the data points for the accident flight. The ATSB considered the final data point (14), which was beyond the accident site, to be an unreliable point for the purpose of analysis as it very likely represented a predictive point.<sup>17</sup>

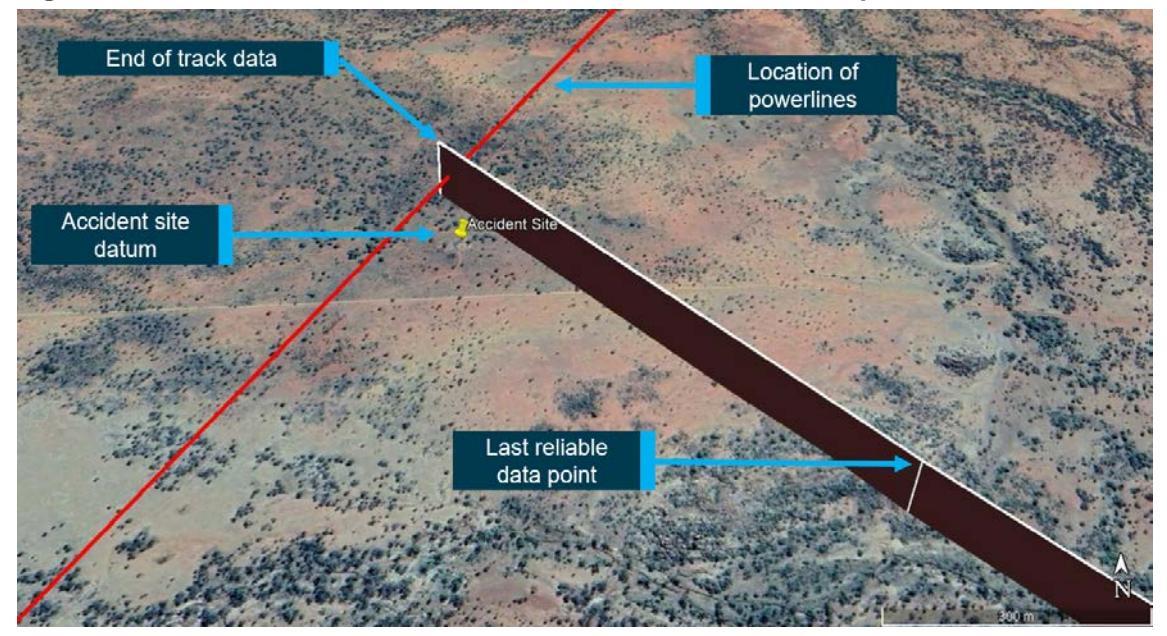
### Figure 4: Accident site datum relative to the last reliable GPS data point

Figure 3 depicts the helicopter's GPS track from take-off to the accident site, and Figure 4 depicts the position of the main wreckage relative to the last reliable GPS data point and vicinity to the

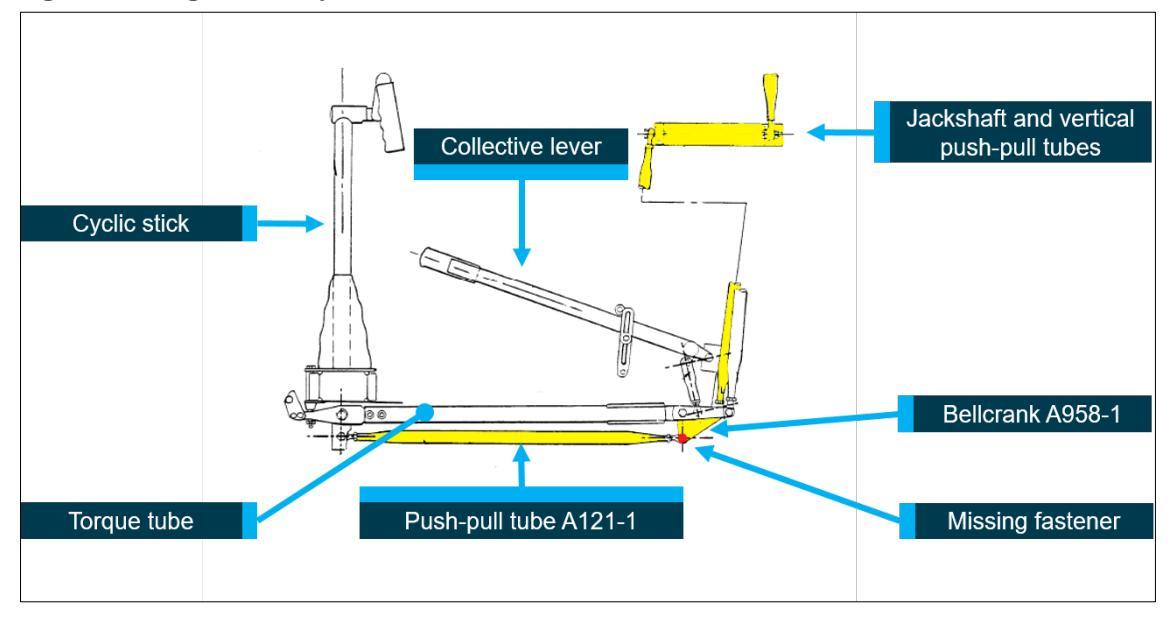
Figure 7: Longitudinal cyclic control

During the photographic review of the wreckage after the initial on-site inspection, the ATSB noted an anomaly with a flight control bellcrank (part number A958-1) in the cyclic control assembly. The fastener,<sup>26</sup> which attached the horizontal push-pull tube (part number A121-1) to the bellcrank, was missing. The remaining bellcrank fasteners were all attached. The missing fastener was part of the longitudinal cyclic control, which controls the fore-aft tilt of the main rotor disc (Figure 7). The RHC R22 *Illustrated Parts Catalog* (IPC) showed that the flight controls should be secured at the bellcrank with a National Aerospace Standard (NAS) 6604-15 bolt and D210-4 self-locking nut.<sup>27</sup>

With reference to Figure 7, a compression load on the A121-1 push-pull tube is consistent with a force tilting the main rotor disc aft and pushing downwards on the aft vertical push-pull tube. In forward flight, the advancing main rotor blade is at a higher airspeed than the retreating blade, which increases the lift on the advancing blade relative to the retreating blade. The reaction to this dissymmetry of lift is that the advancing blade flaps up and the retreating blade flaps down, which the pilot corrects with forward cyclic input as airspeed increases (Wagtendonk, 2011). Therefore, a disconnection of the longitudinal cyclic control in forward flight will result in the rotor disc tilting aft, potentially striking the tailcone.

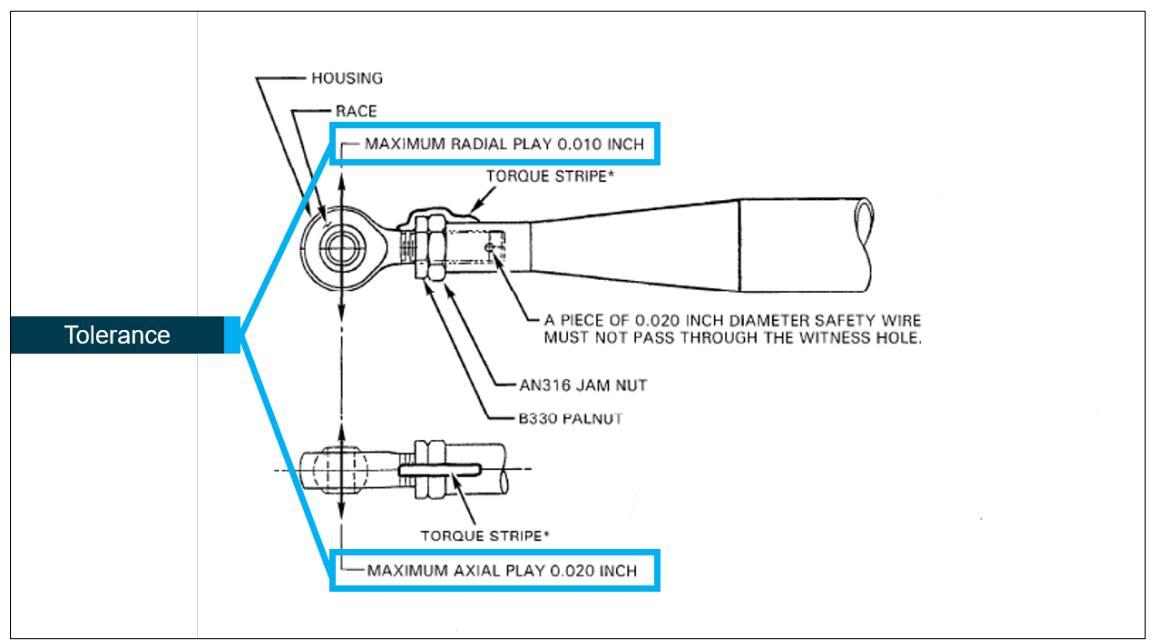
The bellcrank is inspected for cracks and corrosion, and the rod-ends are tested for axial and radial play (Figure 13). According to RHC, the play in the rod-ends can be checked without removal from their respective fastener. The CAM staff reported that the rod-ends would initially be checked for play without their removal, and then only removed for measurement with a dial test indicator if there was doubt. The chief engineer reported that the rod-end would be replaced if it had reached half the permitted tolerance as the wear will accelerate and it was preferable to replace them at the 2,200-hour overhaul, rather than at a 100-hour inspection.

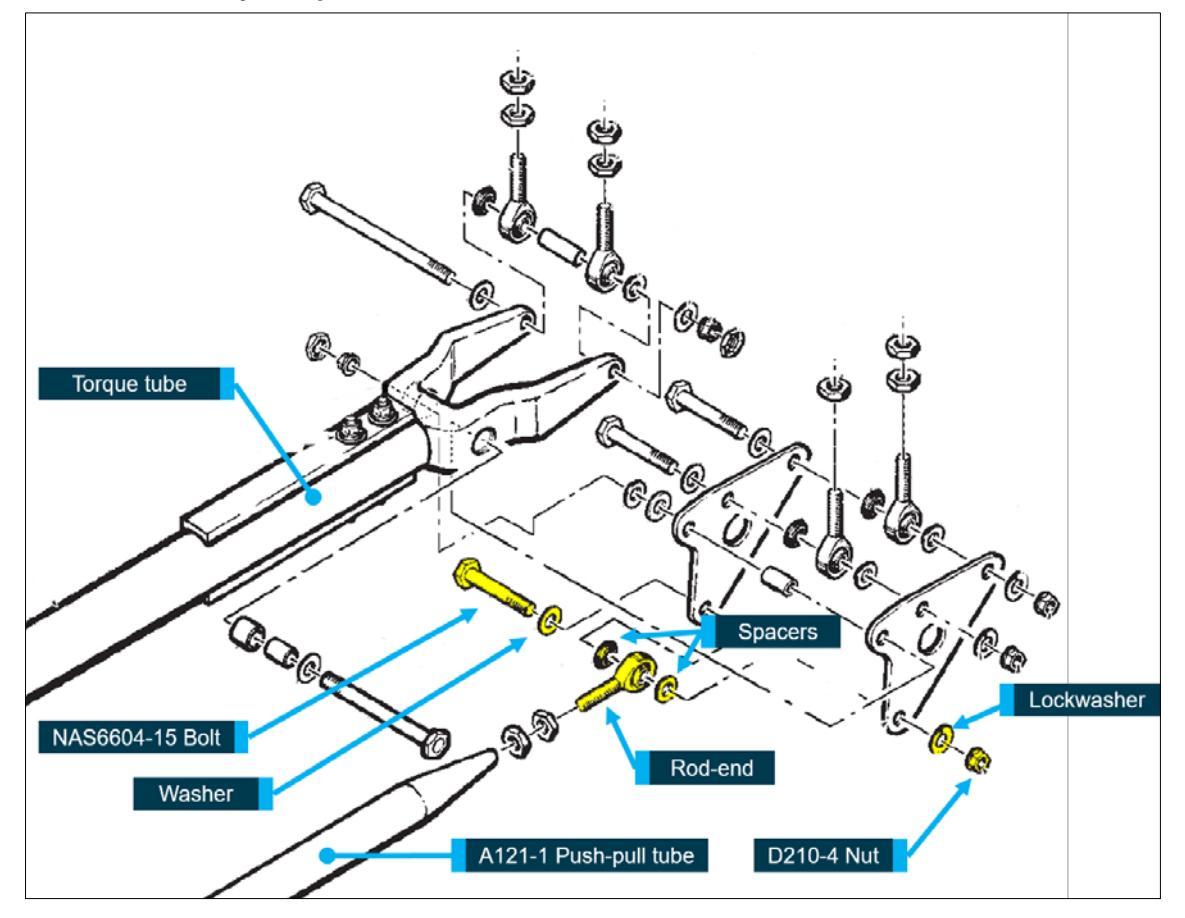
Figure A2: Modified image from the R22 *Illustrated Parts Catalog* showing missing fastener assembly components and location

The missing bellcrank fastener was an assembly of components comprised of the following (Figure A2):

- NAS6604-15 bolt
- NAS1149F0432P washer
- A115-1 spacer
- B332-441 lockwasher
- D210-4 nut
- rod-end.

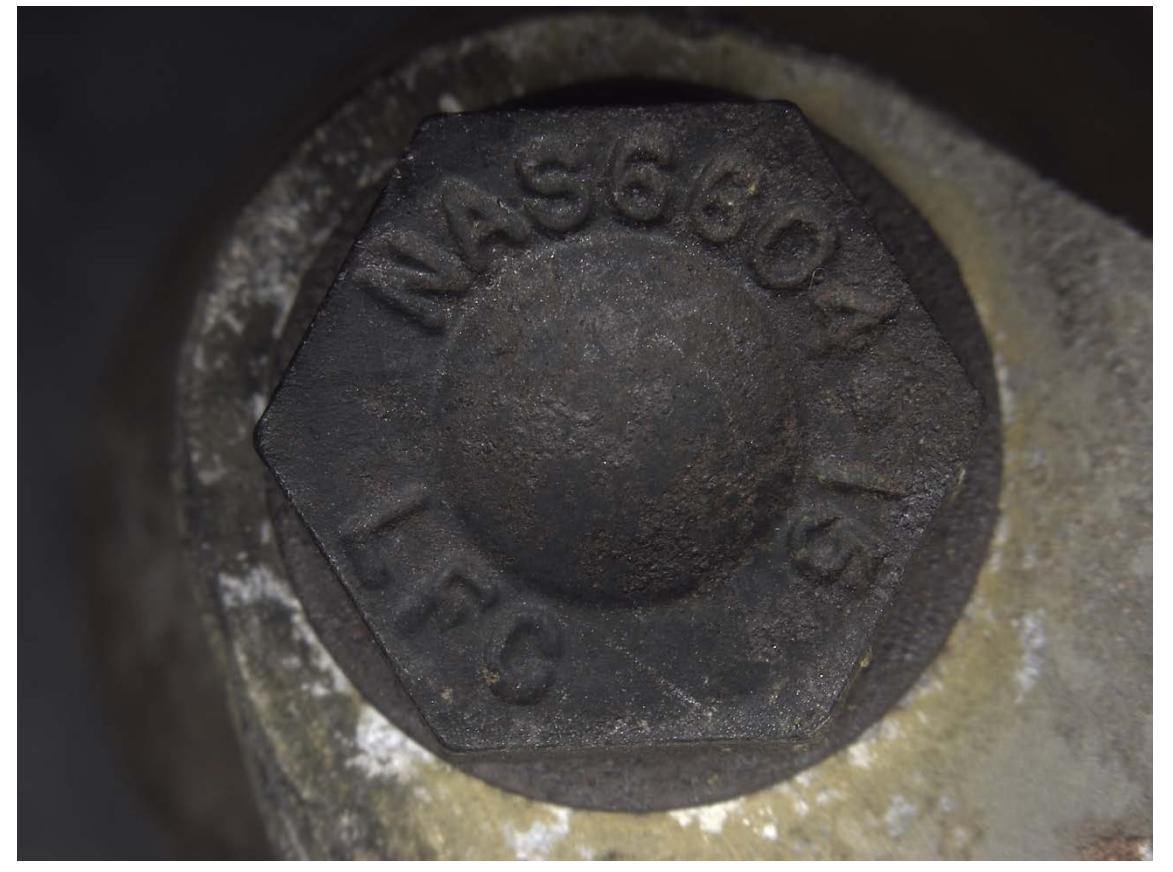
Markings on heads of the two remaining bolts from the bellcrank indicated they were a NAS6604-15 bolt. The marking 'LFC' stamped on the bolt head identified the manufacturer (Figure A8). As per United States Department of Defence Handbook, MIL-HDBK-57G (IS) 16 October 2012, *Listing of Fastener Manufacturer's Identification Symbols*, the manufacturer was likely to be: LFC Industries, Texas, USA.

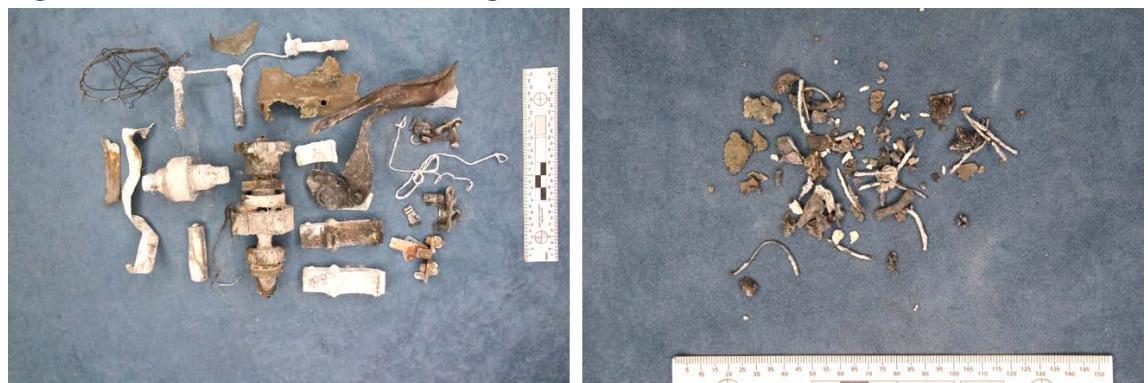
### Figure A13: Recovered items following dissolution of the metallic debris

A number of fasteners and other components were recovered following dissolution of the aluminium (Figure A13). The missing nut to the bellcrank fastener was not amongst the entrapped hardware. Neither a D210-4 nor MS21042-L series (whole or in part) nut was among the recovered items.

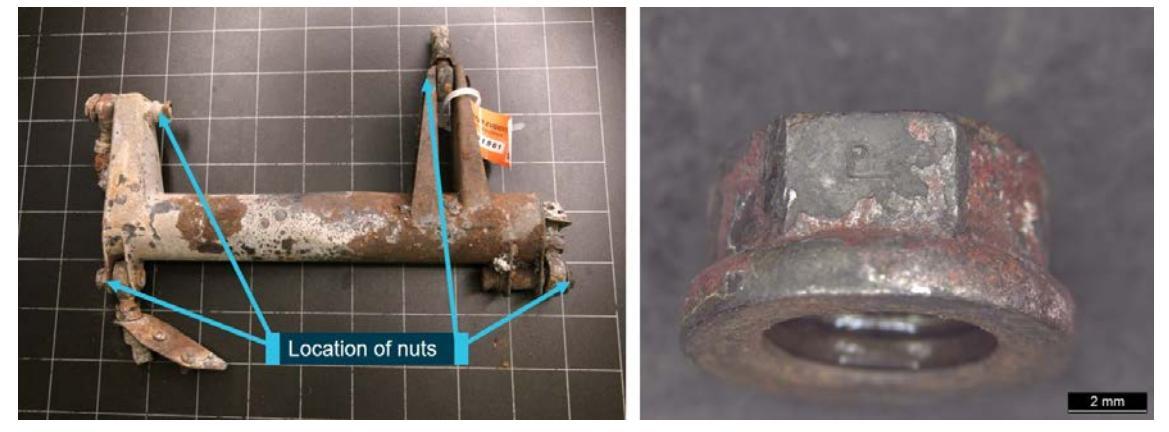
### Figure A14: Jackshaft assembly (left) and magnified view of one of the nuts (right)

Examination of the four nuts showed them to be similar to those remaining in the bellcrank. Specifically, they were of a similar size, and three of them exhibited the same markings 'R' on the flats (Figure A14). Due to heat damage, no markings were able to be resolved on the fourth self-locking nut. Analysis of the four nuts from the jackshaft assembly was performed using the EDS, and showed that all four nuts were consistent with a carbon/alloy steel, not stainless steel. The geometry, markings and chemistry indicated they were MS21042-L4/NAS1291-series nuts.
