Engine vibrations and in-flight shutdown involving Airbus A330, VH-QPI

Near Sydney Airport, New South Wales, on 1 June 2018

ATSB Transport Safety Report

AO-2018-046

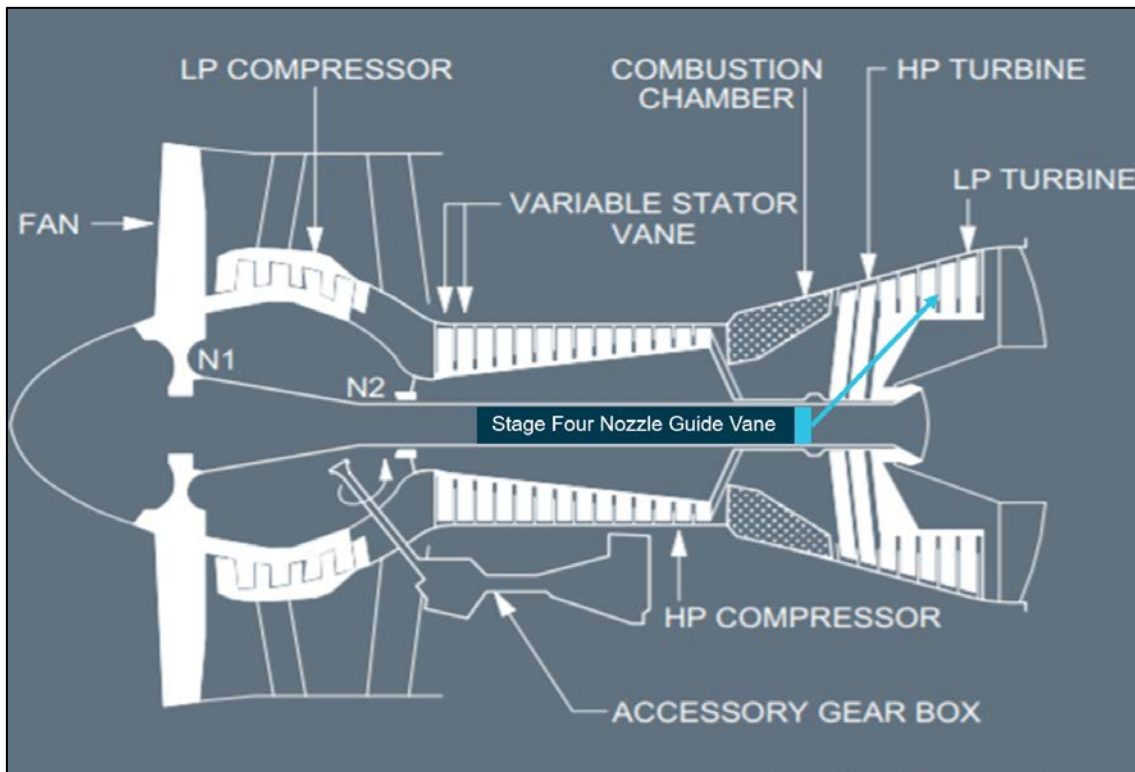
Figure 1: Profile of General Electric CF6-80 engine showing layout of rotating assemblies and position of stage four nozzle guide vane assembly
