# Collision with terrain following an engine power loss involving Cessna 172M, VH-WTQ

12 NM (22 km) north-west of Agnes Water, Queensland | 10 January 2017

**ATSB Transport Safety Report**  
Aviation Occurrence Investigation  
AO-2017-005  
Final – 17 October 2019

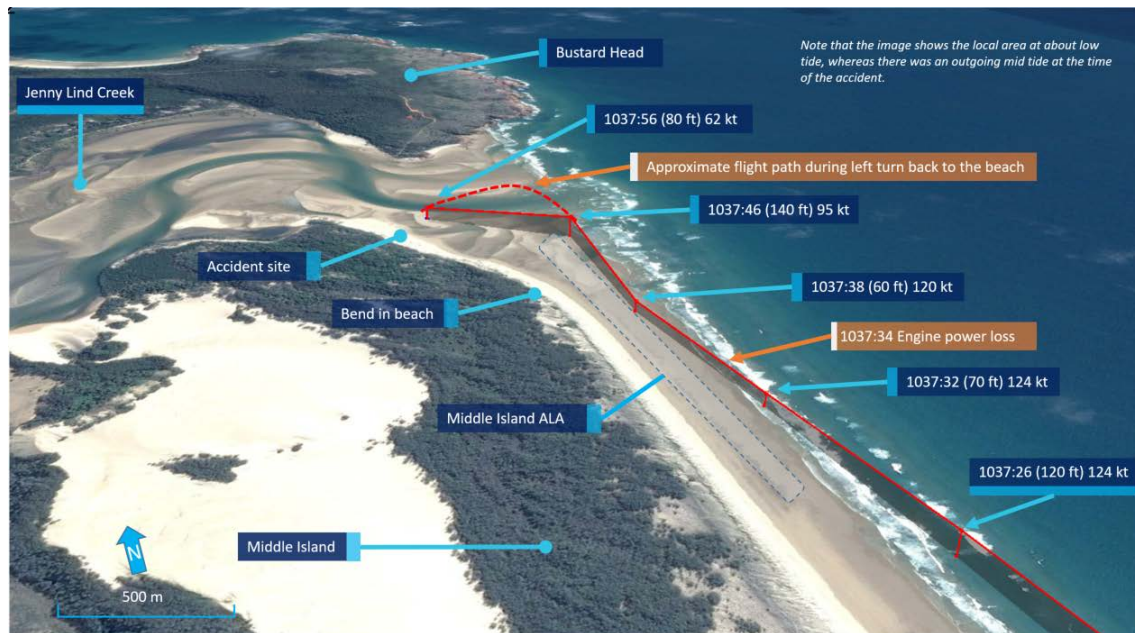
**Figure 2: VH-WTQ's flight path just prior to the accident**

Figure 2 shows the last 36 seconds of recorded GPS data (represented by the red line). As indicated in the figure, at 1037:26, the aircraft was approaching the southern end of the landing area and still descending.

This image shows the altitude and position data from the last five recorded data points prior to impact. The red lines are direct connections between each recorded data point and do not represent the aircraft's actual flight path between points. The landing area is based on reviewing the GPS data for many previous landings; most landings to the south would use the northern end of the area. The Google Earth image was taken in May 2016, and reflects conditions with a lower tide than at the time of the accident. Source: Google earth, modified by the ATSB.

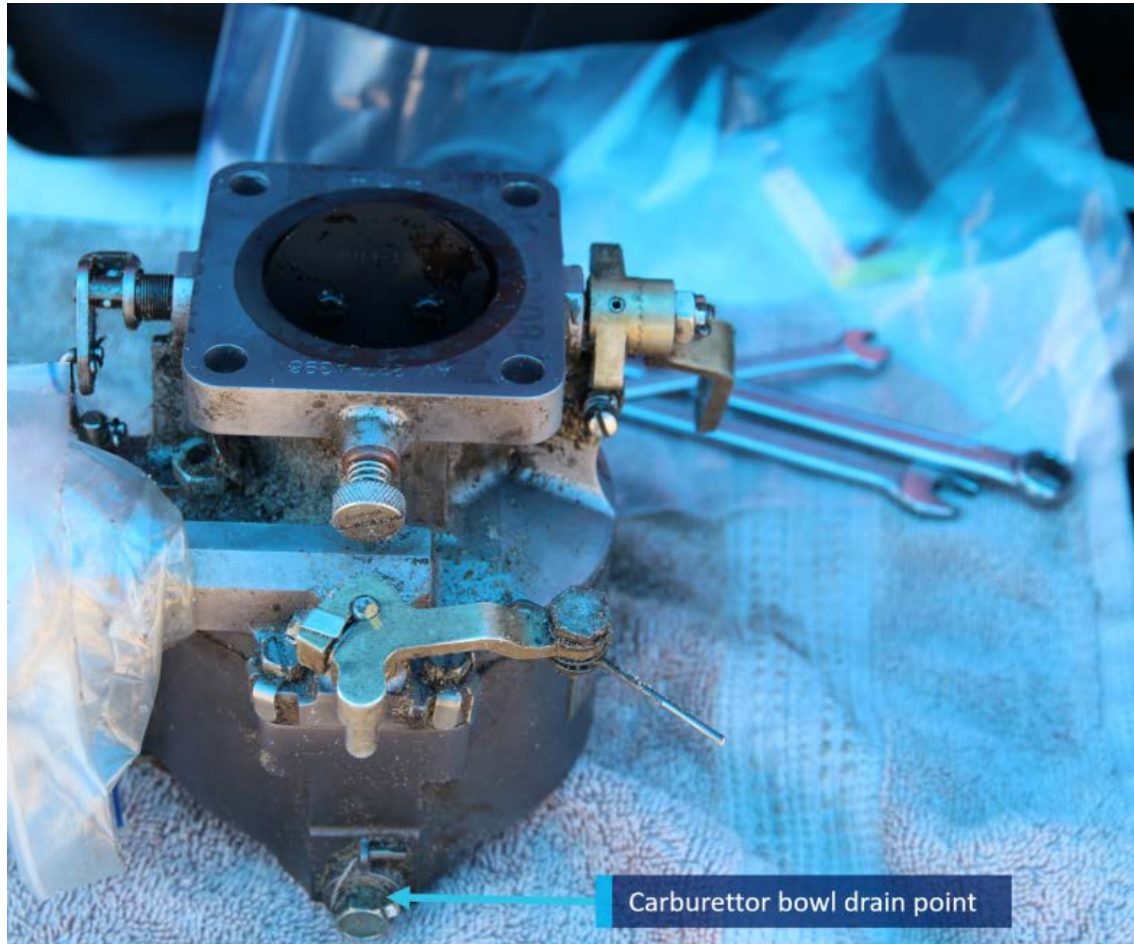
**Figure 12: Carburettor showing drain point located at its base**

As part of the removal process, care was taken not to invert the carburettor so as to prevent fuel draining out of the unit. With the carburettor in an upright position, the carburettor bowl drain was removed in order to ascertain if any fuel remained in the unit (Figure 12). No fluid of any kind was drained from the unit. It is possible that some fuel had leaked out of the unit while it was on its side; however the orientation of the unit meant that some fuel should have remained in the carburettor bowl.

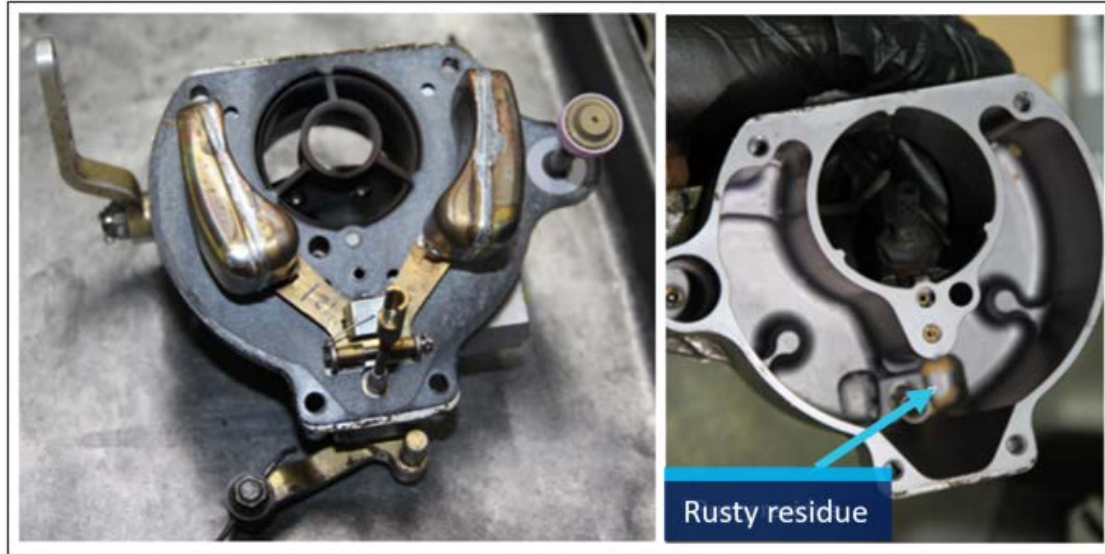
**Figure 13: Disassembled carburettor showing internal components**

- No pre-accident defects were identified with the mechanical components of the engine.
- The carburettor was disassembled and inspected, with no faults identified. There were no foreign particles and debris, apart from a small amount of rust-like residue at the drain point reservoir (Figure 13). The fuel metering orifice was also clean and free of foreign particles and debris. Given that no actual particles or debris were found in the carburettor, the presence of this rust-like residue was very unlikely to have contributed to the engine power loss.
- The magnetos were checked for correct timing and then removed for functional testing. Both magnetos functioned as designed with no faults identified.
- All the spark plugs were removed from the engine, inspected and tested. No faults were identified.

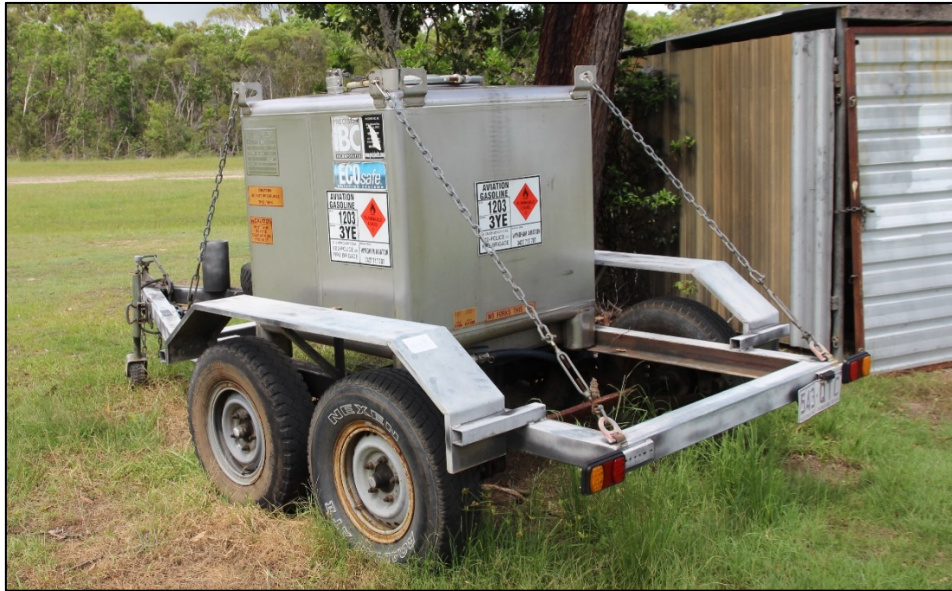
**Figure 15: Fuel storage tank containing aviation grade gasoline**

- The aircraft was normally refuelled from a fuel storage tank at Agnes Water ALA (Figure 15). The fuel storage tank was not fitted with a meter to accurately measure the amount of fuel dispensed when refuelling an aircraft. However, the chief pilot and the pilot of the accident flight stated that 25 turns of the handle produced about 20 L. After refuelling an aircraft, the amount of fuel on board would be checked using a calibrated dipstick.

The fuel storage tank at Agnes Water ALA (Figure 15) was utilised by both of the operator's Cessna 172 aircraft, with the same batch of fuel being used in the period leading up to the day of the accident without any problems being noted.

The chief pilot stated that the fuel in the storage tank was checked visually for quality and the presence of water prior to each aircraft refuel. When the fuel storage tank was empty it was taken to Bundaberg Aerodrome and refuelled with 100LL aviation grade gasoline.

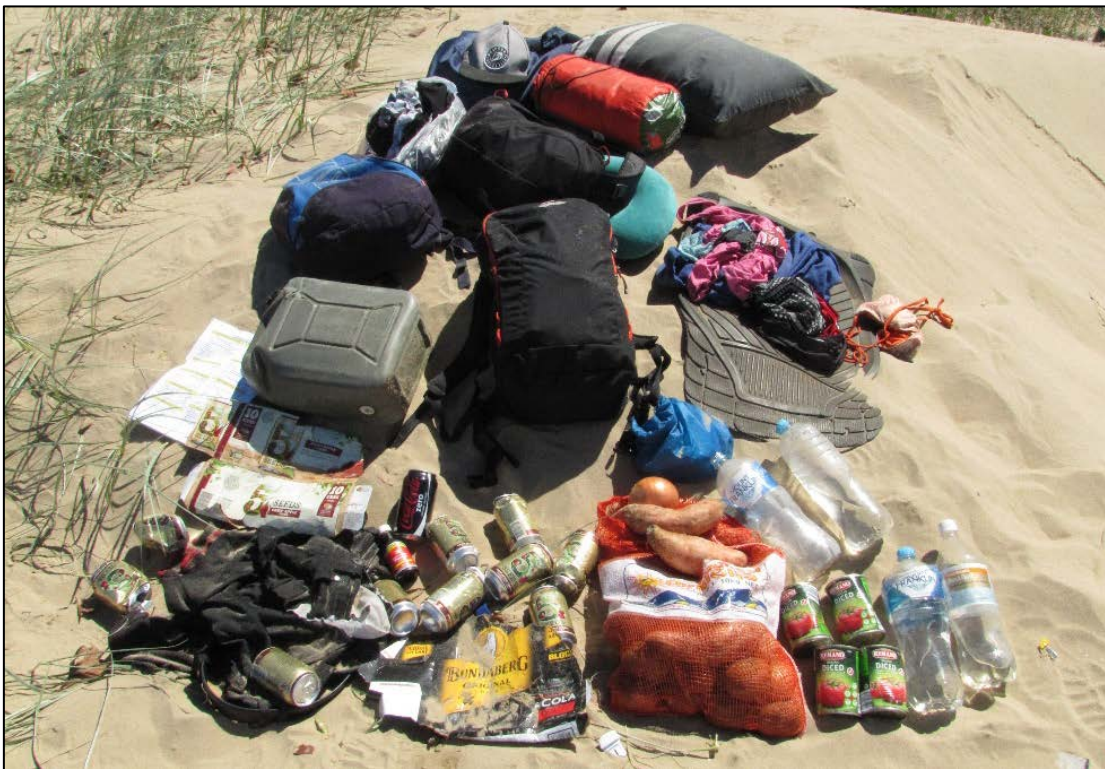
**Figure 16: Some of the contents from VH-WTQ's baggage compartment at the accident site**

The majority of the items were weighed by the police. For some other items not weighed by the police, including camp food supplies and a 10 L water container, the ATSB used weights provided by and agreed to in writing by the chief pilot. The total weight of all items recovered from the aircraft, or known to be on the aircraft at the time of the accident, was calculated to be 42.4 kg. This was considered to be an underestimate, as some other additional food and drink items close to the wreckage may also have been on board.

Some other items recovered by the ATSB from the wreckage are not included in this photograph. Those included cans of alcohol. It was reported that a full carton of rum and cola drink was on board but only 18 cans were recovered and included in the baggage weight. A large (3 kg) pumpkin was found close to the wreckage but not included in the final calculation. Only one of the 1.5 L water bottles shown in the photograph was included in the ATSB weight calculation (although others were found nearby and were potentially on board). The rubber mat was also not included in the ATSB calculations.

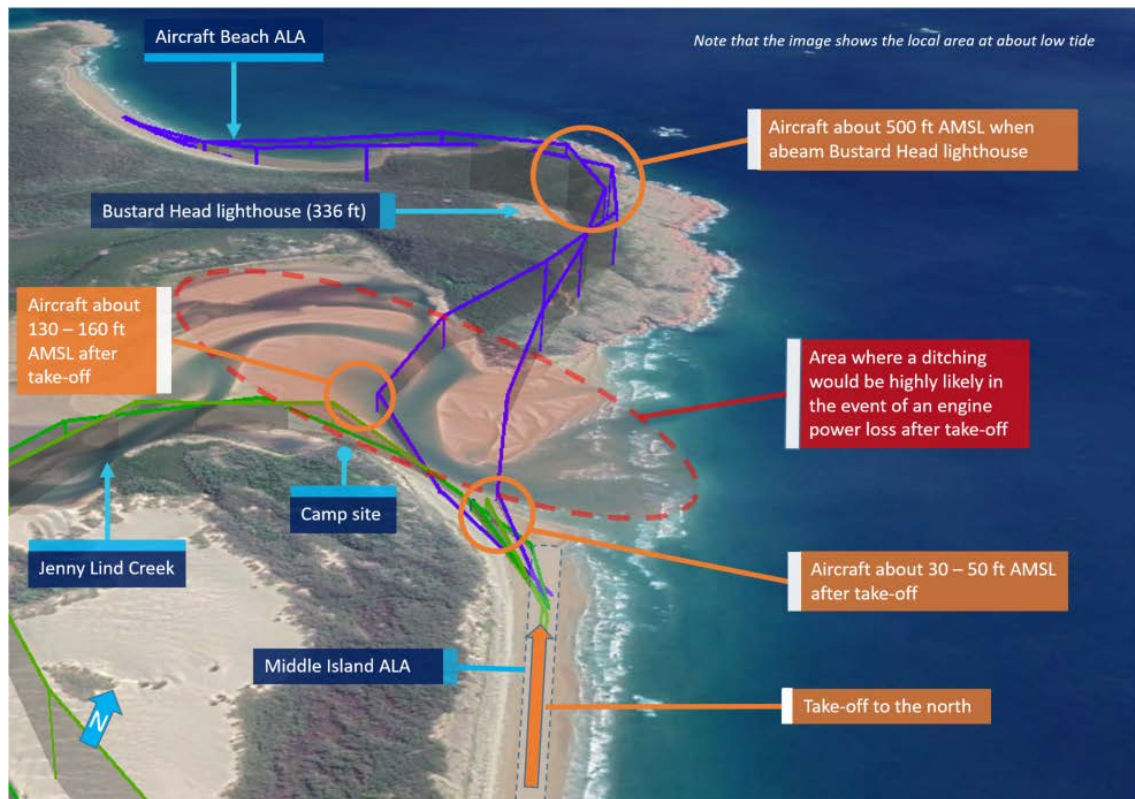
**Figure 25: GPS flight paths of take-offs to the north flown in VH-WTQ**

- Two flights from Middle Island to Aircraft Beach that commenced with a take-off to the north, with both flights passing over the Jenny Lind Creek inlet at a low height soon after take-off before flying over Bustard Head, just to the right of the lighthouse and at a height of about 200 ft AGL (Figure 25).

- Two flights from Middle Island to Agnes Water that commenced with a take-off to the north, before turning to the left at a low height (below 200 ft AMSL) and then proceeding to Agnes Water (Figure 25).

In summary, there were several flights in VH-WTQ during the period from 12 November 2016 to 4 January 2017 at Middle Island where turns were conducted at less than 200 ft after take-off, including some flights over water. In addition, a number of flights involved segments where, if there was an engine failure, a forced landing on to water or hazardous terrain could not have been avoided. It was also relatively common practice to conduct manoeuvring below 500 ft AGL prior to being established on final approach.

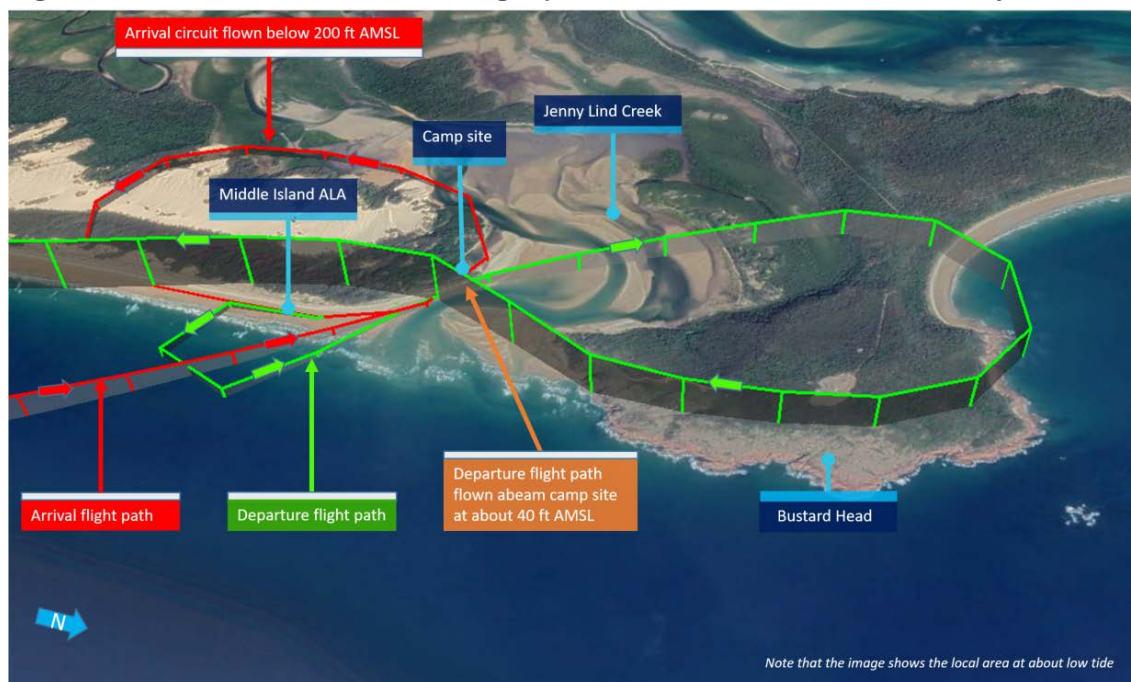
**Figure 26: Additional observed GPS flight paths flown in VH-WTQ on 1 January 2017**

- One flight from Middle Island to Agnes Water that commenced with a take-off to the south before turning sharply to the left over water, coming back over the northern end of the Middle Island ALA and descending to a lowest height of about 40 ft abeam the camp site, conducting a right turn around the Bustard Head lighthouse at an altitude of about 500 ft AMSL and then proceeding back to Agnes Water (see Figure 26).

In terms of approaches to Middle Island ALA, many of the approaches that did not involve an airborne inspection involved conducting a turn onto final approach below 500 ft AGL.<sup>35</sup> The most notable flight was an approach to the Middle Island ALA from over the water down to about 80 ft abeam the camp site before a left circuit and return to a landing on Middle Island. During the left circuit the aircraft only reached a maximum altitude of about 200 ft AMSL (when over terrain of about 100 ft) (see Figure 26). This flight was conducted on the same day (1 January 2017) as the last take-off listed above.

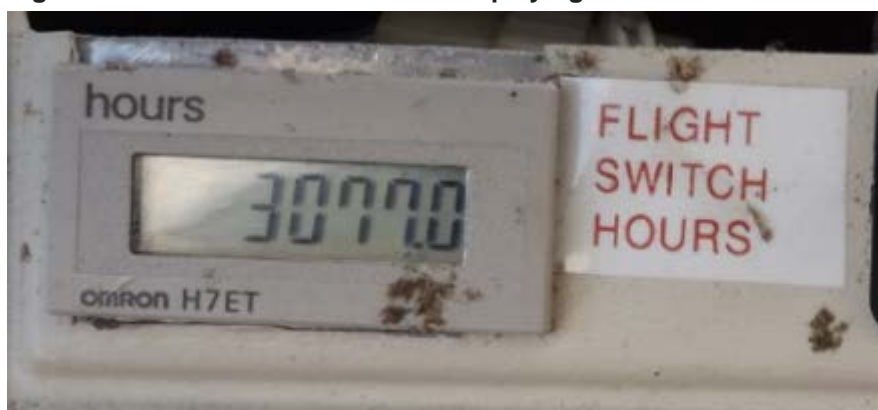
**Figure A1: Hour meter on VH-WTQ displaying the value at the time of impact**

- The hour meter reading after the accident was 3,077.0 hours (Figure A1), and this figure was also visible in the video footage of the accident flight at 1037:39 (20 seconds prior to impact). The reading prior to take-off would therefore have been about 3,076.9 hours. This figure indicated there had been 167.8 hours flight time since the 12 November 2015 inspection. It also indicated that the flight time documented on the maintenance releases underestimated the actual flight time by 34.3 hours (or 20 per cent) during the period from 12 November 2015 to 10 January 2017.
- There was no evidence in the maintenance records that the hour meter was considered faulty during the period that Wyndham Aviation used the aircraft from 2013 to 2017. The chief pilot and pilot of the accident flight reported that they were not aware of any problems with the aircraft's hour meter.

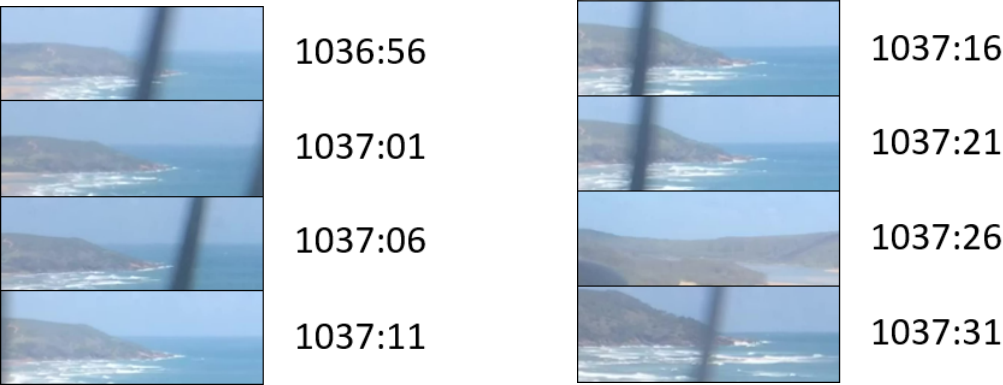
**Figure B4: Video stills at 5-second intervals during descent (last image is 3 seconds prior to engine failure)**

With regard to the altimeter indications in the video footage, the last view of the altimeter prior to the engine power loss occurred at 1037:26, when the altimeter indicated about 200 ft (Figure B3). This was significantly higher than the recorded GPS data at the same time (120 ft), and also higher than the transponder altitude and the altitude indicated by an analysis of terrain features in the video footage at the same time.

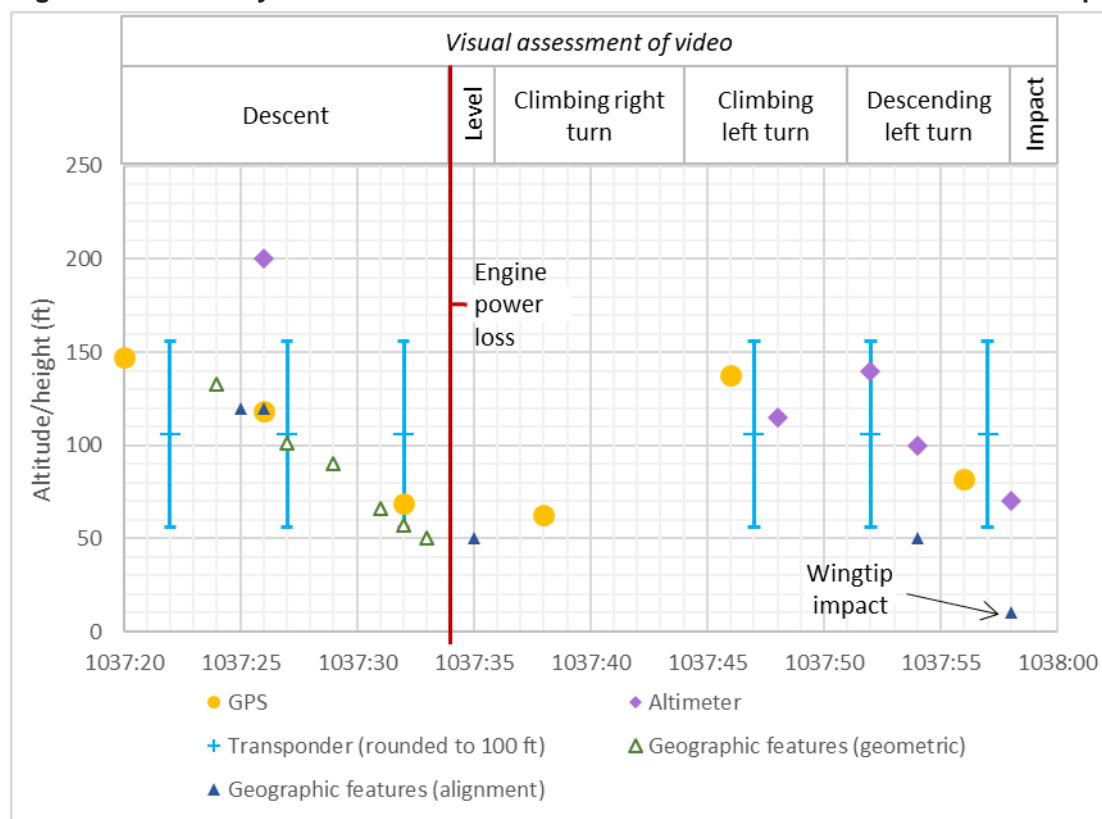
**Figure B5: Summary of information about the aircraft's altitude from 1037:20 until impact**

Figure B5 summarises the available information about the aircraft's altitude during the last part of the flight. As indicated in the figure, altitude information from the recorded GPS data, radar data, and the analysis of terrain features and the horizon geometry in the video footage was in alignment during the aircraft's descent up until the engine power loss (at 1037:34).

The GPS altitude and the altimeter both appeared to be higher than the aircraft's actual altitude in the last 10 seconds of flight (after the engine power loss). This is consistent with the GPS's reduced accuracy in manoeuvring flight, and possibly with the altimeter being affected by sideslip during that period.
