Overspeed and pitch up resulting in cabin crew injury involving Boeing 737, VH-VUE

42 NM ESE Adelaide Airport, South Australia, on 13 September 2017

ATSB Transport Safety Report
Aviation Occurrence Investigation
AO-2017-092
Final – 30 September 2020

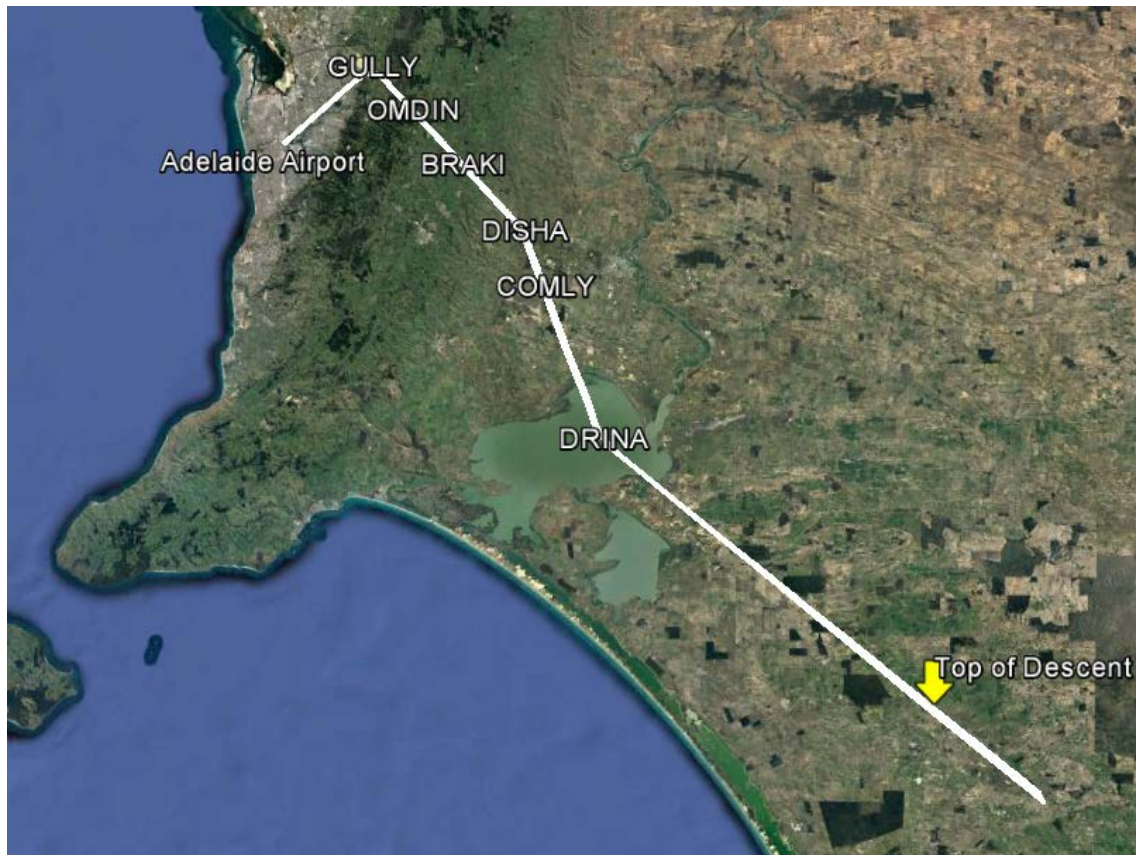
Figure 1: Flight path of VH-VUE with DRINA NINE ALPHA STAR waypoints overlaid

Figure 1 shows the flight path of VUE, with the DRINA NINE ALPHA STAR waypoints overlaid. The original STAR procedure is provided in *Appendix A – DRINA NINE ALPHA STAR*. This procedure required inbound aircraft track to the DRINA waypoint, then to pass overhead COMLY at or below 13,000 ft.

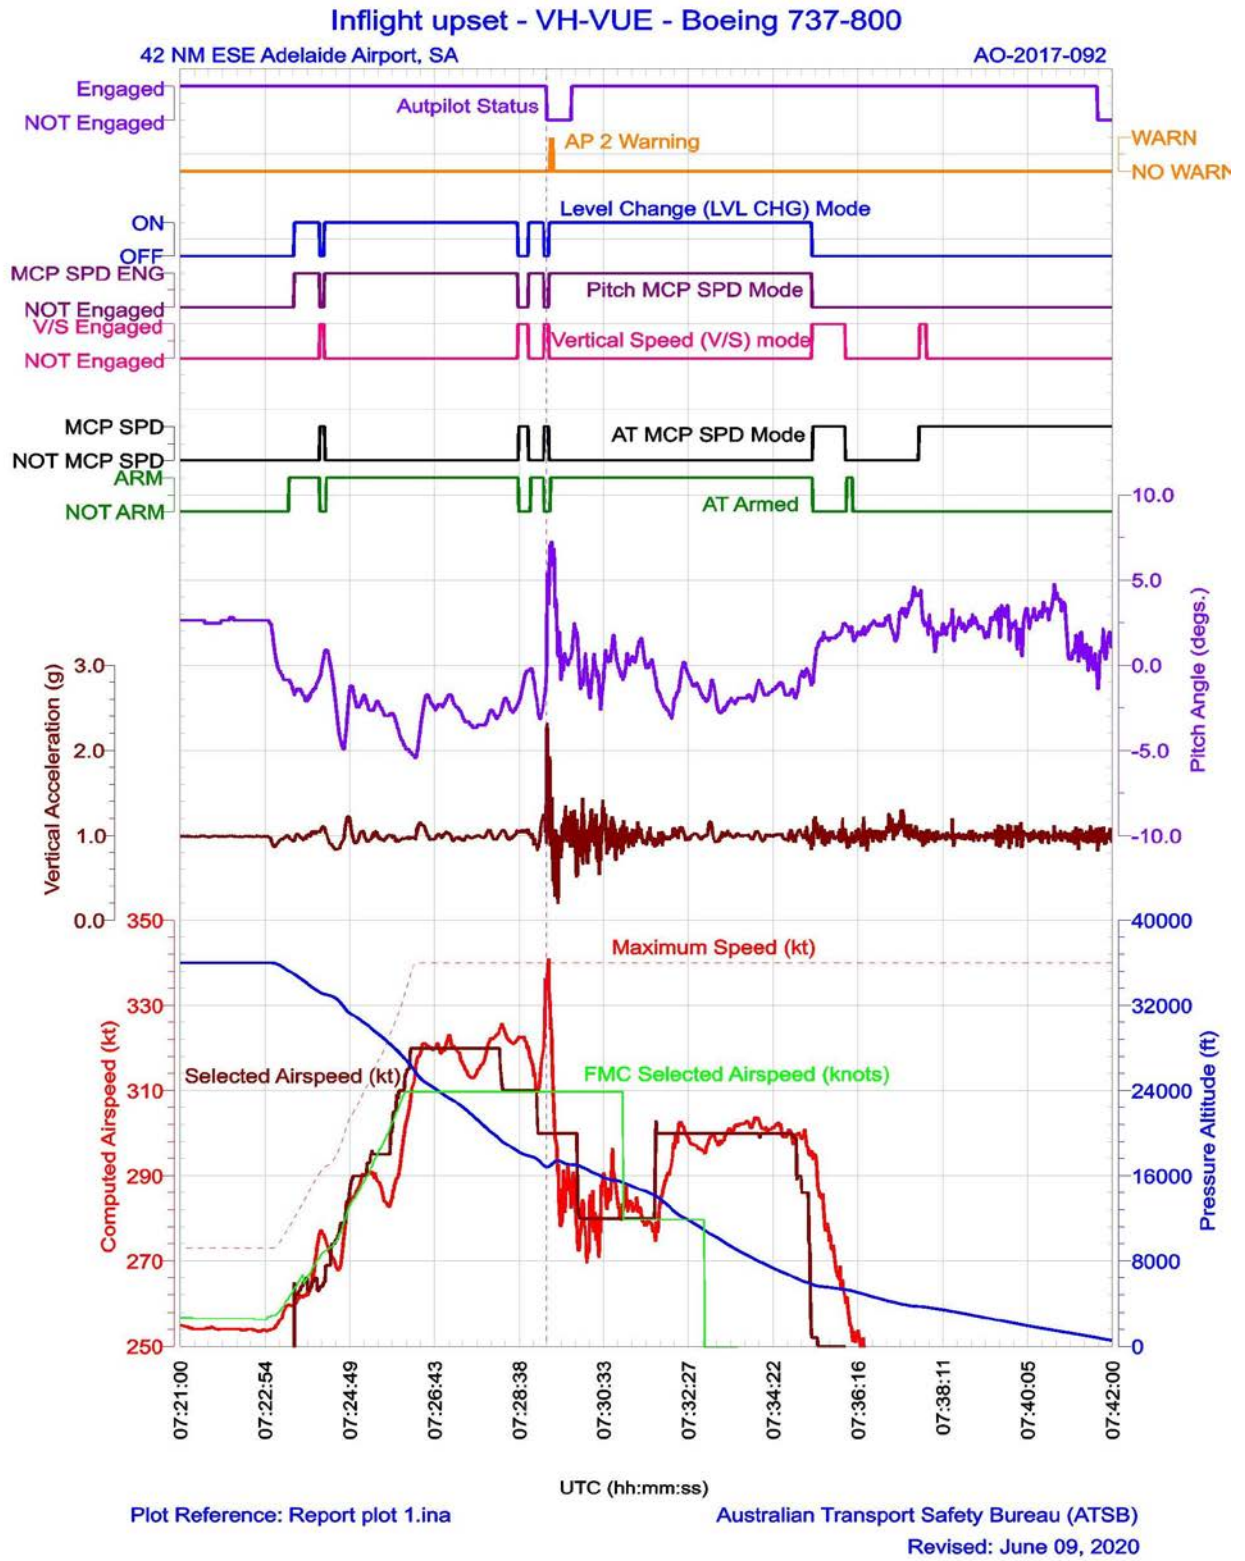
Figure 11: Selected parameters during descent

Recorded data indicates the crew began increasing the selected airspeed on the mode control panel (MCP) incrementally during the early stages of the descent when approaching the start of the STAR. (Figure 11 in *Appendix B – Flight data recorder data* shows changes to the selected airspeed, actual airspeed, autopilot modes and other recorded parameters during the descent.)
