# Rotor RPM decay and hard landing involving Robinson R44, VH-HGX

5 km south of Ayers Rock Airport, Northern Territory, on 17 January 2018

**ATSB Transport Safety Report**  
Aviation Occurrence Investigation  
AO-2018-006  
Final – 7 October 2020

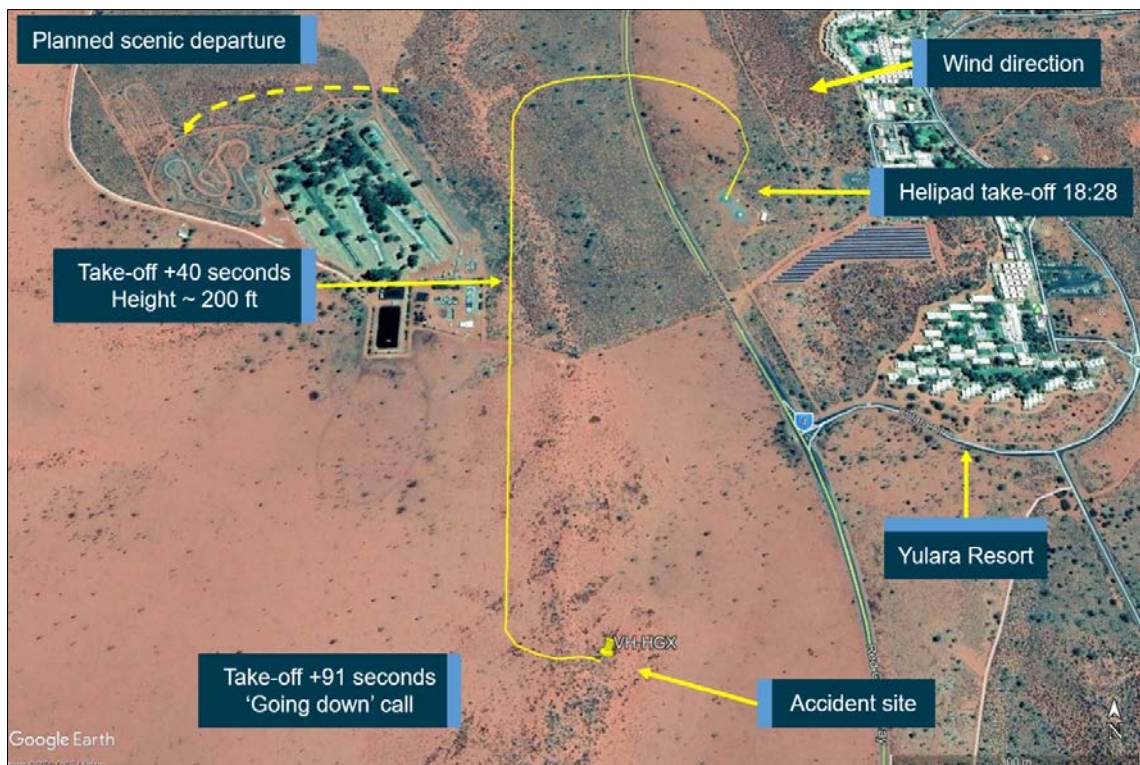
**Figure 4: Accident flight path**

The rear right seat passenger's phone camera was activated intermittently in video mode several times during the flight. The low rotor RPM warning was audible throughout the recordings, which included the ground impact, and was reported by the passenger as sounding continuously throughout the flight. Figure 3 depicts the accident site. Figure 4 depicts the accident flight path, based on tracking data provided by the operator. The flight track was about 1.0 NM (1.85 km) at an average ground speed of about 40 kt.

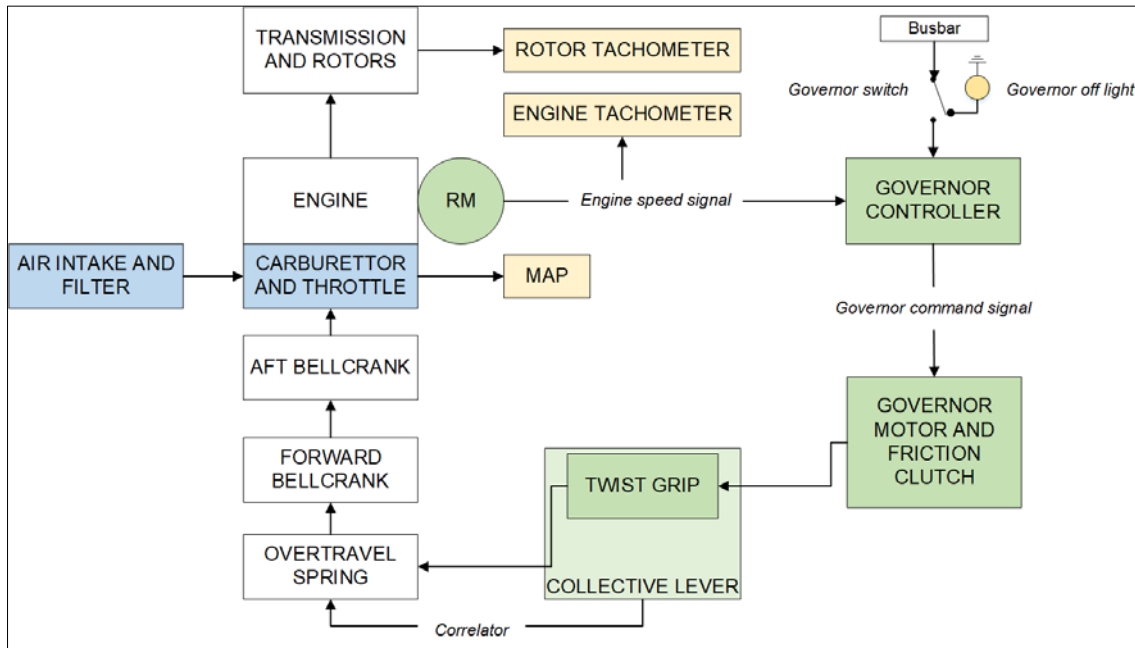
**Figure 5: R44 engine throttle control**

The engine throttle control is depicted in Figure 5. The engine right magneto (RM) senses engine RPM, which is sent to the governor controller. The governor controller provides the correction signal to the engine throttle via the governor motor, friction clutch and pilot's twist grip on the collective lever. This provides a closed-loop system to maintain RPM. Figure 5 shows the components in green that were tested during the investigation, the components in yellow are the cockpit gauges and those in blue represent the air intake path.

In Figure 5, the governor switch is represented in the off position, which will illuminate the 'governor off' light. The governor switch is located at the end of the collective lever, and was not visible in any videos. When the switch is closed (on position) by the pilot, the 'governor off' light will extinguish to indicate the controller is receiving electrical power - the light does not provide a fault indication.

If there is a fault with the right magneto points, a faulty signal will be sent to the controller, which will respond accordingly. The engine tachometer in the cockpit receives a signal from the same source as the controller (RM). Therefore, irregular engine RPM indications (erratic movement) will be present if the points are producing a faulty signal. This was not observed on the passenger video or reported by the accident pilot.

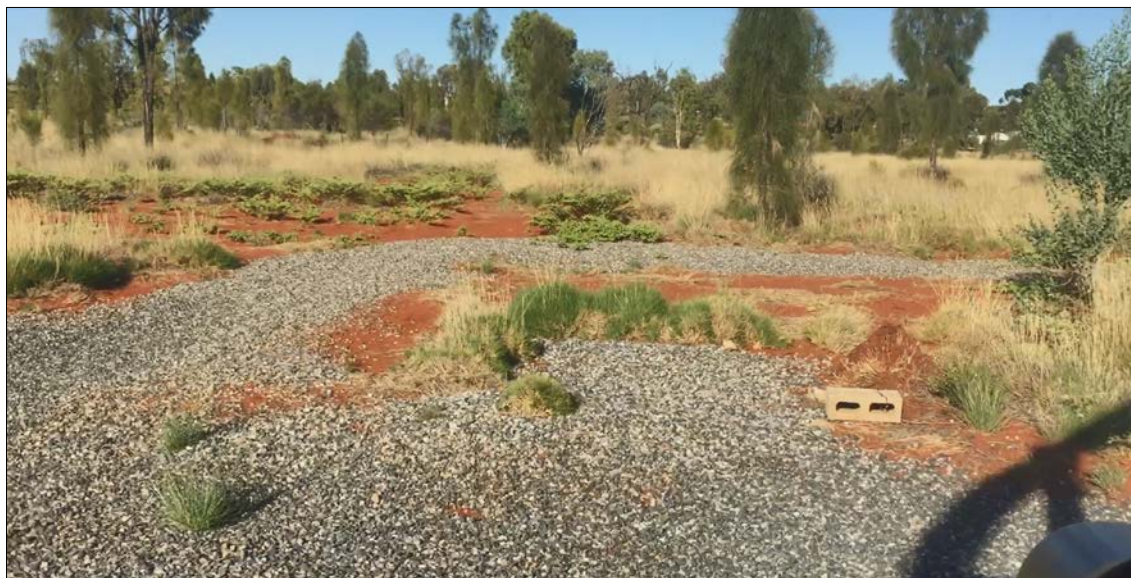
**Figure 9: Departure path from pad 2**

Helipad camera video footage captured the accident helicopter arrive at the far pad (pad 2), and change passenger loads for what would be the accident flight.<sup>21</sup> The footage showed the helicopter lift-off and continue to climb vertically to a height of about half a rotor diameter (16.5 ft)<sup>22</sup> before transitioning into forward flight 5 seconds after lift-off, while continuing to climb. The take-off direction selected by the pilot required the helicopter to clear smaller trees closer to the pad and then larger trees beyond the smaller trees (Figure 9).
