ATSB TRANSPORT SAFETY REPORT  
Aviation Short Investigations  
AB-2011-128  
Final

# Aviation Short Investigation Bulletin: Third Quarter 2011

Issue 7

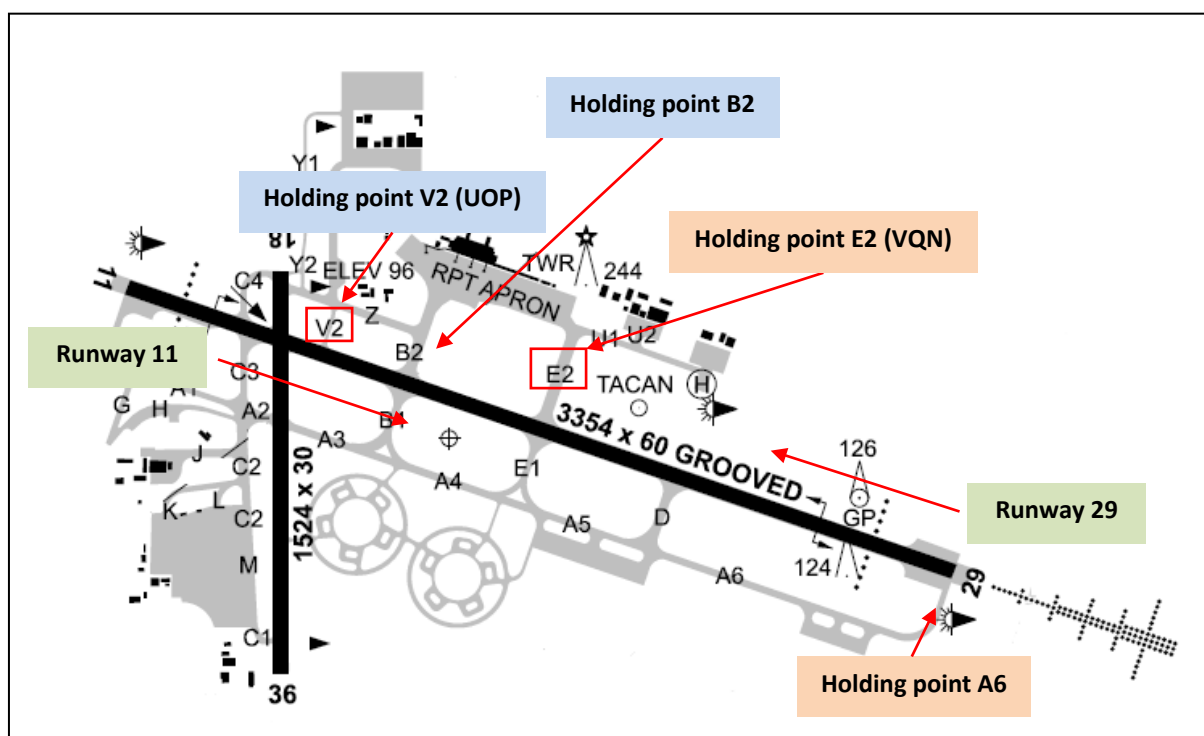
Figure 1: Darwin Airport

Prior to crossing the runway, the crew of VQN checked the runway and approach paths for traffic. The pilot in command (PIC) stated that they were clear to the left and the copilot initially replied that they were clear to the right. The copilot then noted that there was an aircraft (UOP) lined up and stopped on runway 11, abeam the 'Bravo Two' (B2) holding point. The PIC looked to the right and confirmed the presence of UOP. Shortly after, the copilot observed UOP commence the take-off roll. He advised the PIC, who immediately stopped the aircraft.

The ADC had provided the instruction for VQN to cross based on the expectation that UOP would have commenced the takeoff soon after receiving the take-off clearance, and would have past taxiway 'Echo' prior to VQN reaching the holding point. However, UOP remained on the runway for about 1 minute before commencing the take-off roll. In hindsight, the ADC stated that he should have provided a conditional clearance for VQN to either hold short of the runway or to cross behind UOP.

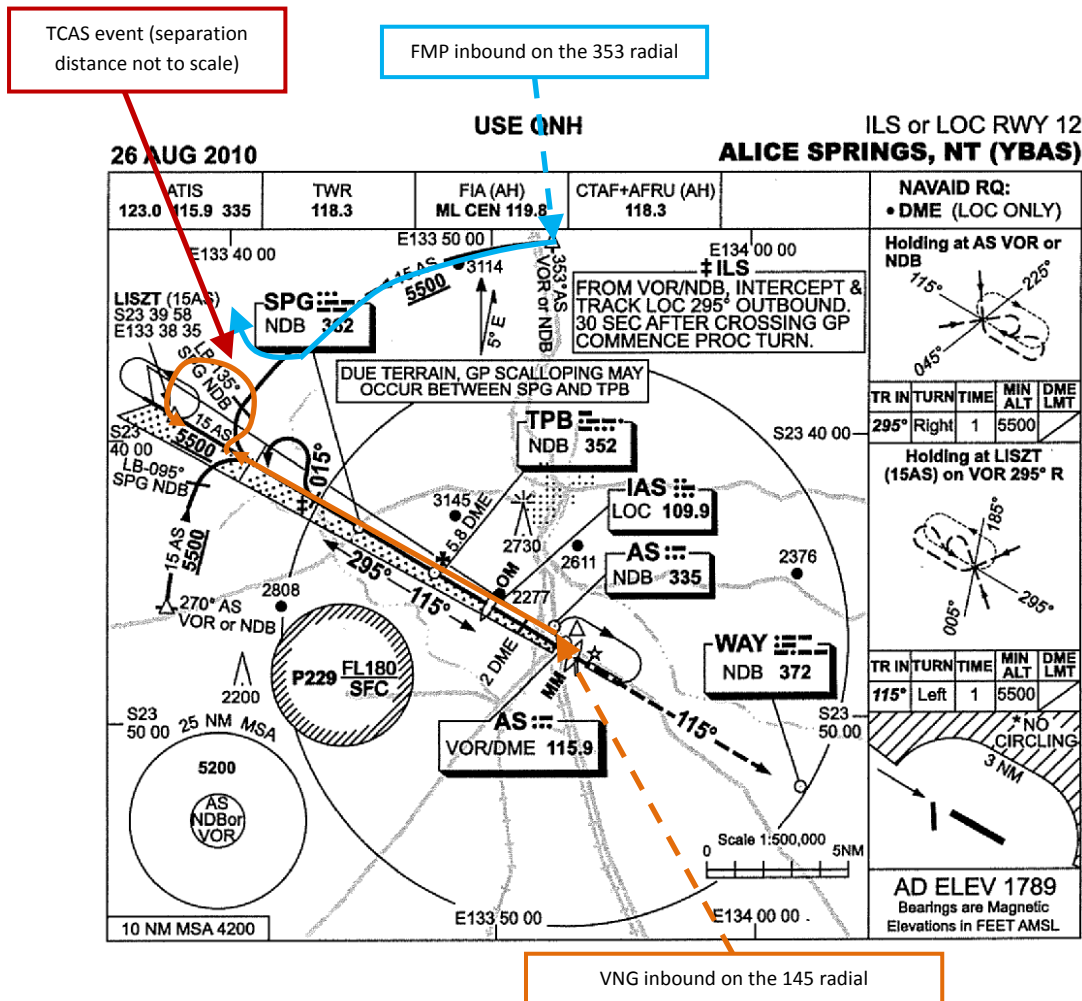
Figure 1: Approximate flight path of FMP and VNG into Alice Springs

Conducting an instrument approach into a non-towered aerodrome in instrument meteorological conditions (IMC) can create a high workload situation. Clear, accurate and concise radio communication is crucial in order to maintain situational awareness. When operating in cloud, radio communication is the most important tool available for avoiding conflict. This increases the importance of providing precise estimates for the aircraft's position in the approach.

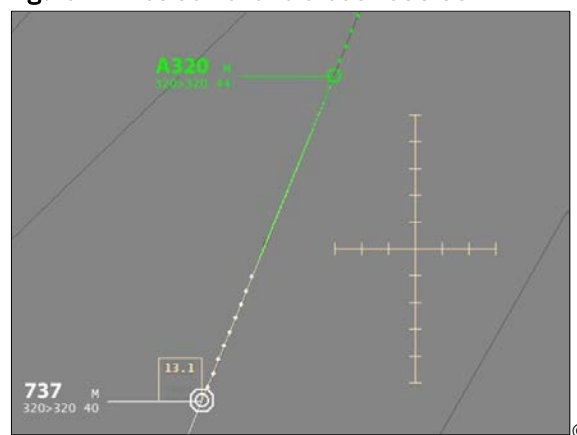
Figure 1: Position of aircraft at 1638:35

At 1638:35, the flight crew of the 737 contacted ATC and reported that their aircraft was maintaining FL320. The controller issued the flight crew with a Standard Arrival clearance to runway 25 at Sydney. At that time, the following A320 was 13.1 NM (24.28 km) behind, with a closing ground speed of 40 kts (Figure 1).

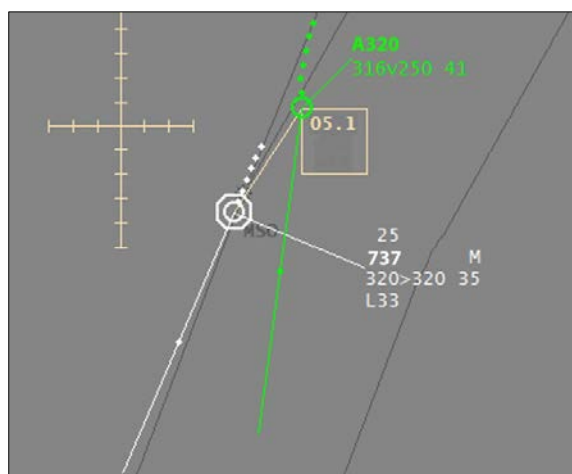
**Figure 2: Position of aircraft at 1648:27**

Separation between the aircraft closed to 5.1 NM (9.45 km) at 1648:27 as the A320 became established in the turn onto the assigned heading, before the distance between the aircraft began to increase (Figure 2).

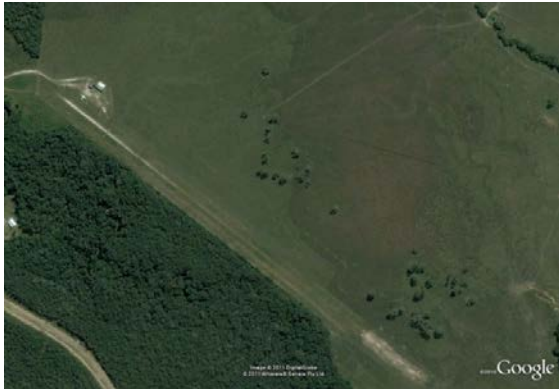
**Figure 1: Bloomfield River Airstrip**

Both propellers were found in the feathered position on the ground. It could not be determined if the left propeller was feathered during flight or on the ground due to conflicting statements between the pilot and witnesses.

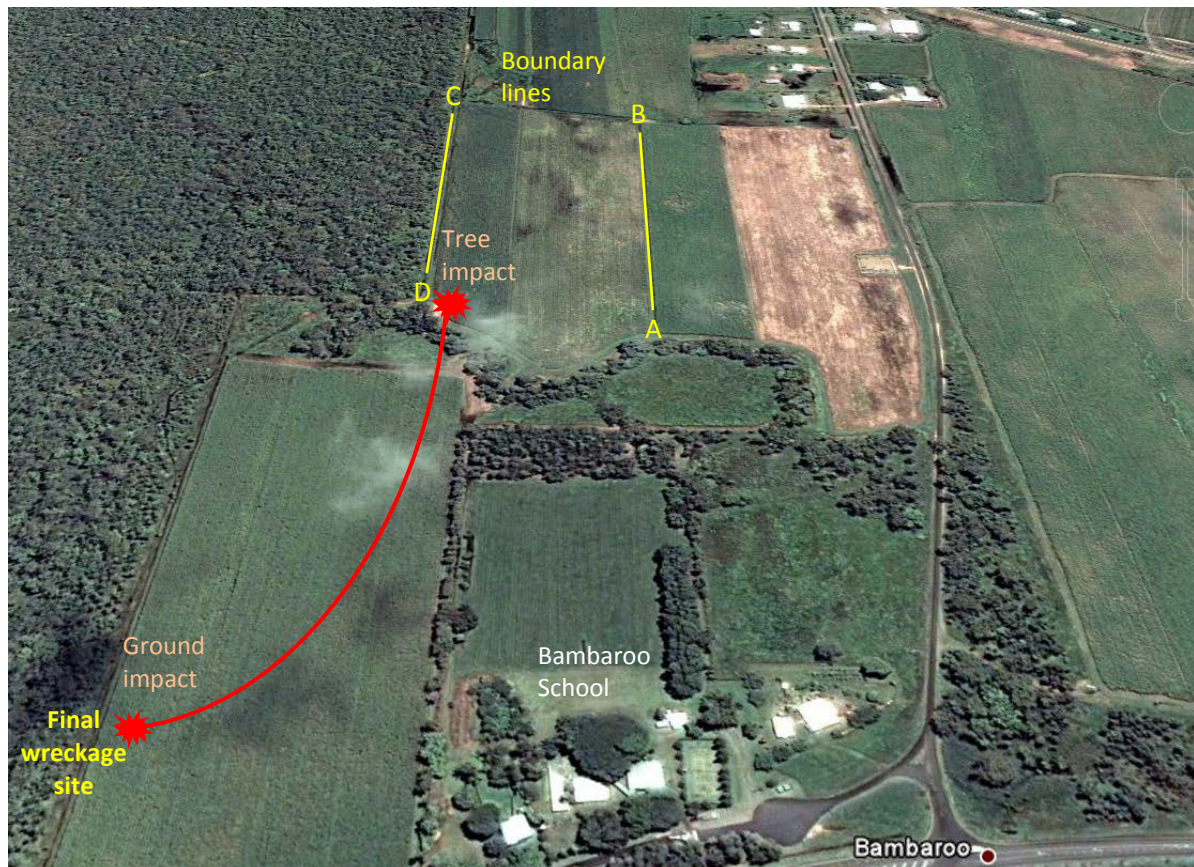
**Figure 1: Spray field and ground impact site**

Although the pilot's injuries were serious, his being securely restrained and wearing a helmet significantly reduced the potential level of injury.

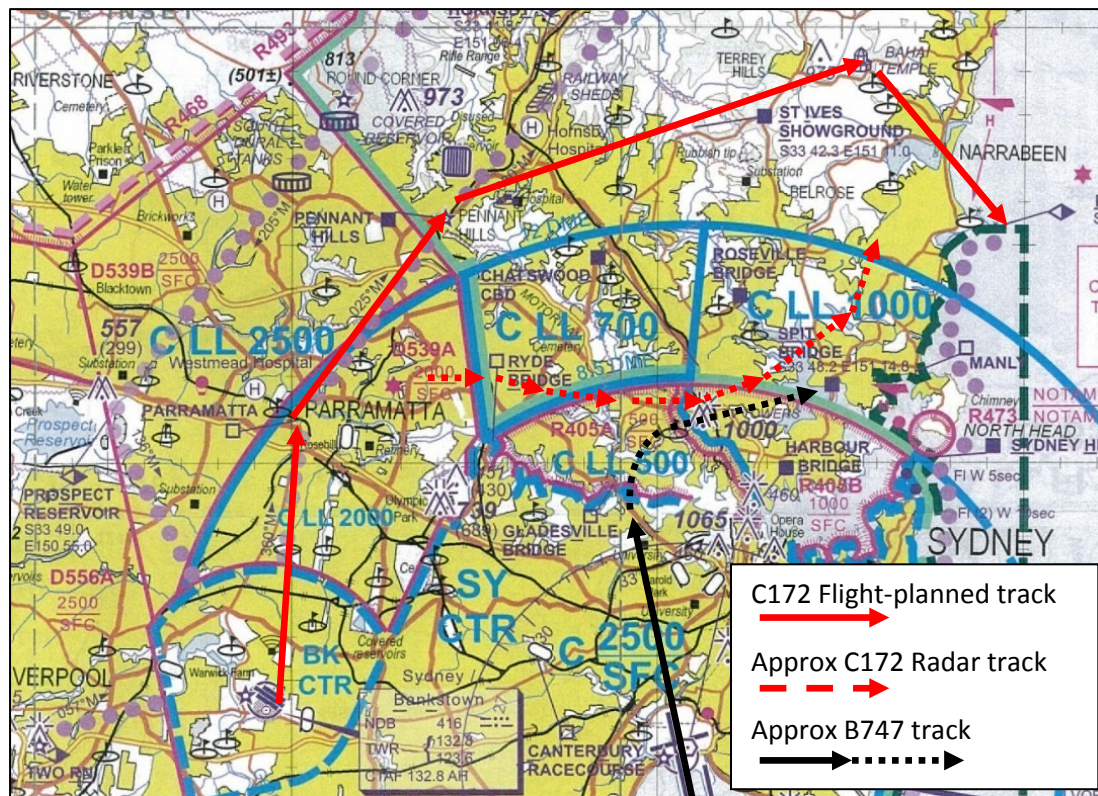
Figure 1: Flight-planned and actual routes

- Information to assist pilots to navigate into and out of Bankstown aerodrome, and to remain clear of controlled airspace, is published in the *Sydney VTC* and *En-Route Supplement Australia (ERSA)*. In addition, the Civil Aviation Safety Authority and Airservices Australia have produced the *Sydney General Flying Guide*, which provides aircraft navigation information using detailed mapping and imagery. The guide also states that it is to be used in conjunction with the current Sydney VTC and ERSA.

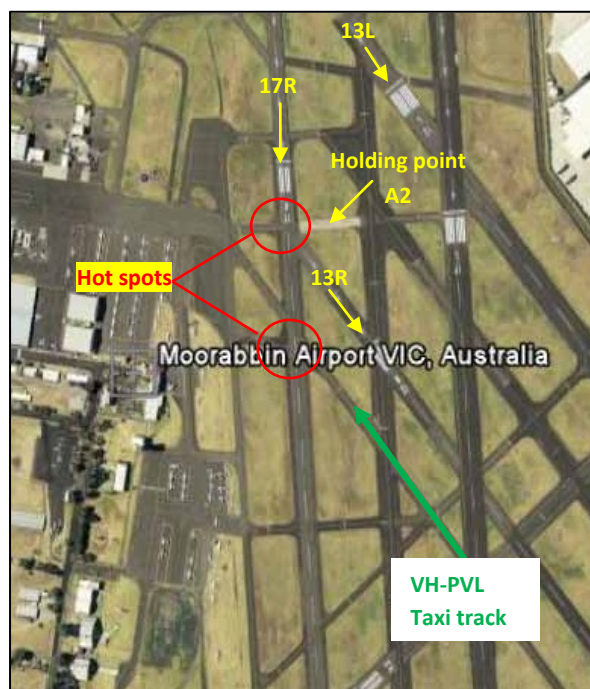
Figure 1: Moorabbin Airport

Aerodrome Controller (ADC) who instructed BZE to cancel the takeoff and exit the runway via the first taxiway. BZE was taxied back to the apron and parked. PVL also continued taxiing to the apron and parked (Figure 1). The instructor of PVL reported the aircraft came within 100 m of each other before stopping.

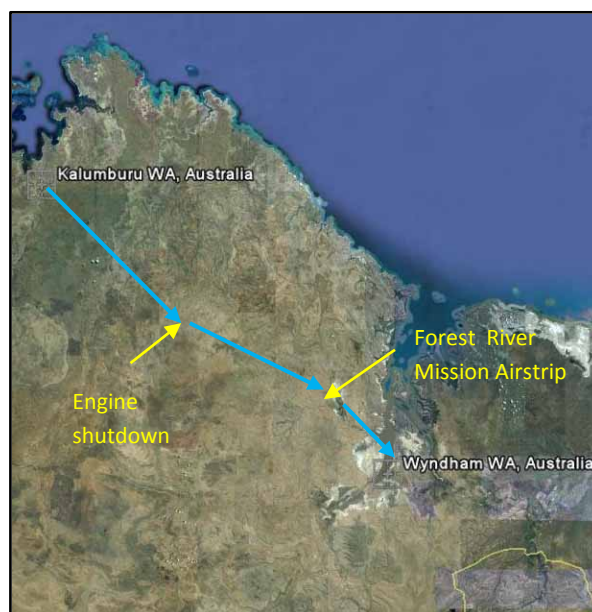
Figure 1: Map of flight

the pilot chose to continue on to Wyndham (Figure 1). An uneventful landing was completed at Wyndham.
