Derailment of coal train TM94

Moss Vale, New South Wales, on 28 June 2019

ATSB Transport Safety Report Rail Occurrence Investigation RO-2019-013 Final – 24 November 2020 Cover photo: Office of Transport Safety Investigations (OTSI)

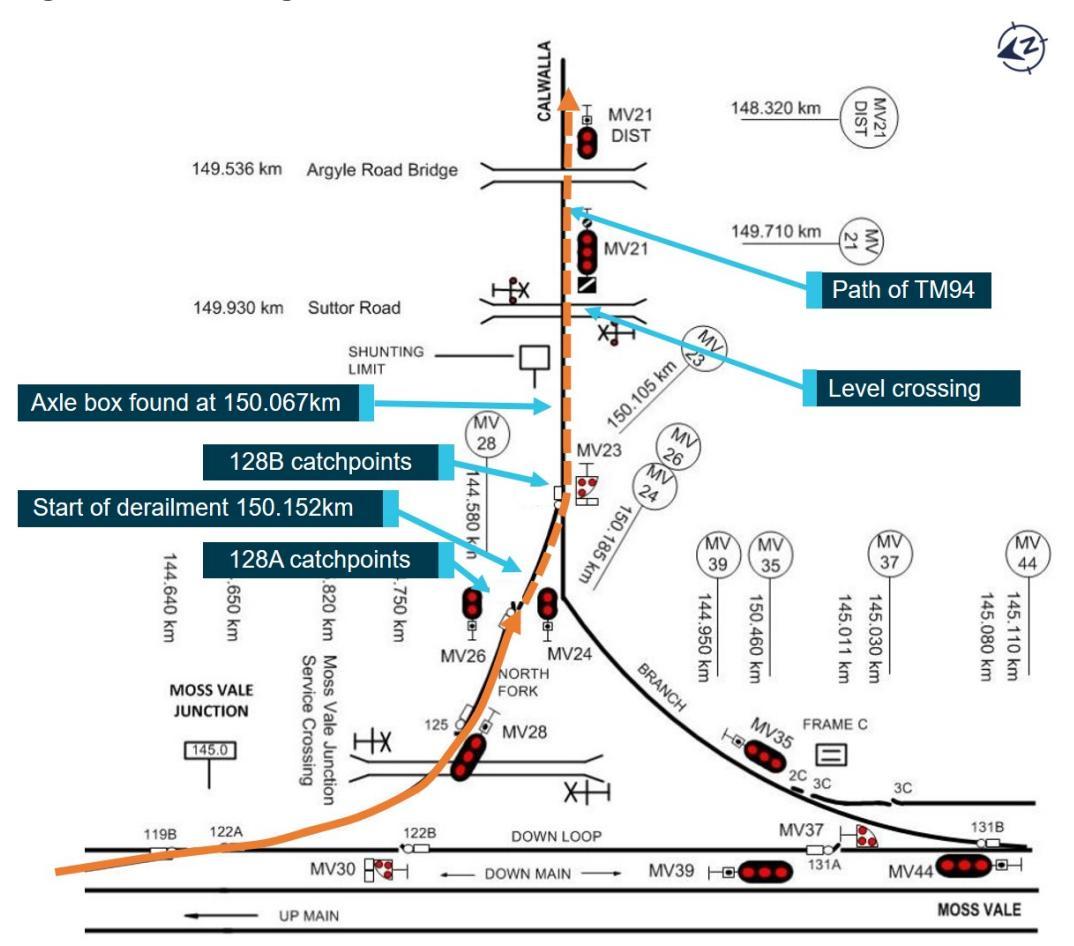
Figure 2: Track configuration at derailment location

At 0041, the 14th wagon in the train's consist (NHSH 42774Q) passed the 128A catchpoints, and the L1 axle journal separated from the rest of the axle. This created unloading of the R2 wheel, which resulted in the R2 wheel climbing the Down rail and the L2 wheel moving into the four foot⁴ and derailing. The train continued with the broken axle and the No. 2 wheelset derailed, there was no loss of brake pipe pressure. Approximately 80 m past the point of derailment, at 150.067 km, the axle box and suspension elements were found later on the Up side of the track (Figure 3).

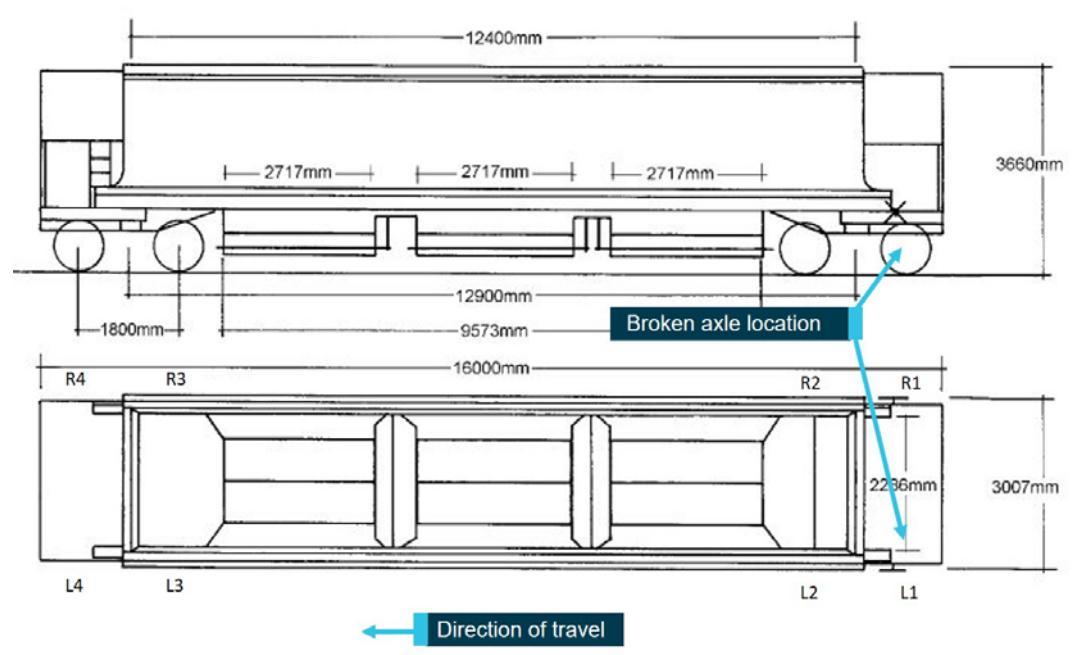
Figure 4: NHSH wagon diagram

At 0046, the front driver brought TM94 to a stand at 147.550 km. The second driver from the front locomotive then left the cabin and inspected the train. They found the train had derailed one wheelset (R2/L2) of the 14th wagon in the consist (Figure 4 and 5). A short time later, the driver reported to Junee network control details of the derailment. The train crew were instructed to wait on site and at 0309, they were tested for drugs and alcohol. The results of these tests were negative.

Following the derailment, investigators from ARTC, OTSI and Pacific National attended the site. On-site evidence identified the location of the derailment at 150.152 km. The likely point of dropoff was identified from a mark on the Up Rail gauge face and the start of sleeper damage. The track sustained damage beyond this point for approximately 2.6 km. Following the incident, 4,350 concrete sleepers were replaced. The 128B turnout had damage to multiple areas, which required repair and replacement. There was also damage to the concrete pad at the Suttor Road level crossing (Figure 6). The significant damage to the concrete pad at the level crossing was almost entirely on the Down side, having been caused by the L2 wheel. The R2 wheel caused minimal damage to the concrete pad.

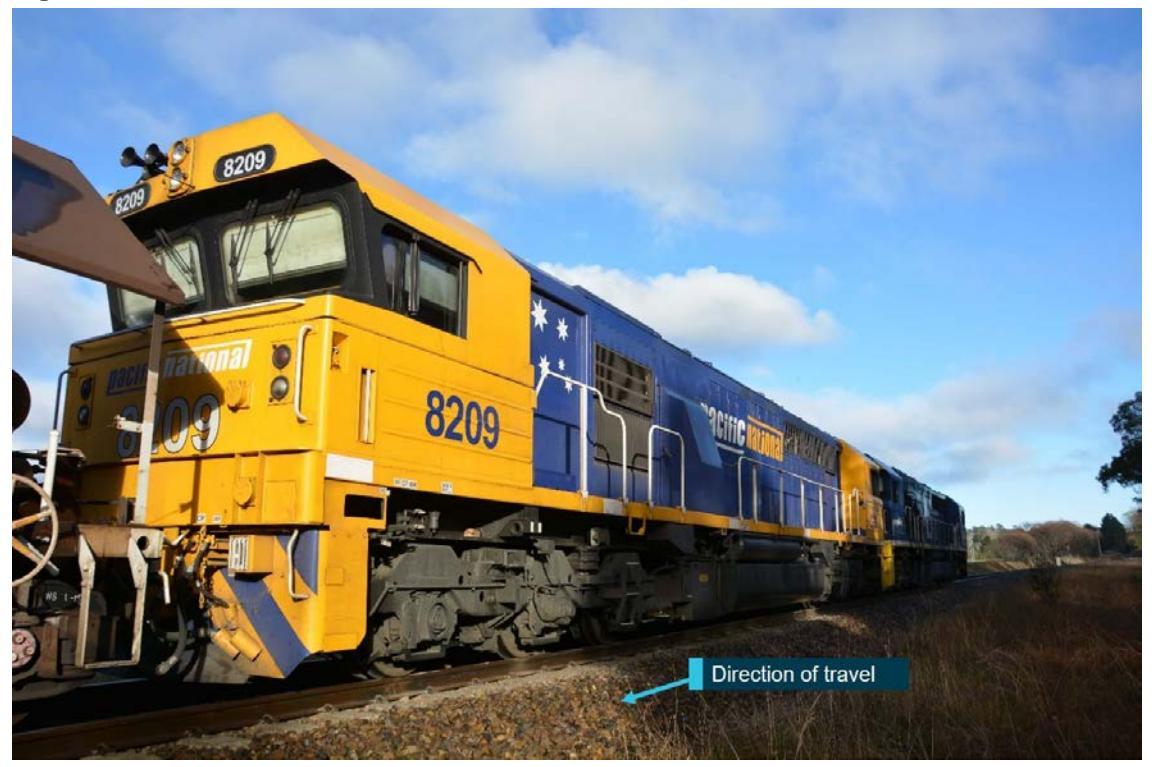
Figure 7: Two locomotives at rear of train TM94

Train TM94 was a coal service operated by Pacific National. This push/pull train was powered by three 82-class locomotives, consisting of one leading locomotive (8238) and two propelling locomotives (8209 and 8225) (Figure 7).
