Collision with terrain involving Liberty Aerospace XL-2, VH-XLK

9 km north-east of Braidwood, New South Wales, on 6 August 2019

ATSB Transport Safety Report

AO-2019-040

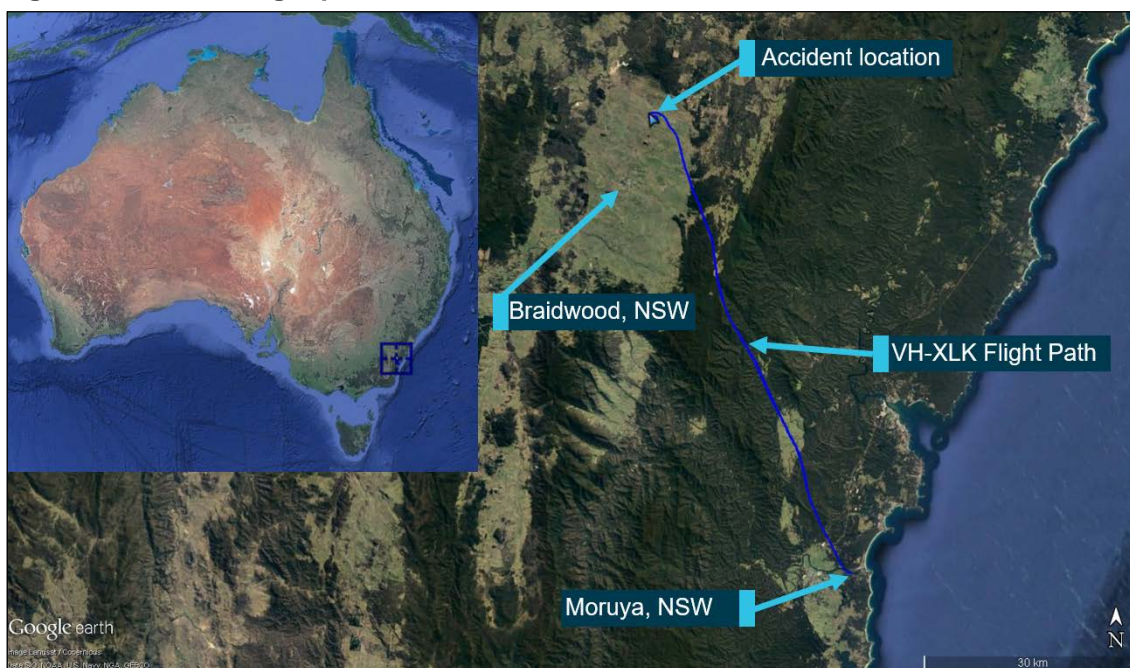
Figure 1: Aircraft's flight path and accident site location

On 6 August 2019, both pilots planned to fly to a property located 9 km to the north-east of Braidwood to meet friends that owned the property (Figure 1). This was the first time an aircraft would use the freshly prepared landing area on the property. The pilot of VH-XLK then intended to continue on to Camden Airport later that day.

The accident site was located about 150 m to the south of the western threshold of the landing area in relatively flat and open farmland, about 9 km north-east of Braidwood (Figure 1).

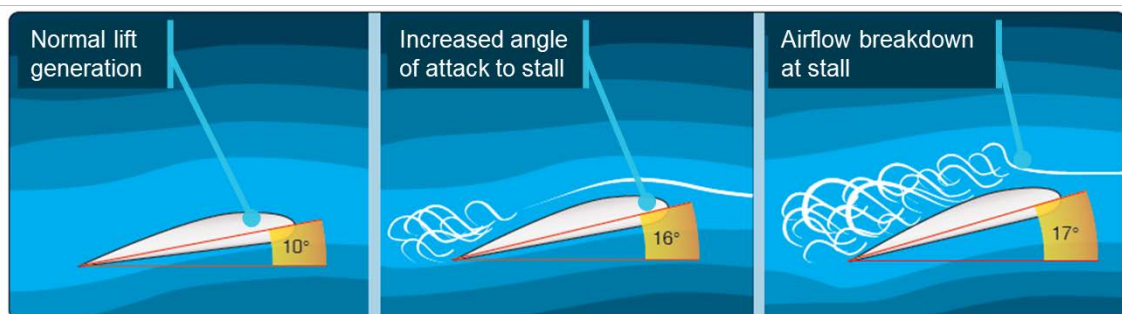
Figure 6: Angle of attack increase to stall

A wing generates lift when the airflow around the upper and lower surfaces results in a pressure difference between those surfaces. At a certain angle of attack,⁸ which is a characteristic of the wing design, the flow over the upper surface of the wing separates from the surface (Figure 6). This condition is known as an aerodynamic stall (or simply a stall) and results in a rapid reduction in the lift generated.

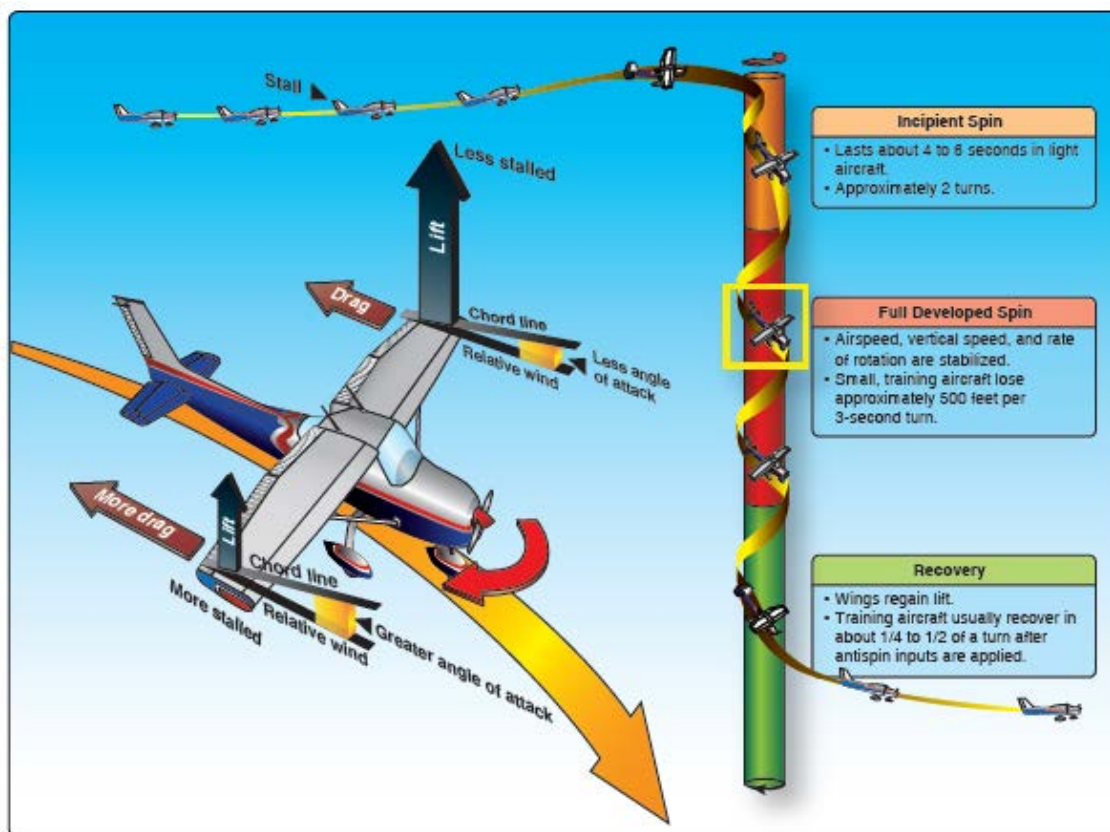
Figure 7: Spin entry and recovery

A spinning aircraft (Figure 7) will descend more slowly than one in a vertical or spiral dive and it will have a lower airspeed. The pitch angle can also vary considerably from significant pitch down, to a relatively flat attitude, depending on the aircraft type.
