Track obstruction due to loss of freight involving train 6WM2 and subsequent impact of passenger train 8615 with track obstruction

near Winton, Victoria, on 30 March 2018

Rail Occurrence Investigation RO-2018-008 Final – 10 December 2020 Cover photo: Pacific National

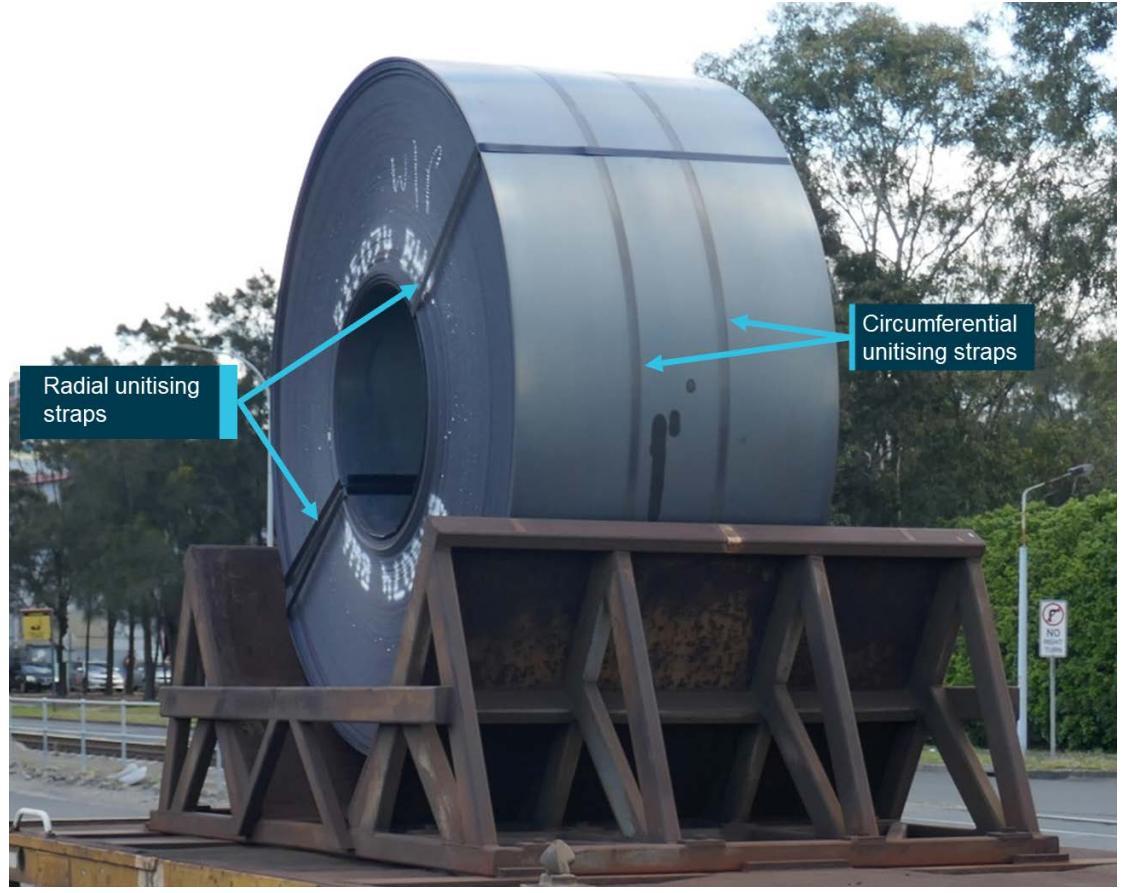
Figure 1: Jumbo coil fitted on a wagon within a cradle, showing radial and circumferential unitising straps

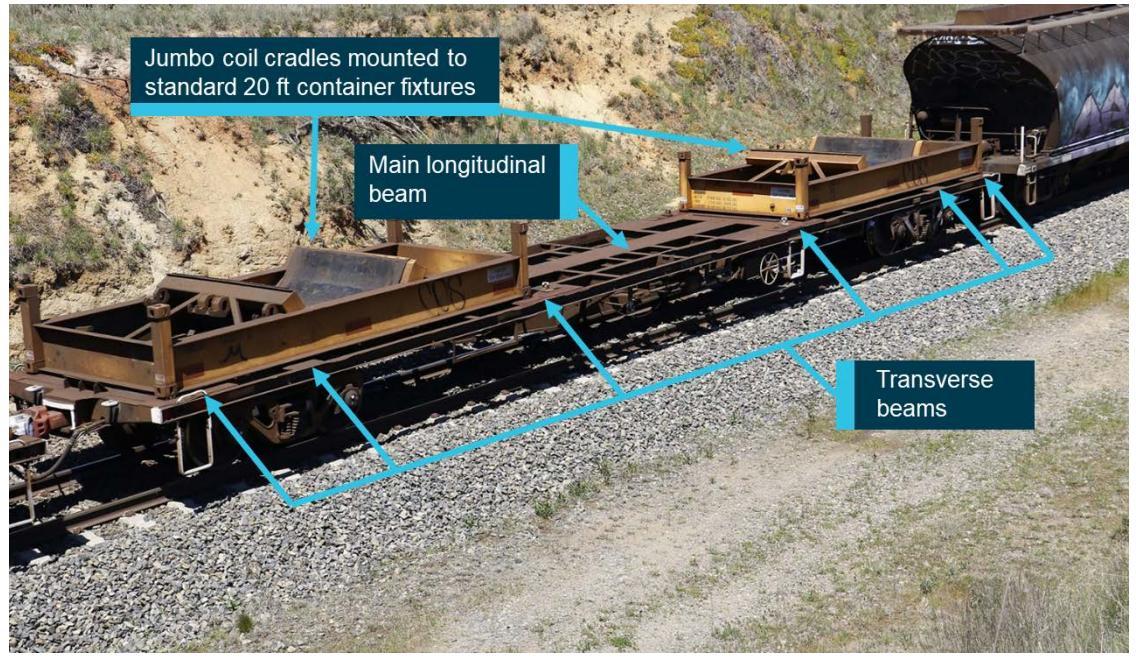
Figure 4: Structural components of an NQJF class wagon with jumbo coil cradles mounted.

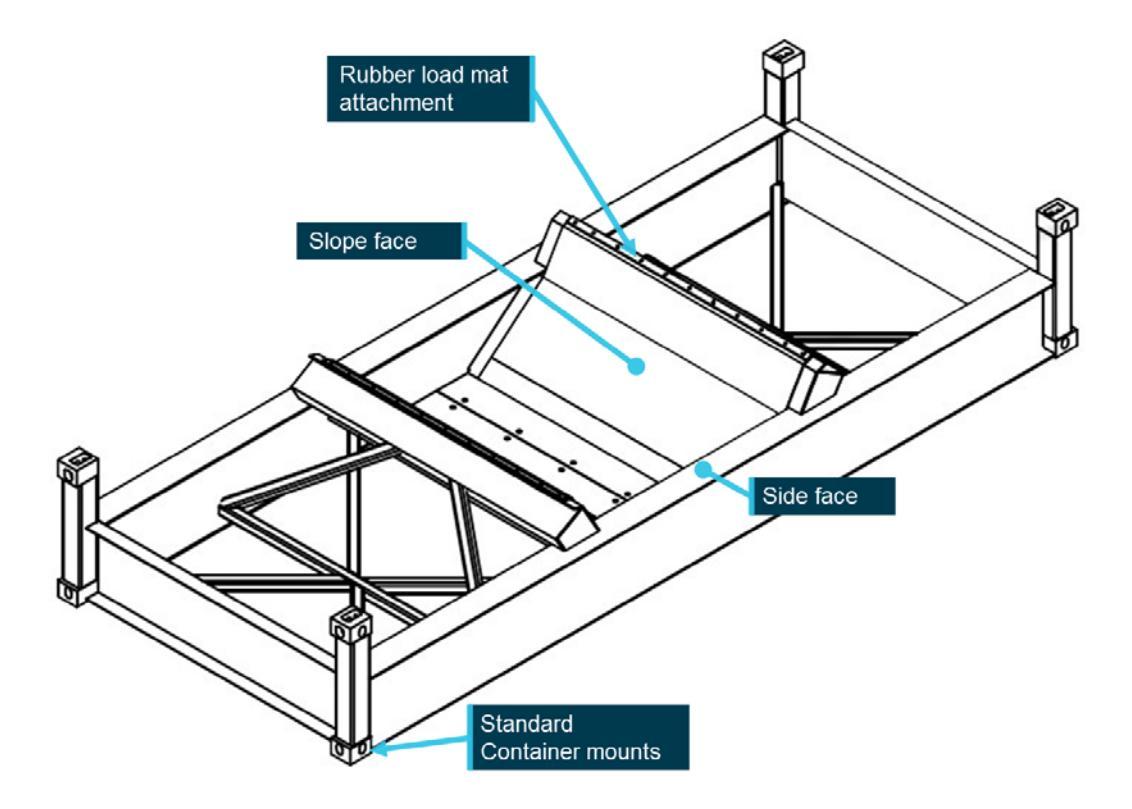
Figure 5: Isometric drawing of demountable coil cradle

The design of the cradles included rubber mats on the slope faces that contact the coils. The mats were attached on their top edge by bolts passed through a metal plate. The manufacturer indicated that the intended purpose of the rubber mat was to protect the coil from contacting the steel surface of the cradle.

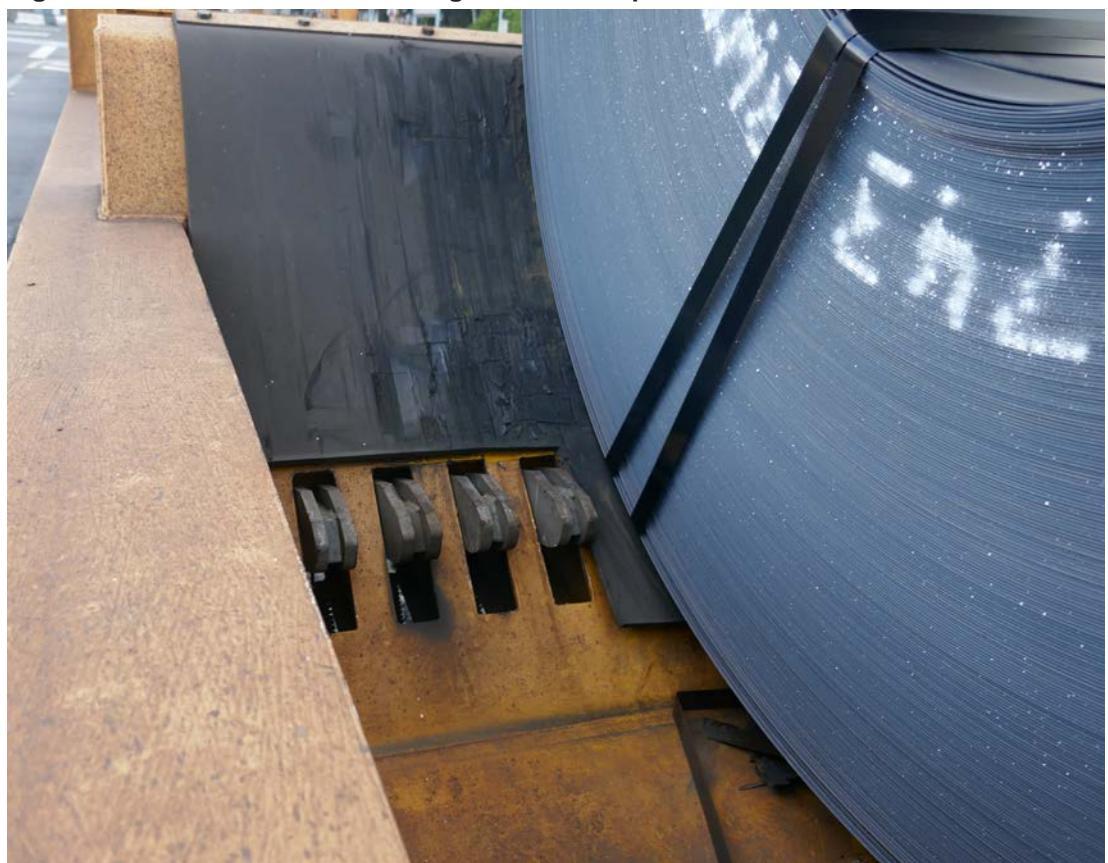
In addition, while not shown in the drawing, the design included retractable fingers that protrude from the cradle slope faces. These were intended to provide lateral support to the coils while accommodating different coil widths. While the exact contact position is a function of the coil diameter, which varied from coil to coil, the ATSB's observation of a coil being loaded into the same cradle type (Figure 6) showed that the fingers aligned with the coil below the contact point and close to the bottom surface of the coil. Therefore, while the fingers potentially provided some resistance to lateral movement, they did not significantly restrain the load from rotation around a longitudinal axis (toppling to the side).

Figure 6: Coil cradle retractable fingers and their position relative to a loaded coil

Note: The position of the radial steel straps are below the contact location with the slope face of the cradle. Source: ATSB

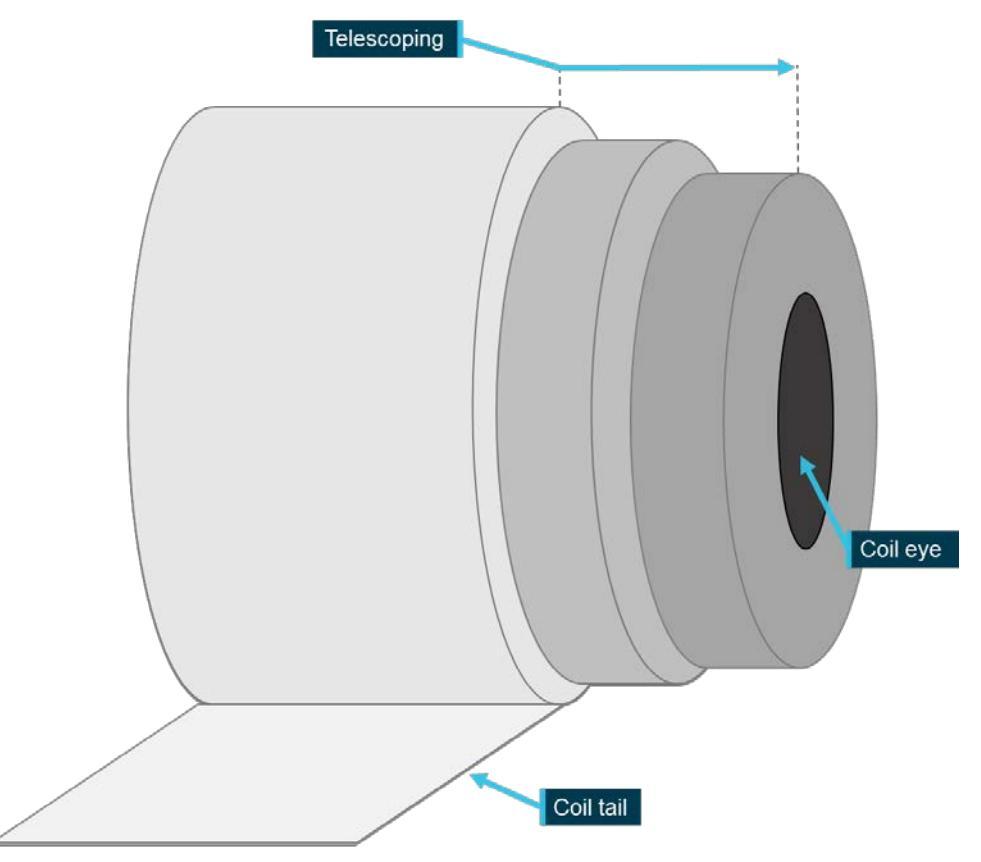
Telescoping refers to a situation where the inner layers of a steel coil move laterally relative to the outer layers (Figure 7). This is undesirable as it results in a shift in the centre-of-mass to one side, reducing the stability of the coil, and making it more likely to tip in that direction as well as creating difficulty in handling. A method used to prevent this occurring is to apply multiple radial and circumferential straps to the coil. The circumferential straps keep the coil layers tight so that the resulting inter-wrap friction between the layers can resist the relative motion required for telescoping. The radial straps provide additional support to keep the wraps tight as well as resistance to relative motion of the layers as the straps themselves would have to stretch for telescoping to occur.

Figure 7: Illustration of coil telescoping
