# Engine failure and forced landing involving Cessna 208B, VH-LNH

8 km north-west of Solomon Airport, Western Australia, on 16 November 2016

**ATSB Transport Safety Report**  
Aviation Occurrence Investigation  
AO-2016-155  
Final – 18 December 2020

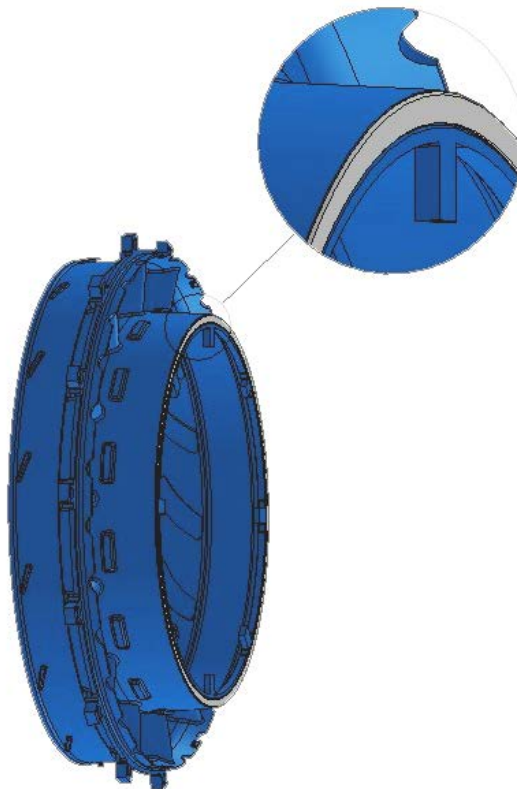
**Figure 17: Illustration of a PT6A CT vane ring with the blue highlighted section displaying the approximate portion that is replaced as part of the STI 72-50-254 repair**

In broad terms, the repair workflow involved replacing a major portion of the existing PWC vane ring through machining and welding processes. Following the machining processes, only a small portion of the original structure remained (Figure 17). A brazing process was then used to weld the remnant PWC part to the Southwest Turbine replacement casting, which contained the vanes and supporting structure. The CT vane was then finish machined and coated for oxidation resistance. The flow area was adjusted and the flow class recorded. The item then underwent non-destructive penetrant inspection for cracks in the structure, dimensional inspection and part marking (inscribing manufacturing identifiers), followed by a final inspection before being issued an authorised release certificate.

The remnant section of the original PWC part is identified as the grey ring located along the mounting flange. The ring of original material was kept while the remainder of the part discarded to be replaced as part of the STI 72-50-254 repair process.  
Image source: Southwest Turbine Inc.
