Australian Government Australian Transport Safety Bureau

Derailment and collision between coal trains

Ravenan (25km from Muswellbrook), New South Wales, on 26 September 2018

ATSB Transport Safety Report Rail Occurrence Investigation (Defined) RO-2018-017 Final – 4 December 2020

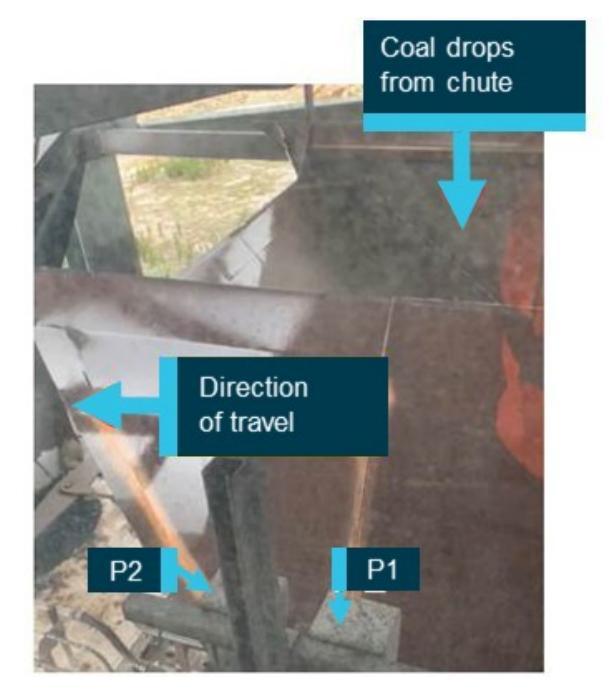
Figure 5: Sensor P1 and P2 instructing system to drop coal

Sensors P1 and P2 initiate the loading of coal from the coal bin above the wagons. The coal bin has a capacity of 1000 t and it is continuously monitored and filled by conveyor belts during a typical train loading operation. A typical 93 x 120 t train will carry approximately 9021 t of coal.

The sensors detect a gap between the front of the wagon to be loaded and the rear of the wagon which had just been loaded. Once the front of the wagon to be loaded obstructs P1 and P2, there is a delay and the system instructs the bin gates to open to commence loading.
