Controlled flight into terrain involving Mooney M20J, VH- DJU

26 km west of Coffs Harbour Airport, New South Wales, on 20 September 2019

ATSB Transport Safety Report

AO-2019-052

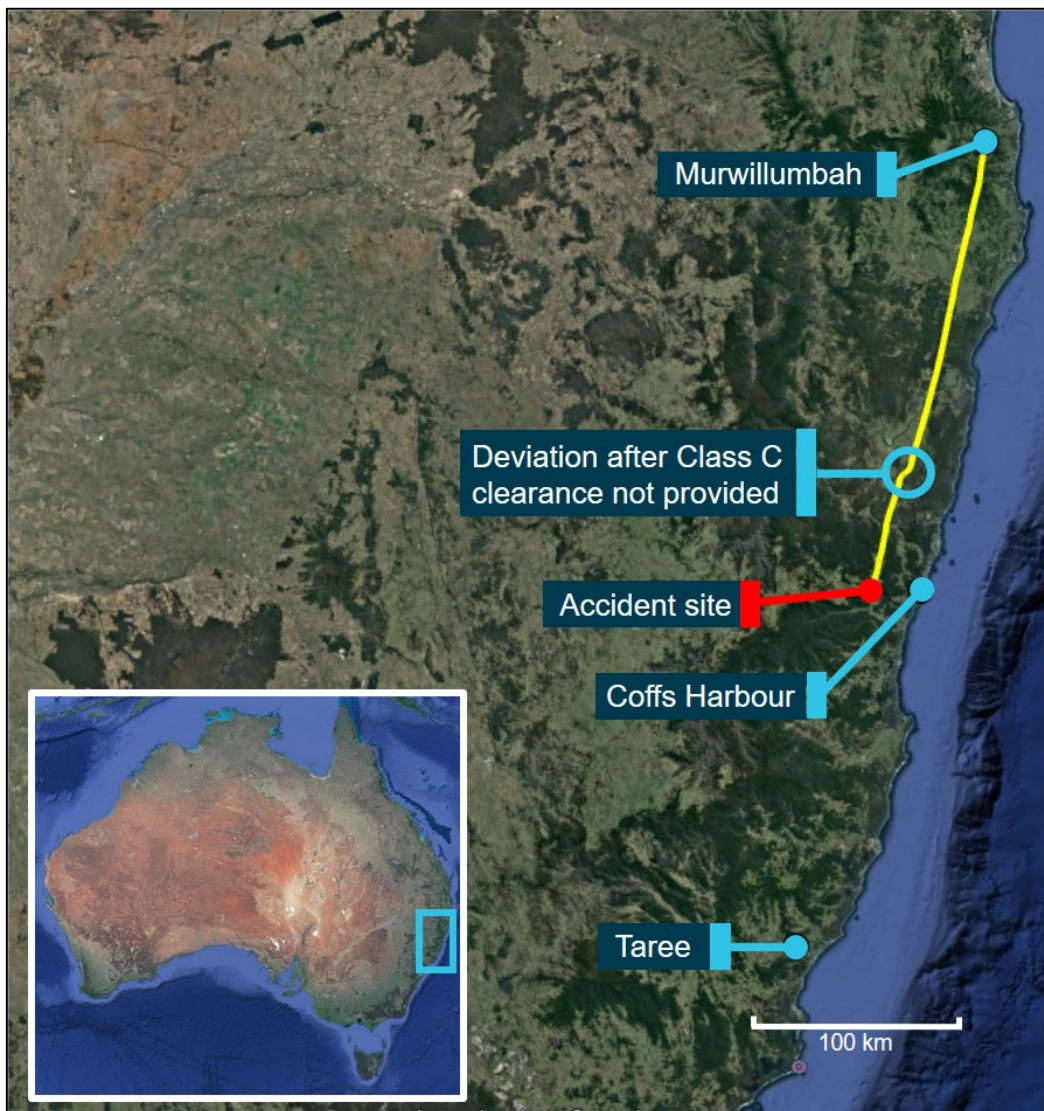
Figure 1: Aircraft track (yellow) on 20 September 2019

After departing Murwillumbah, the aircraft climbed to 6,500 ft above mean sea level (AMSL) on a direct track to Taree (Figure 1).

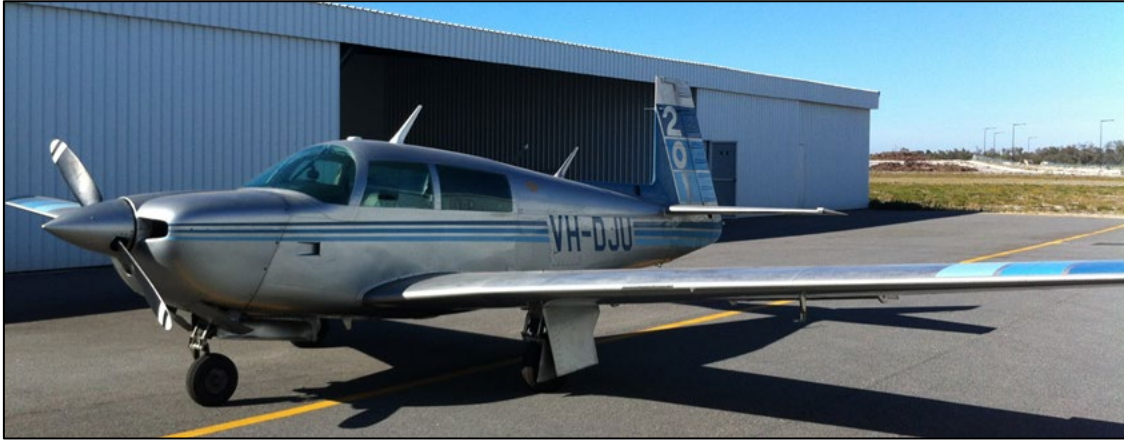
Figure 3: The aircraft, VH-DJU

The Mooney M20J is a four seat, piston-engine aircraft with a two-blade variable-pitch propeller and retractable tricycle landing gear. VH-DJU (serial number 24-1075, Figure 3) was manufactured in 1981 and first registered in Australia in 2005.³

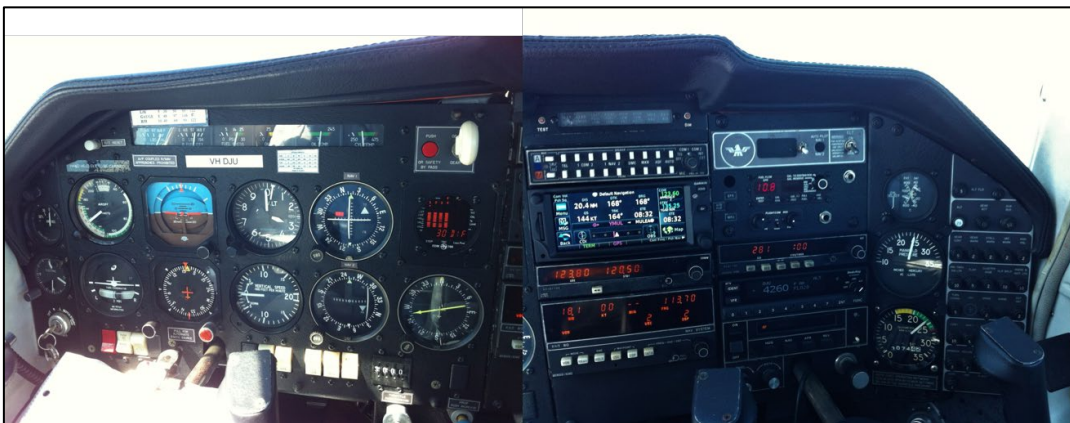
Figure 4: Composite image of the instrument panel

At the last scheduled maintenance inspection, in December 2018, the required inspections and test of the pitot-static system⁴ to maintain the aircraft's approval for instrument flight rules (IFR)⁵ operation were not undertaken. However, as a condition of purchasing the aircraft, the pilot of the accident flight required that the test and inspections be carried out. In April 2019, this was carried out and at the time of the accident the aircraft was equipped and approved for IFR operation (Figure 4).

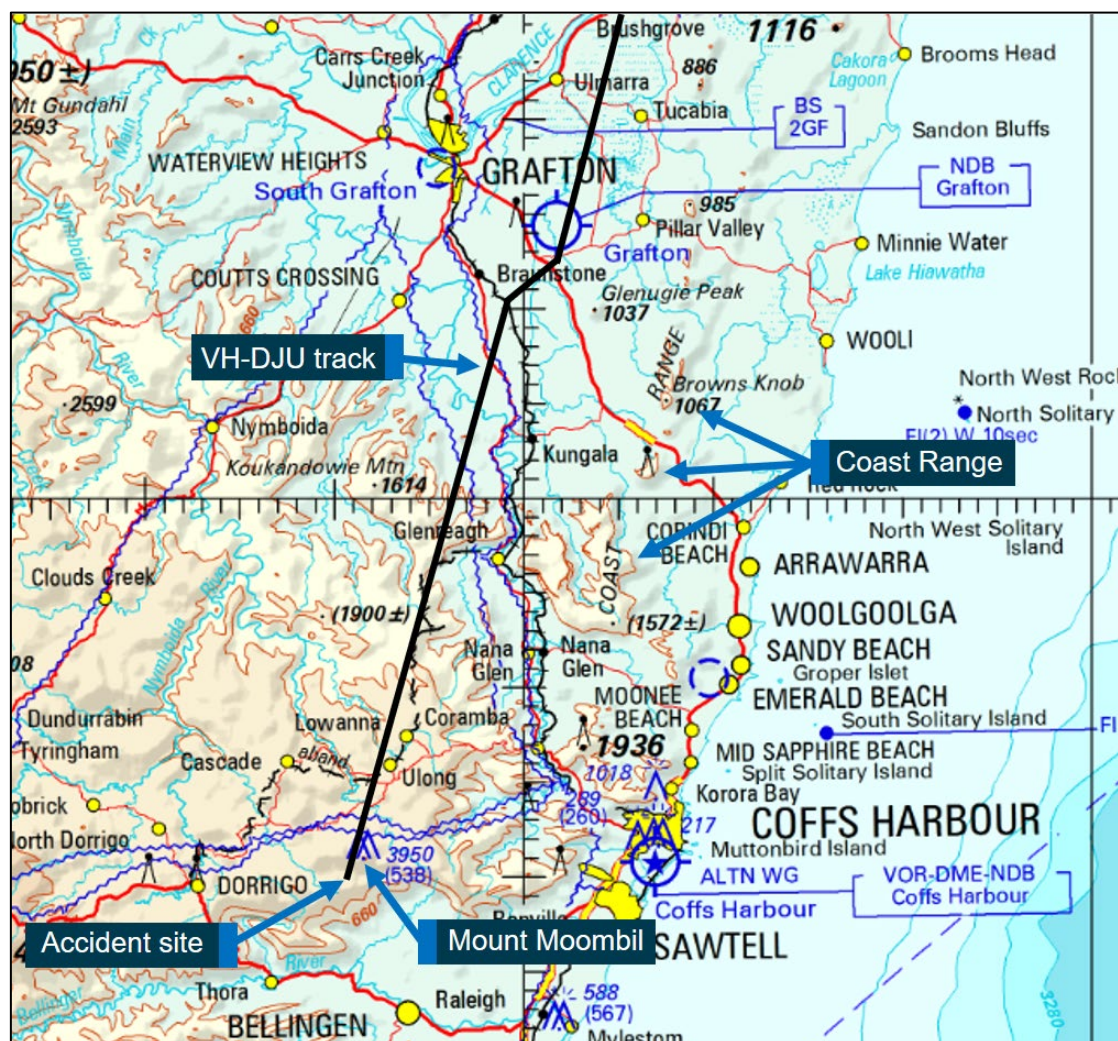
Figure 5: World Aeronautical Chart extract showing terrain in the vicinity of the aircraft's track

At the time of the request to transit Class C airspace, the aircraft was about 10 NM north of Grafton (Figure 5). The area to the north of and surrounding Grafton was low-lying coastal terrain with elevations generally below 1,000 ft AMSL. However, the line of hills associated with the Coast

Range, between the aircraft's position and a track toward the coast and Coffs Harbour, rose to elevations in excess of 1,000 ft AMSL.

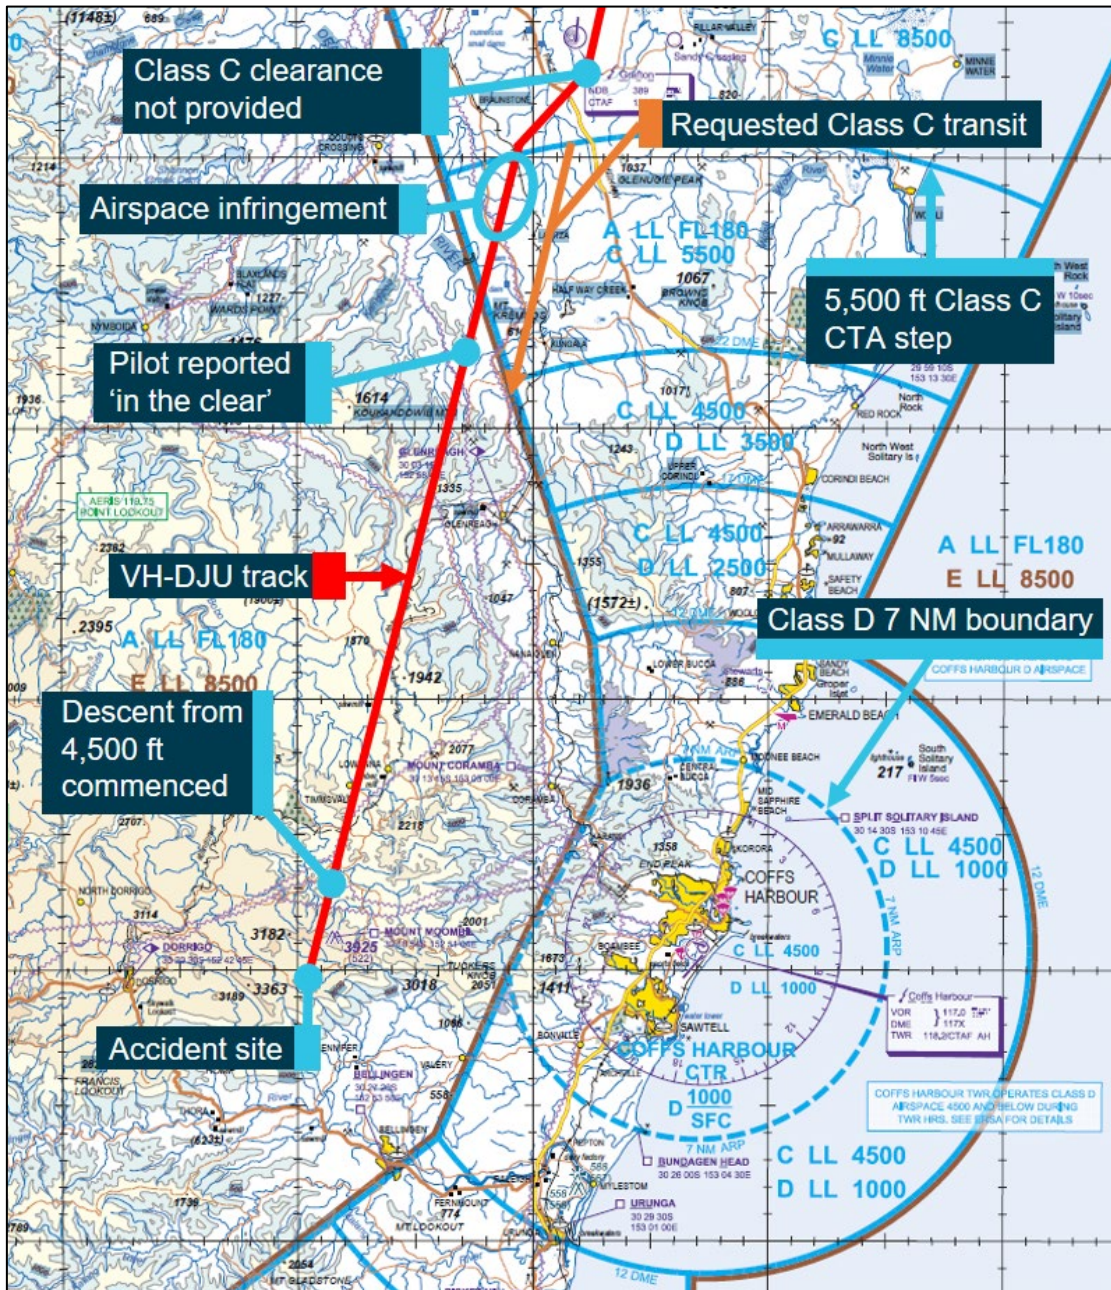
Figure 7: Visual terminal chart extract of Coffs Harbour airspace showing key events

Coffs Harbour Airport is situated within Class D terminal airspace (Figure 7). This airspace was controlled by an air traffic controller situated within the Coffs Harbour control tower. The Class D airspace extended to the north and south-west at ground level to a 7 NM boundary. West of the airport, the airspace extended about 6 NM and further west of this boundary, the controlled airspace base was the overlying Class E airspace at 8,500 ft.¹⁰ To the north and south-west, the airspace fanned out at increasing distances from Coffs Harbour. The base of the airspace also progressively stepped up at increasing distances to a maximum altitude of 4,500 ft at about 22 NM.
