Runway undershoot involving Beechcraft 200, VH-FDO

Cairns Airport, Queensland, on 9 July 2020

ATSB Transport Safety Report

AO-2020-034

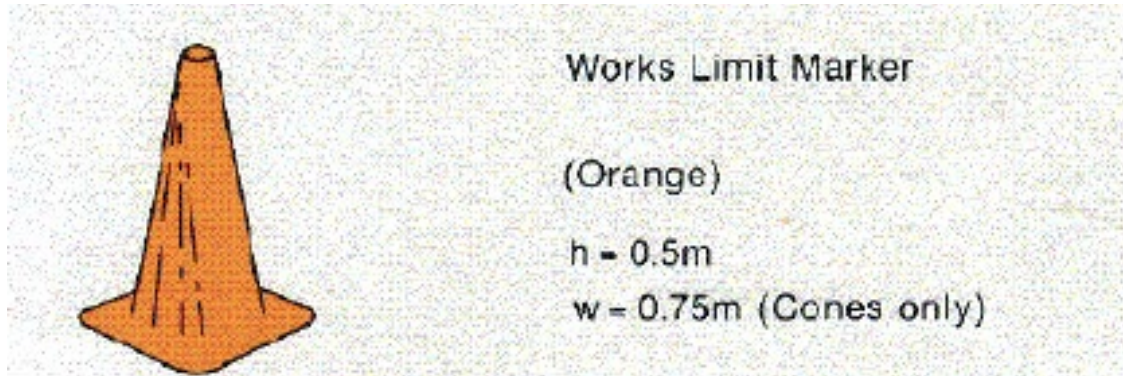
Figure 3: Works limit marker

Daytime works limit markers were fluorescent orange PVC cones or witches' hats (Figure 3). These were to depict aerodrome works to the works personnel and not to convey information to pilots regarding the movement area.
