# Engine failure involving Fokker 100, VH-FWI

41 km south-east of Geraldton Airport, Western Australia on 9 July 2019

## **ATSB Transport Safety Report**

AO-2019-033

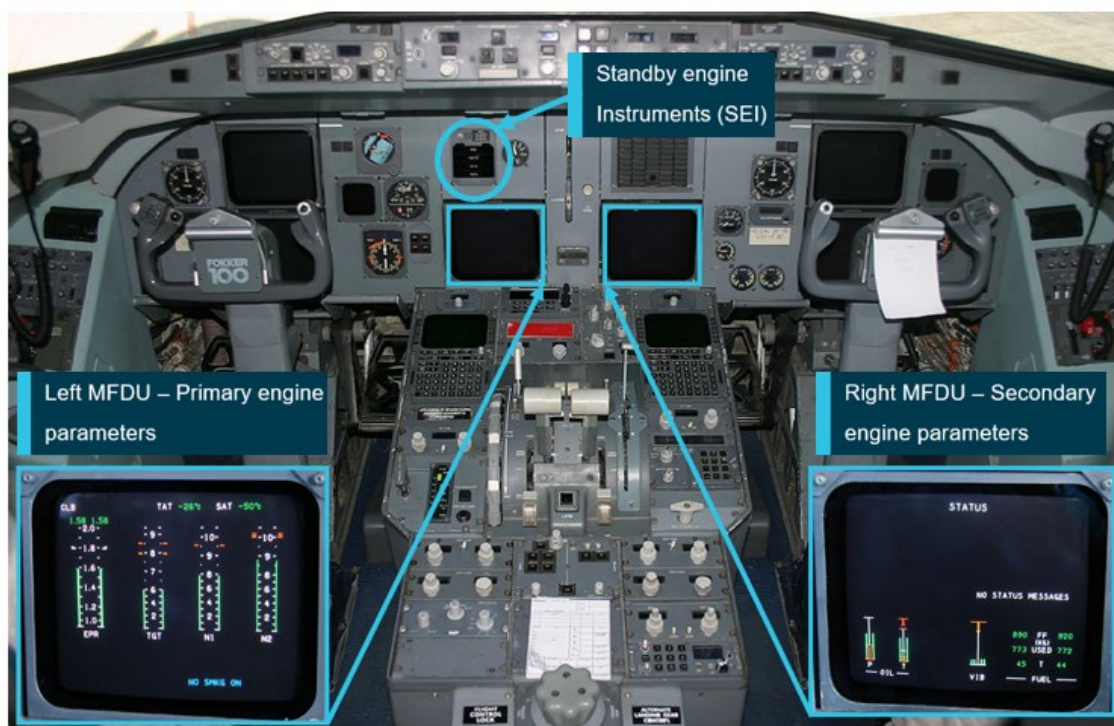
Figure 2: Fokker F100 VH-FWI – MFDU and standby engine indications to flight crew.

At 1251:10 the left engine (engine 1) thrust started gradually increasing beyond what was commanded by the flight augmentation computer and the ATS, which was not noticed by the flight crew (see the section titled *Recorded engine data* and appendices A and B). The PF reported that, at about this time, while still climbing and just prior to entering the transition layer,<sup>9</sup> both thrust levers began to move abnormally without crew input. Due to minor 'play' characteristic of the clutch-tie mechanism the PF observed a minor split between the two thrust levers during this movement.<sup>10</sup> The PF reported that throughout this time, there was no indication of engine vibrations and that the engine 2 indications displayed on the multi-function display unit (MFDU)<sup>11</sup> all remained 'in the green' (normal). However, during interview the PF could not recall what any of the actual engine indications were (Figure 2).

The PF also reported at about this time the aircraft's nose started to drop slightly, accompanied by a 'very minor yaw' to the right. The PM reported being preoccupied with support duties and not detecting either the abnormal thrust lever movement or the engine status.
