# Collision with water involving de Havilland Canada DHC-2, VH-NOO

Jerusalem Bay (Hawkesbury River), New South Wales, on 31 December 2017

## **ATSB Transport Safety Report**

AO-2017-118

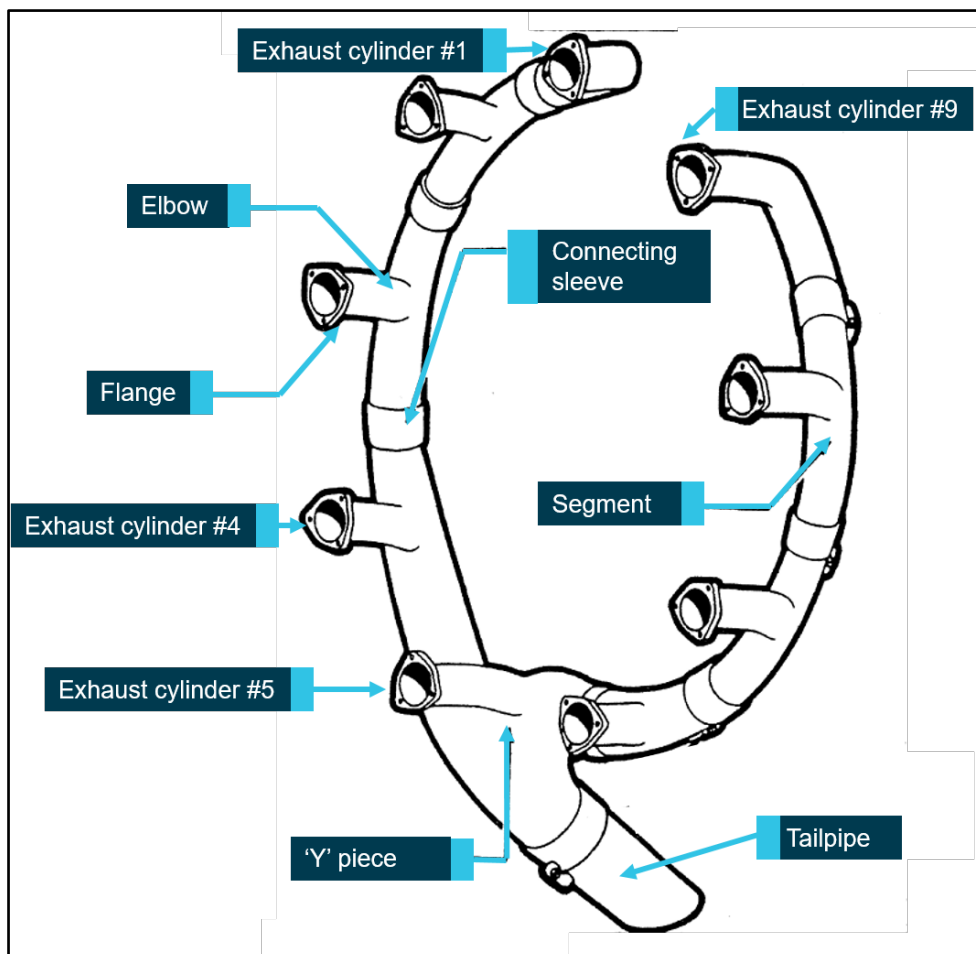
**Figure 7: DHC-2 exhaust collector ring**

The DHC-2 engine exhaust system (collector ring) consisted of seven segments, each of which connected to the cylinder exhaust port on the engine by an integral elbow and flange. The segments terminated in a 'Y' piece, which connected to the exhaust ports of cylinders number 4 and 5, and to the exhaust tailpipe (Figure 7). Exhaust gases were expelled through this tailpipe on the lower, right side of the engine bay.

Each of the segments were joined using connecting sleeves (slip joints). These were a friction-fit join, which permit individual segment maintenance. They were designed to expand with heat when the exhaust system reaches operating temperature, effectively sealing the joints. A licensed aircraft maintenance engineer (LAME) from the maintenance organisation reported that the slip joints were generally not completely sealed.

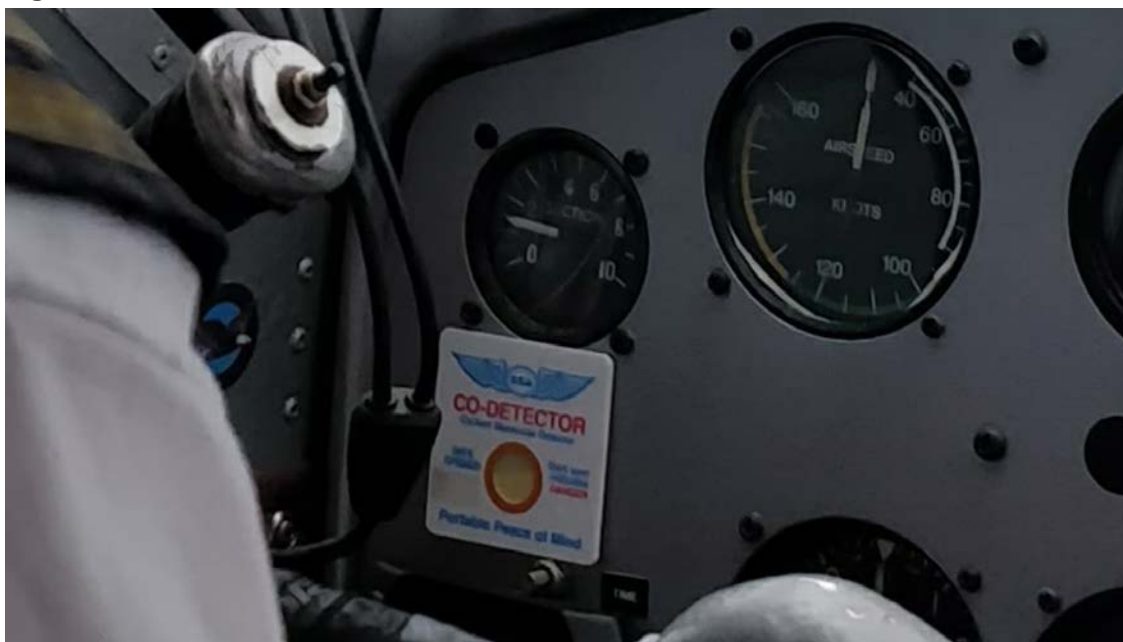
**Figure 9: Carbon monoxide detector fitted to VH-NOO**

While not required, the aircraft was fitted with a disposable carbon monoxide (CO) chemical spot detector (refer to section titled *Carbon monoxide information*). The detector was affixed to the instrument panel, to the left of the pilot, and below the suction gauge (Figure 9).

The detector had a shelf-life of 3 years when unopened, but once removed from its packaging it had a useful life of 12 months. The detector fitted to the aircraft had a use-by date of 1 April 2018, written on the reverse side of the card.

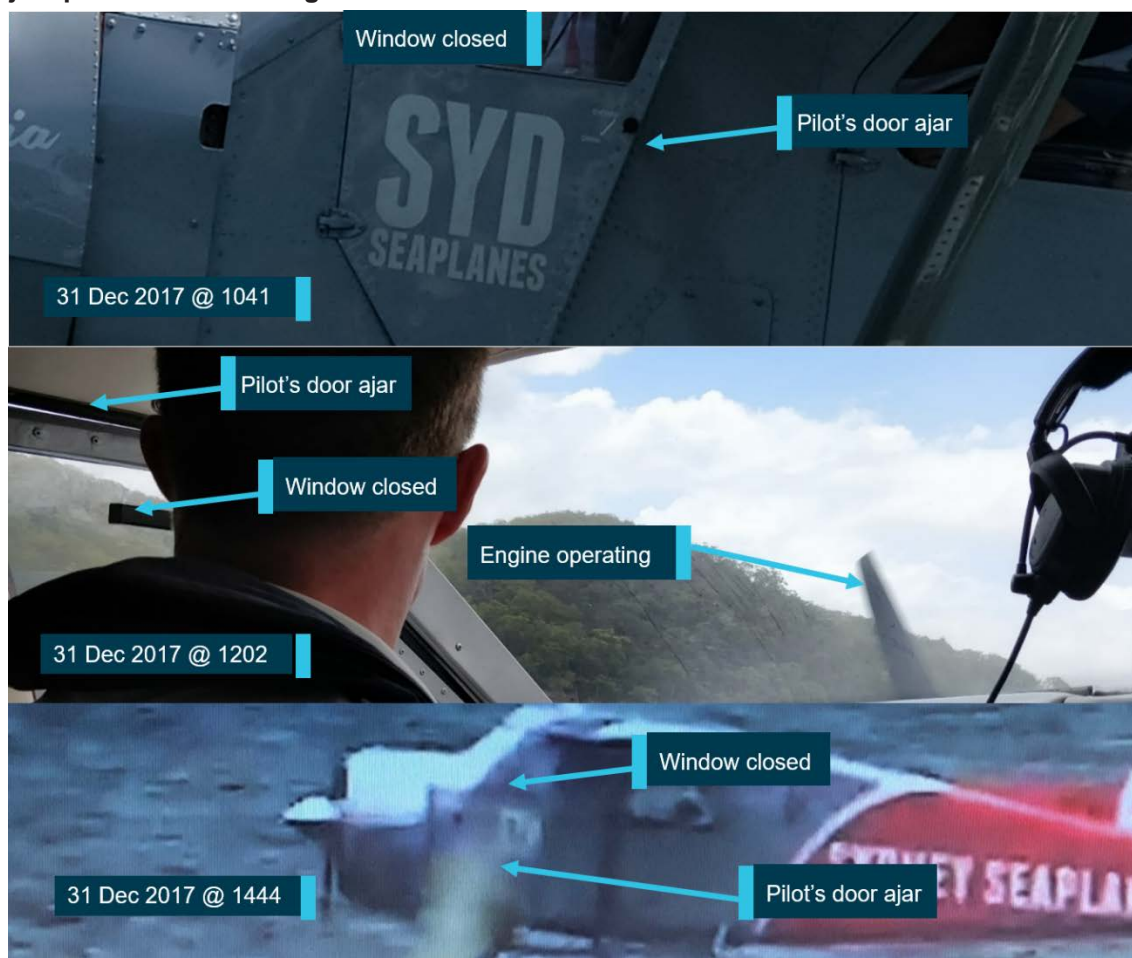
**Figure 16: Pilot's door ajar and window closed during previous flights and extended taxi just prior to accident flight**

Other company DHC-2 pilots advised that their routine was to open their sliding window rather than having the door ajar when ventilation in the cabin was required before take-off. Sydney Seaplanes indicated that taxiing with the door ajar was common practice in light non-airconditioned aircraft, especially in summer.

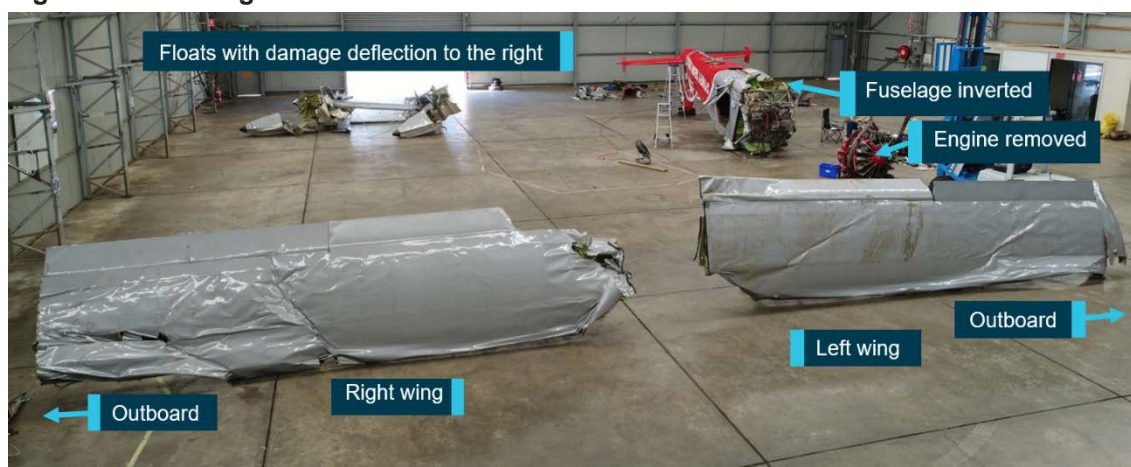
**Figure 19: Wreckage examination**

The aircraft was transported to secure facilities at Bankstown Airport for further examination by the ATSB. A representative from the aircraft type certificate holder also attended. Examination of the aircraft wreckage indicated that (Figure 19):

- no foreign objects were found obstructing the rudder pedals or the control column.

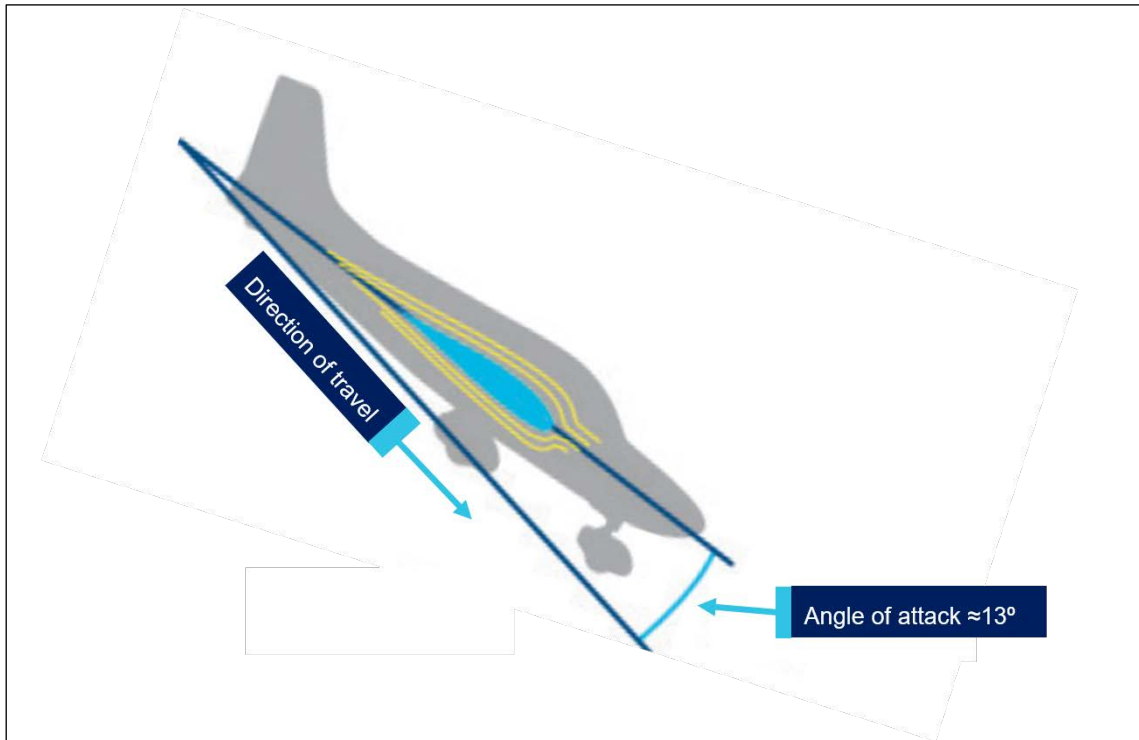
**Figure 20: Aircraft descending with a high angle of attack**

The damage to the aircraft suggested that the aircraft entered the water with the aircraft body at a high angle of attack<sup>31</sup> relative to the direction of travel (Figure 20).

This high angle of attack was consistent with an aerodynamic stall and was evident by:

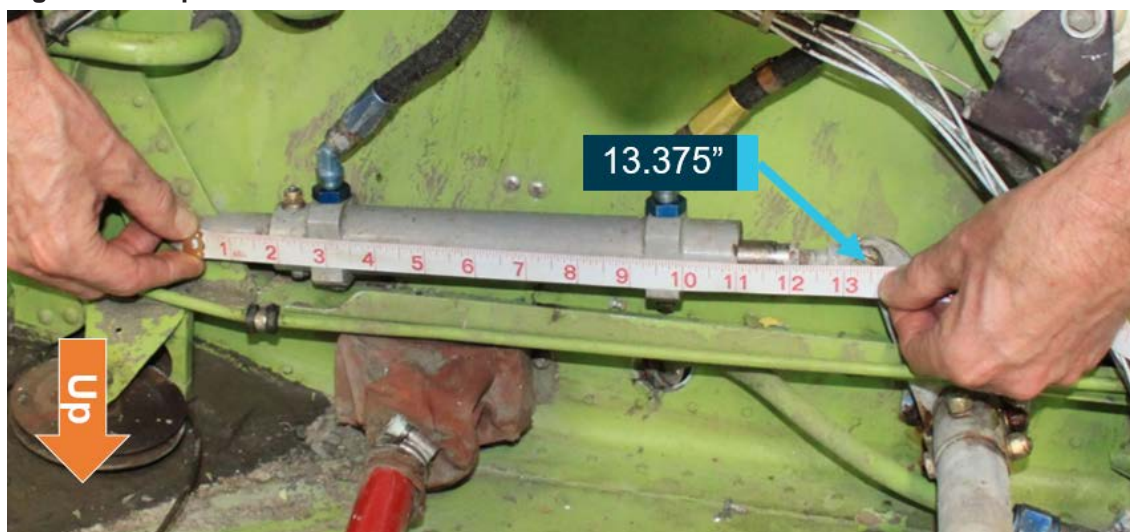
**Figure 23: Flap actuator**

The examination found that the flap actuator was extended to 13.375 inches (Figure 23), which was consistent with 'climb' flap of 15° (Figure 23 and Table 3) and the amount of flap visible in the witness photographs (Figure 2). The flap setting noted during the initial climb on a previous flight matched the setting observed in the witness photographs.

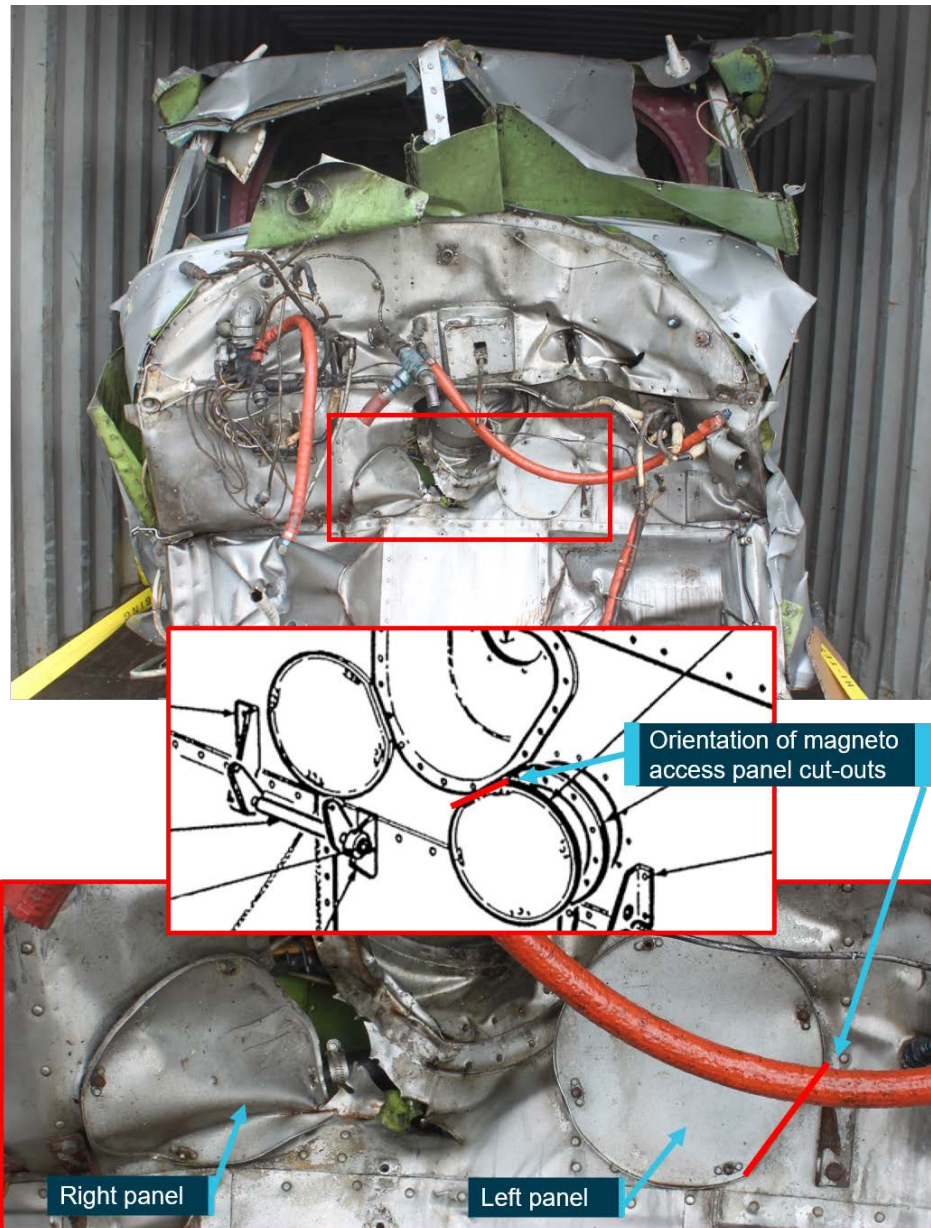
**Figure 27: VH-NOO main firewall to aircraft cabin with magneto access panels highlighted**

The engine main firewall was examined and the two magneto access panels were identified as a potential pathway for CO to enter the cabin. Both panels were found to be installed in the main firewall. The left panel had minor impact damage, while the right panel had significant distortion and impact damage (Figure 27).

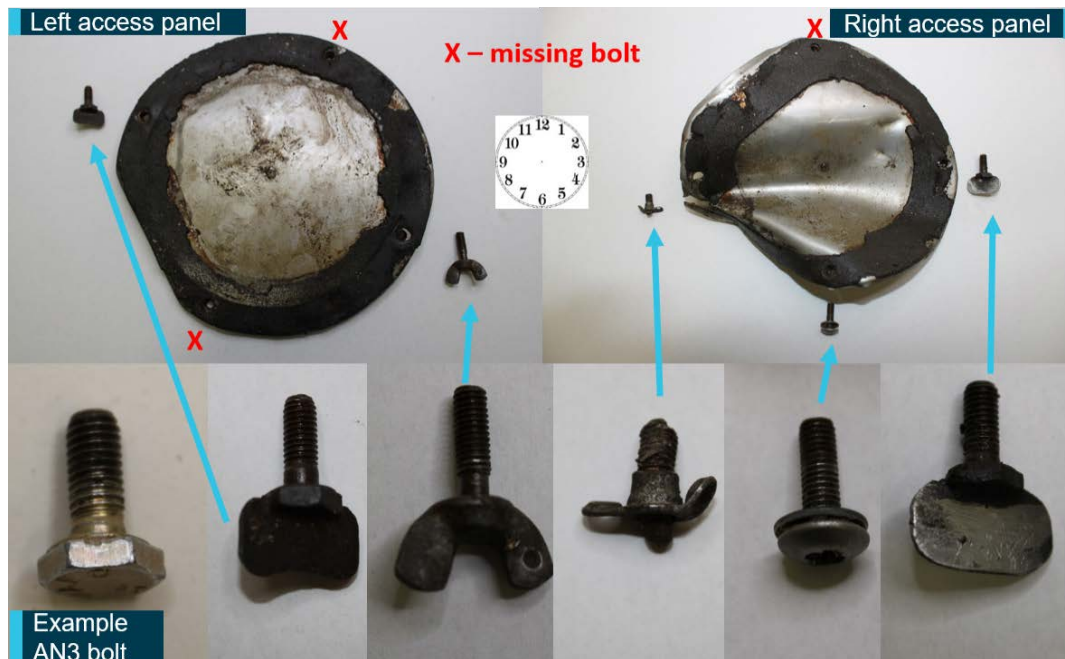
**Figure 28: Magneto access panels, attaching hardware and gaskets**

The installed bolts and a new AN3 bolt were tested in the missing bolt nutplate, with the same result as identified for the left panel.

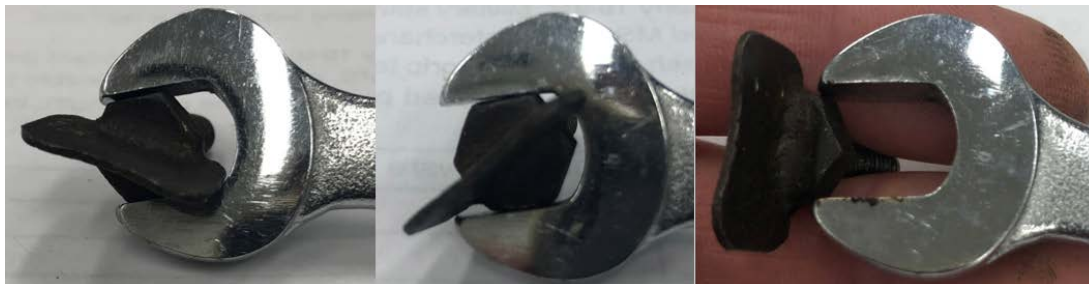
**Figure 29: Spanner accessibility on AN3 modified bolt**

A modified AN3 bolt was tested to determine if a standard 3/8” spanner could be utilised for the final torque. The spanner could be used to tighten the bolt on two of the three sides, but it did not fit onto the third due to the modification (Figure 29).

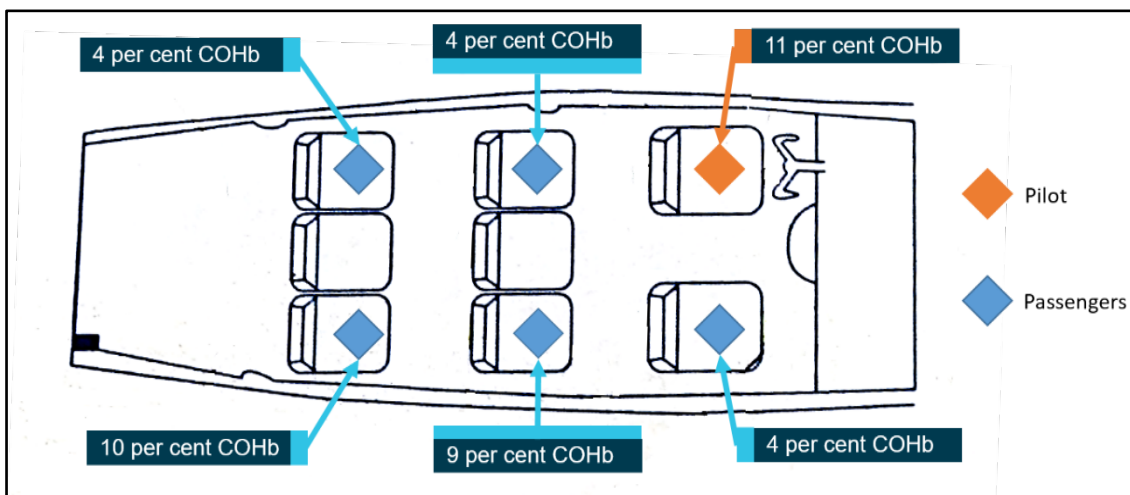
**Figure 32: Occupant seating positions and associated COHb levels**

The levels of COHb detected in relation to the occupants' seating position within the aircraft cabin are shown in Figure 32. The significance of these results is discussed further in the section titled *Physical symptoms and cognitive performance effects of carbon monoxide exposure*.

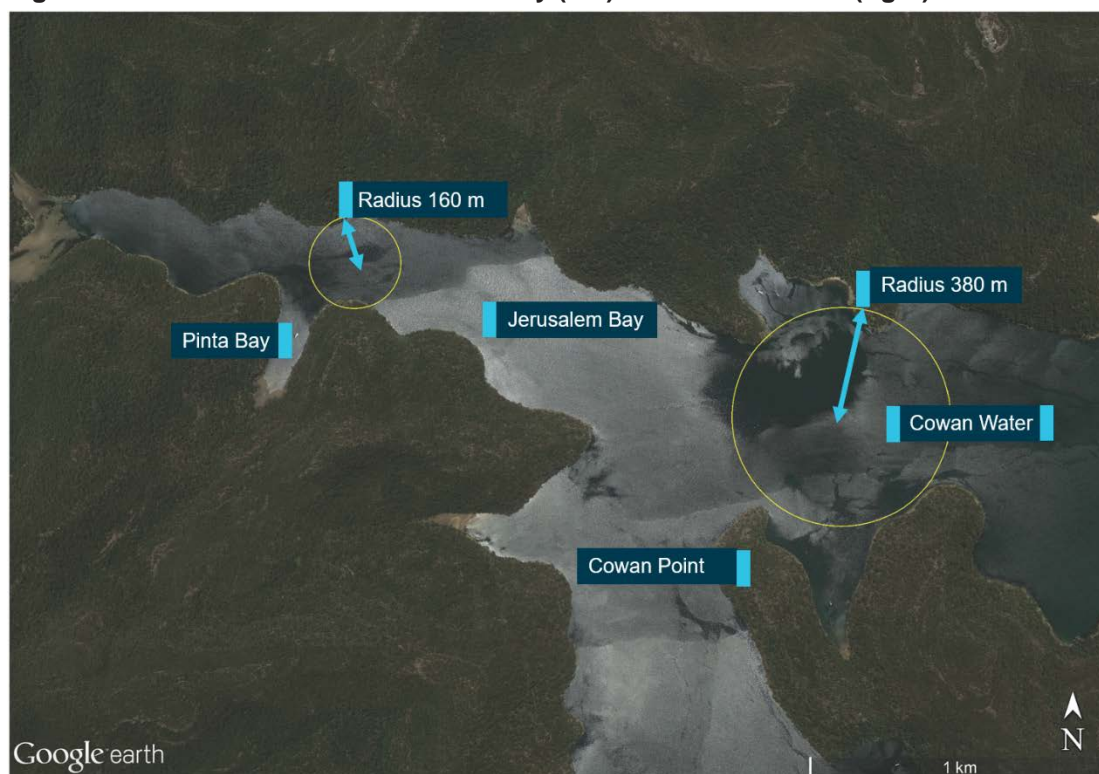
**Figure 39: Radius of turn in Jerusalem Bay (left) and Cowan Water (right)**

At the position where the initial turn in Cowan Water was conducted there was a width of about 760 m available in which to turn the aircraft over water (Figure 39). The ATSB estimated that for the 380 m radius turn, at an indicated airspeed of 70-80 kt, the minimum angle of bank required

At the location of the steep turn in Jerusalem Bay, there was a width of about 320 m available in which to manoeuvre over water (Figure 39). This 160 m radius turn would have required a minimum angle of bank of 41-49° to complete the turn at 70-80 kt. If the aircraft's speed was higher, the angle of bank required would have also increased.

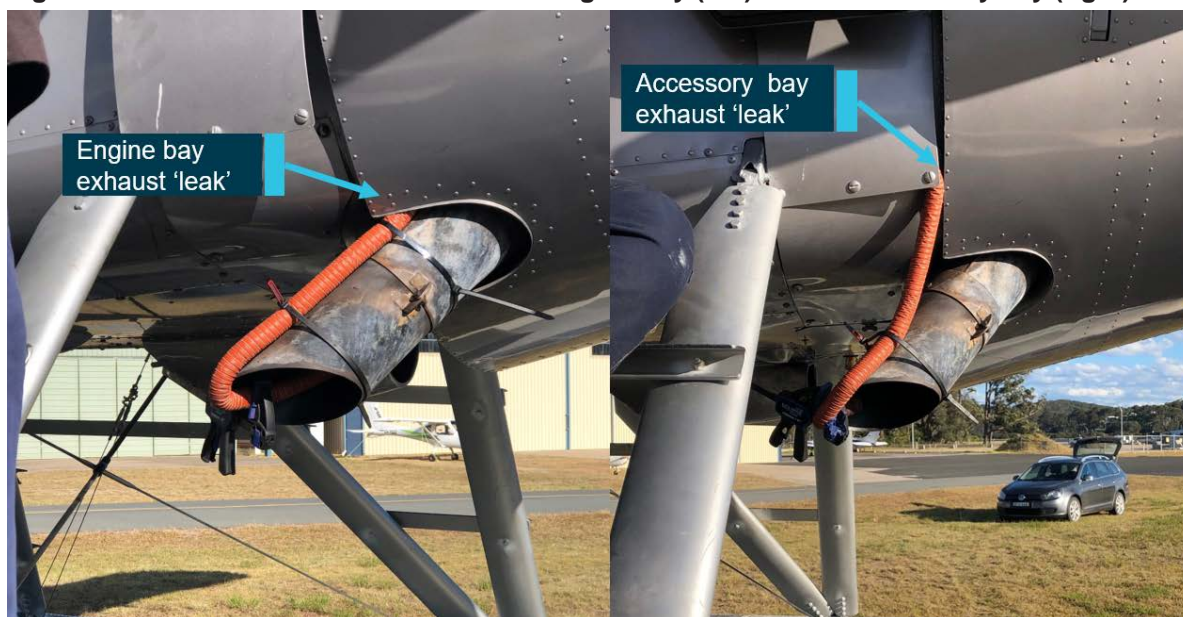
**Figure 45: Simulated exhaust leak into the engine bay (left) and the accessory bay (right)**

An engine exhaust leak was then simulated by feeding a small diameter hose from the exhaust tailpipe, initially into the engine bay and then into the accessory bay (Figure 45). The CO concentration level measured at the outlet of the simulated exhaust leak exceeded 500 ppm.

With the magneto access panel bolts removed and the simulated exhaust leak in the engine bay, the detector reached the second alarm level (60 ppm) with the door closed. This then increased quickly above 100 ppm when the pilot's door was ajar (Table 6). The levels were highest in the pilot's footwell adjacent to the holes in the firewall, and were less in the middle and rear rows. With the simulated exhaust leak in the accessory bay, the CO level quickly increased to 144 ppm, again highest in the pilot's footwell. The CO levels reduced slightly with the pilot's door ajar (Table 6). When the magneto access panel bolts were reinstalled with the simulated exhaust leak remaining in the accessory bay, the CO concentration level dropped considerably to 28 ppm with the pilot's door closed. With the door ajar the CO levels reduced slightly (Table 6).

This testing demonstrated that either the simulated exhaust leak or missing magneto access panel bolts did not result in high levels of CO in the cabin in isolation. However, the simulated exhaust leak in combination with missing magneto access panel bolts resulted in elevated CO levels in the cabin. The CO was more evident at the pilot's position and was exacerbated when the pilot's door was ajar with a simulated exhaust leak source in the engine bay. The CO levels reduced markedly in the cabin (by more than 80 per cent) when the access panel bolts were reinstalled with the exhaust leak remaining. The door position in this configuration did not adversely affect the CO levels.

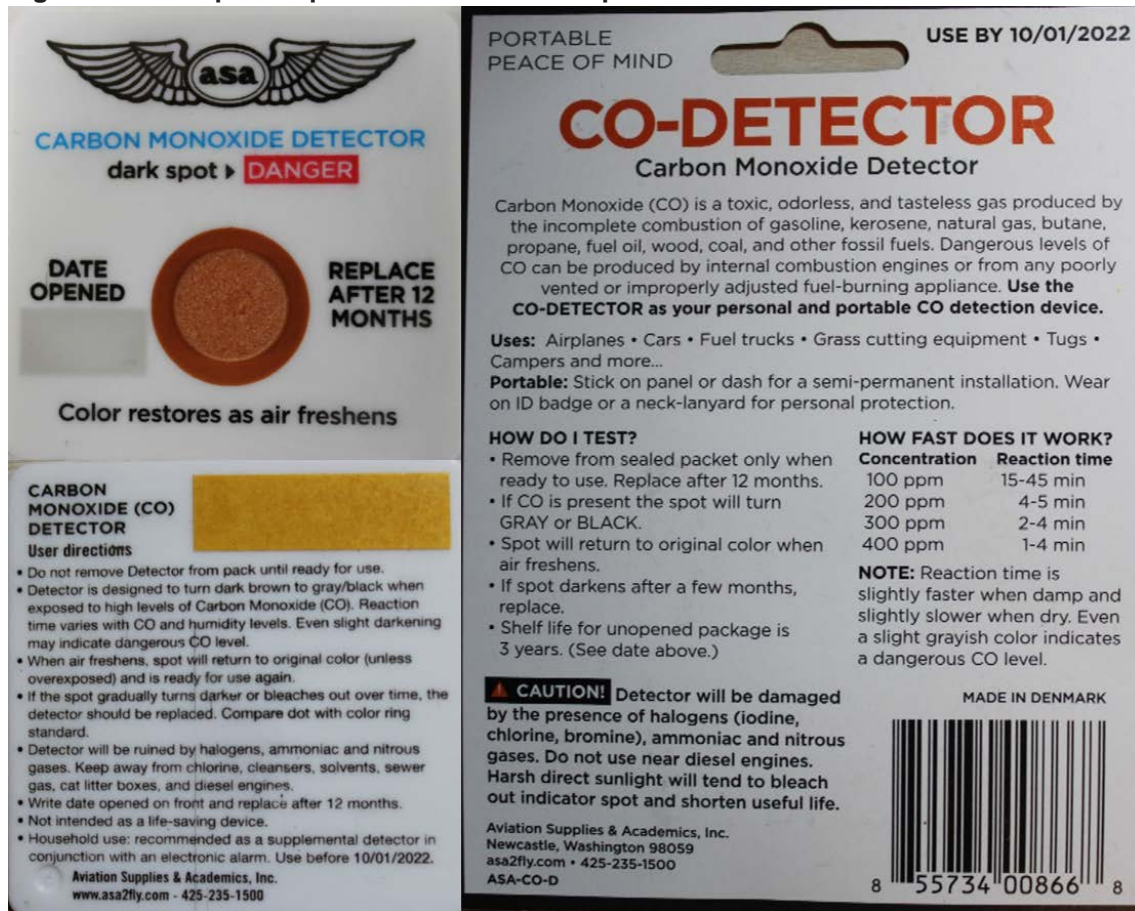
Figure 46: Exemplar disposable CO chemical spot detector

The manufacturers of disposable chemical spot detectors are openly transparent about the limitations of these types of devices. For example, the ATSB purchased the same detector that was fitted to VH-NOO at the time of the accident and noted that the back of the detector and the associated packaging detailed the limitations as (Figure 46):

Aside from highlighting the useful life of the detector, none of the above limitations were specified on the front of the detector for pilot awareness when the detector has been attached to the aircraft cabin.

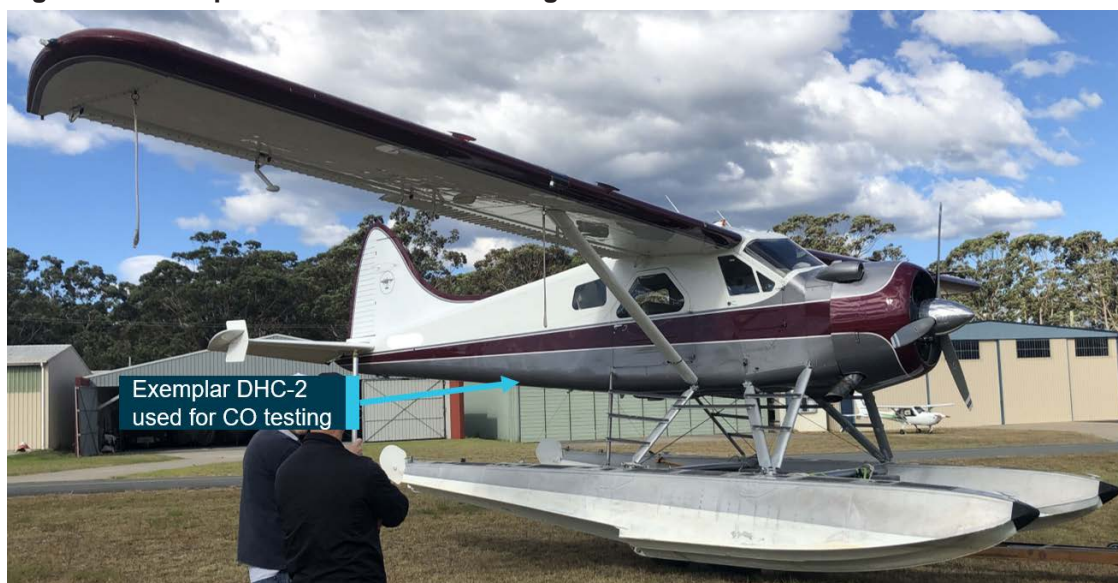
**Figure 53: Exemplar DHC-2 used for testing**

Prior to the commencement of testing, it was noted that the aircraft was missing one bolt from the left access panel and another was loose. A new AN3-3A bolt was sourced and fitted before testing began.

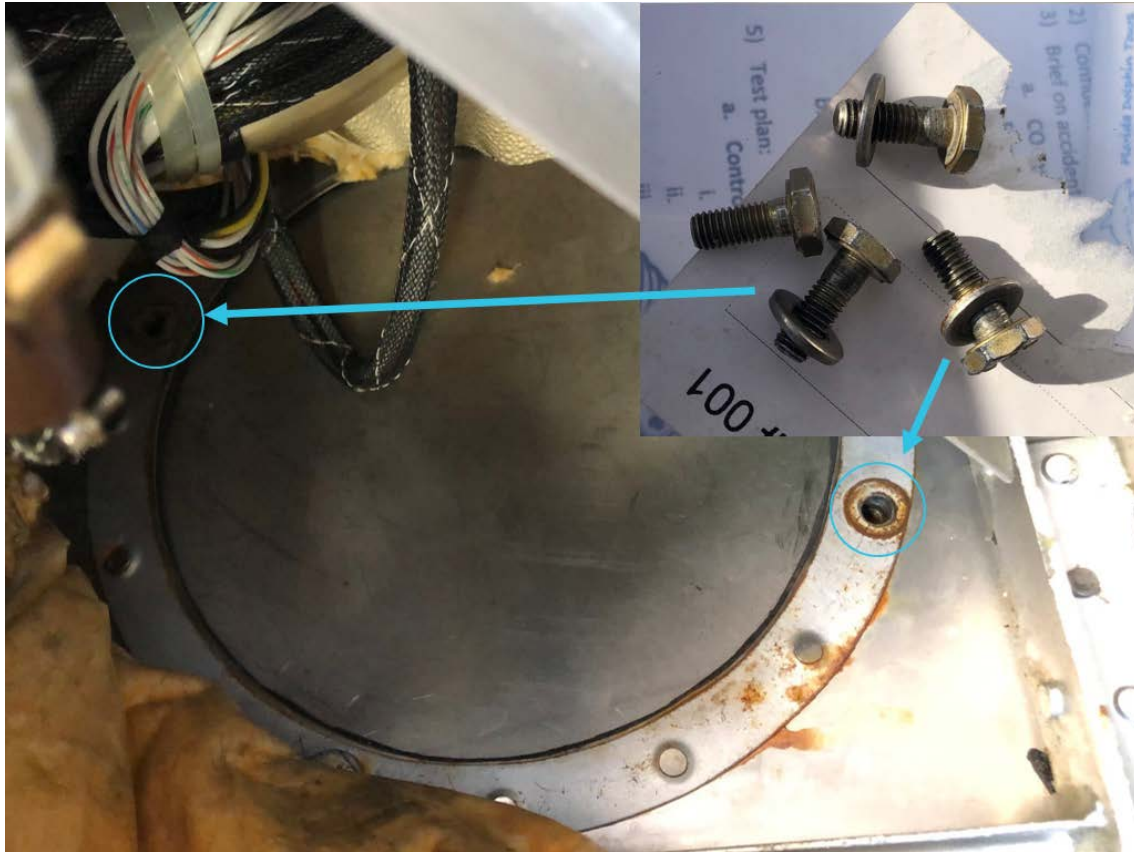
**Figure 55: Magneto access panel during testing with bolts removed**

Figure 55) to represent the condition known at the time of the accident. At the time of the CO testing, it was considered that four bolts were not in place at the time of the accident. This was later assessed to be three bolts, with two not in place on the pilot's side panel.

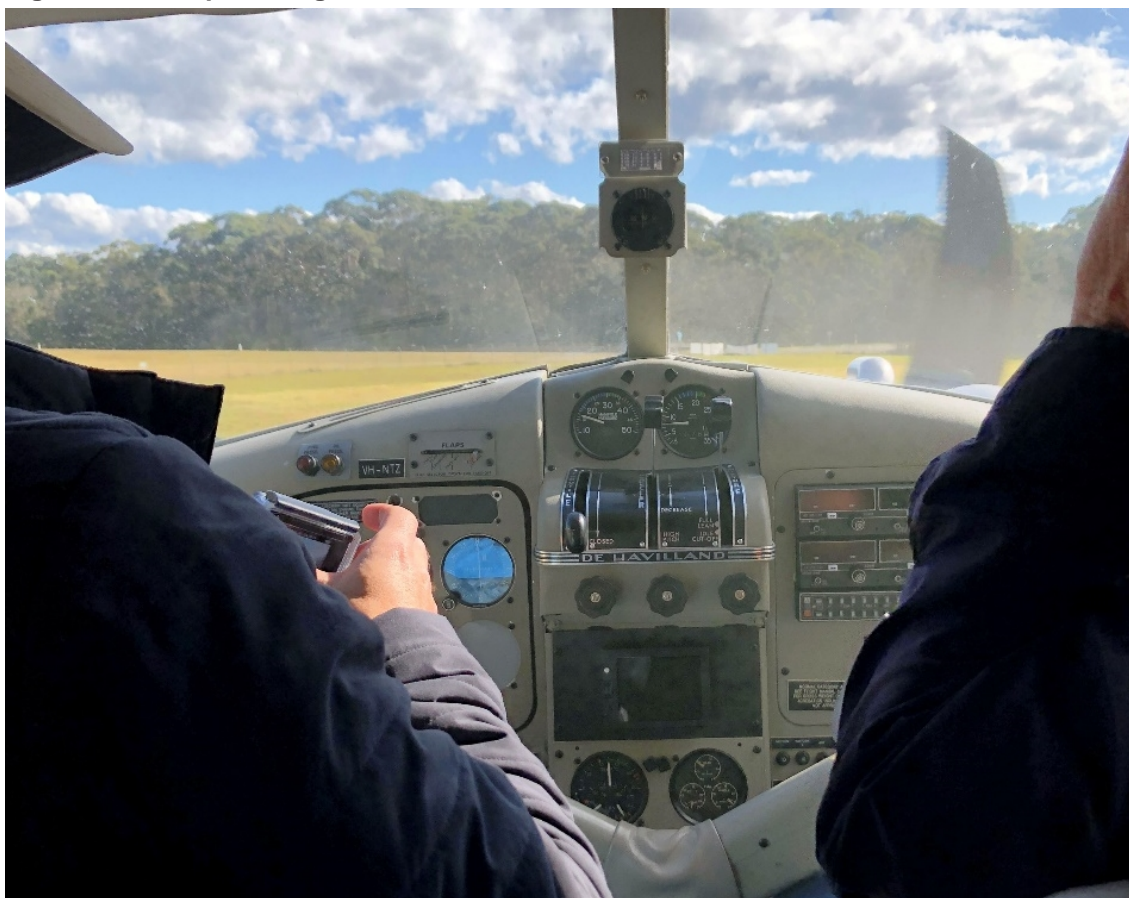
**Figure 56: Cockpit during smoke test with bolts removed**

A second smoke test was then conducted with the bolts removed and the snap vent open. The amount of smoke in the cabin was observed to be noticeably greater than the first test (Figure 56). With the pilot's door slightly ajar, more smoke was drawn into the cabin.

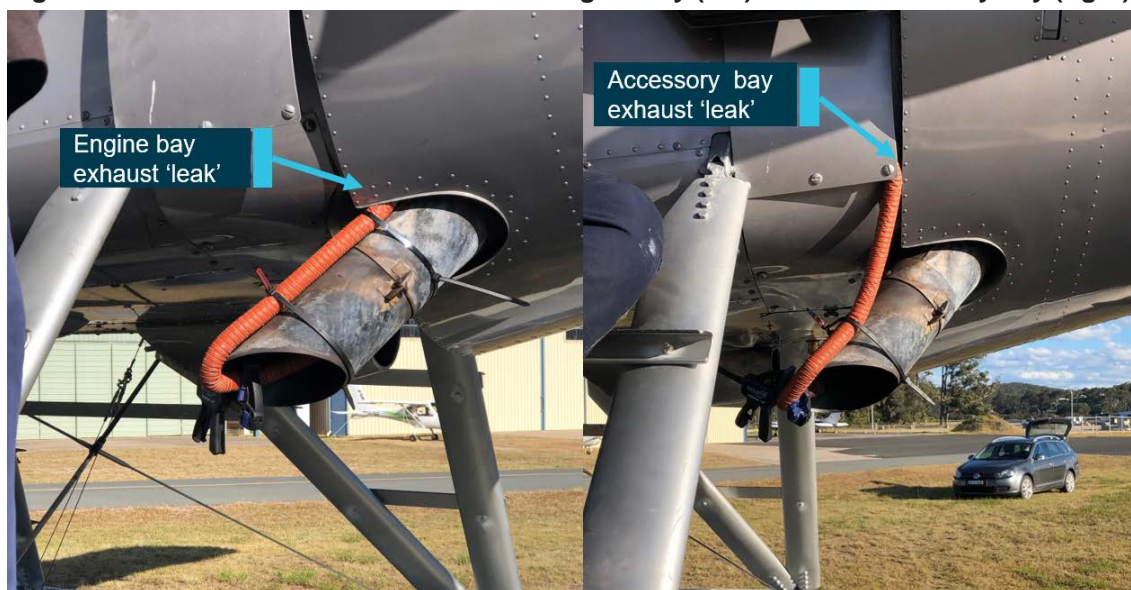
**Figure 57: Simulated exhaust leak into the engine bay (left) and the accessory bay (right)**

An exhaust leak was then simulated by extending a small diameter hose from the exhaust tailpipe into the engine bay in front of the accessory firewall (Figure 57). The CO concentration level was measured at the outlet of the simulated exhaust 'leak' and was found to be greater than 500 ppm.

The simulated exhaust leak was then moved to the accessory bay, in between the accessory and main firewalls (Figure 57). Even higher CO levels were detected in the pilot's side footwell with the door closed (144 ppm), compared with the right side at chest height (48 ppm). However, when the pilot's door was ajar the CO concentration levels reduced slightly.
