# Engine power loss and collision with terrain, Bell 206B3 helicopter, VH-FHW

107 km south-west of Jabiru, Northern Territory, on 21 May 2019

**ATSB Transport Safety Report**  
Aviation Occurrence Investigation (Defined)  
AO-2019-025  
Final – 26 February 2021

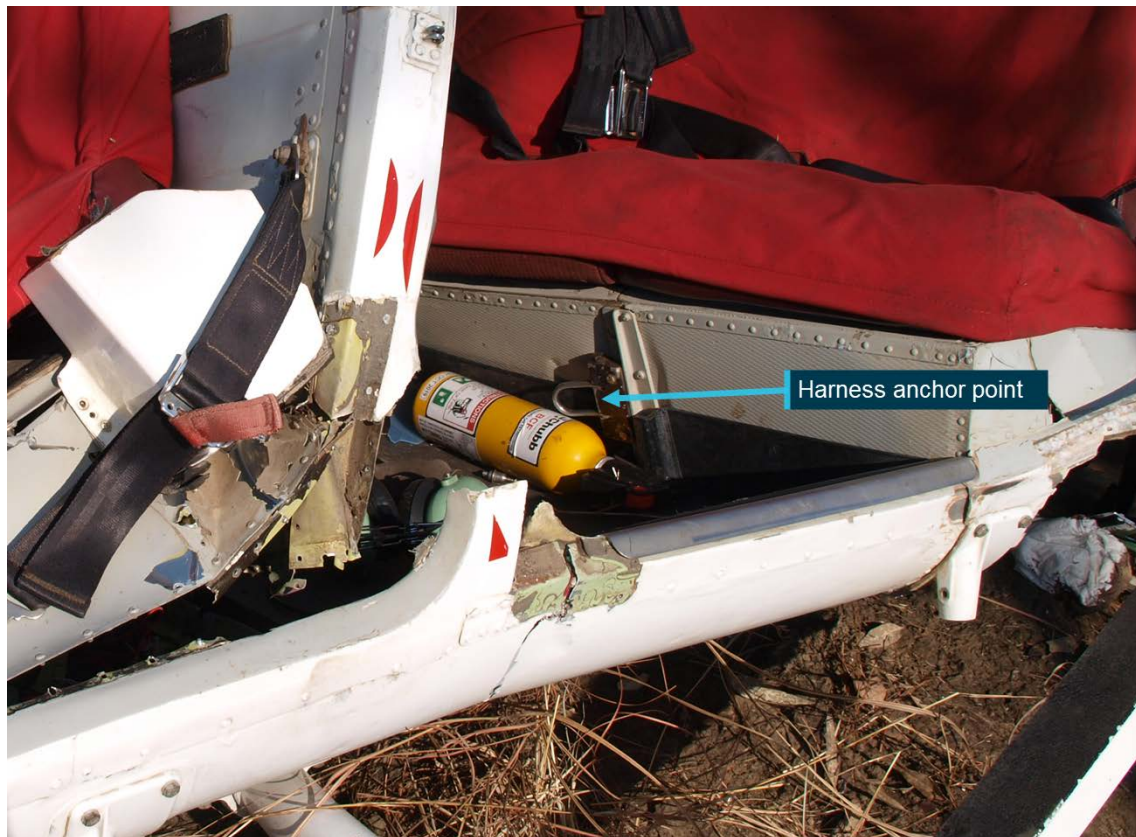
**Figure 8: Harness anchor point**

The harness's design complied with ATSO-C1003<sup>3</sup> and was a quick release type, that could be released under load using two distinct movements (Figure 7), and it was approved under Civil Aviation Safety Regulation (CASR) 21 (*Certification and airworthiness requirements for aircraft and parts*). It was attached to the aircraft with an adjustable strap. Figure 8 shows the location of the anchor point installation in VH-FHW, which was approved by an authorised engineer under CAR 35 (*Approval of design of modification or repair*). The anchor point design required it to be installed on the left side of the cabin for use at the rear right door.

Both the shooter's harness and the anchor point in VH-FHW carried a caveat. Figure 9 shows the harness manufacturer's statement:

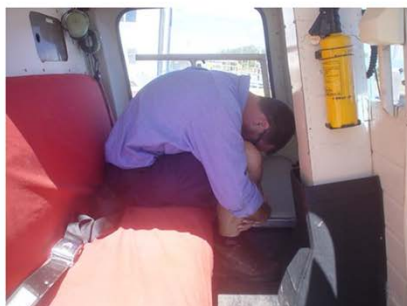
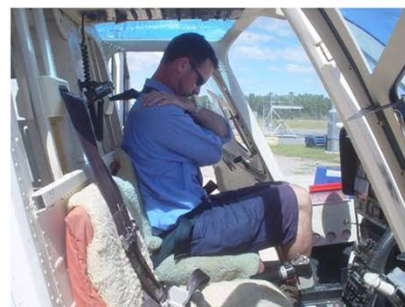
**Figure 9: Brace position information provided by operator**

Although the spotter was aware of the brace position, and the UTR held the spotter in their seat, they reported that they lifted their legs prior to impact. In contrast, the specified brace position required the occupant's feet to be flat on the floor, as depicted in Figure 9.

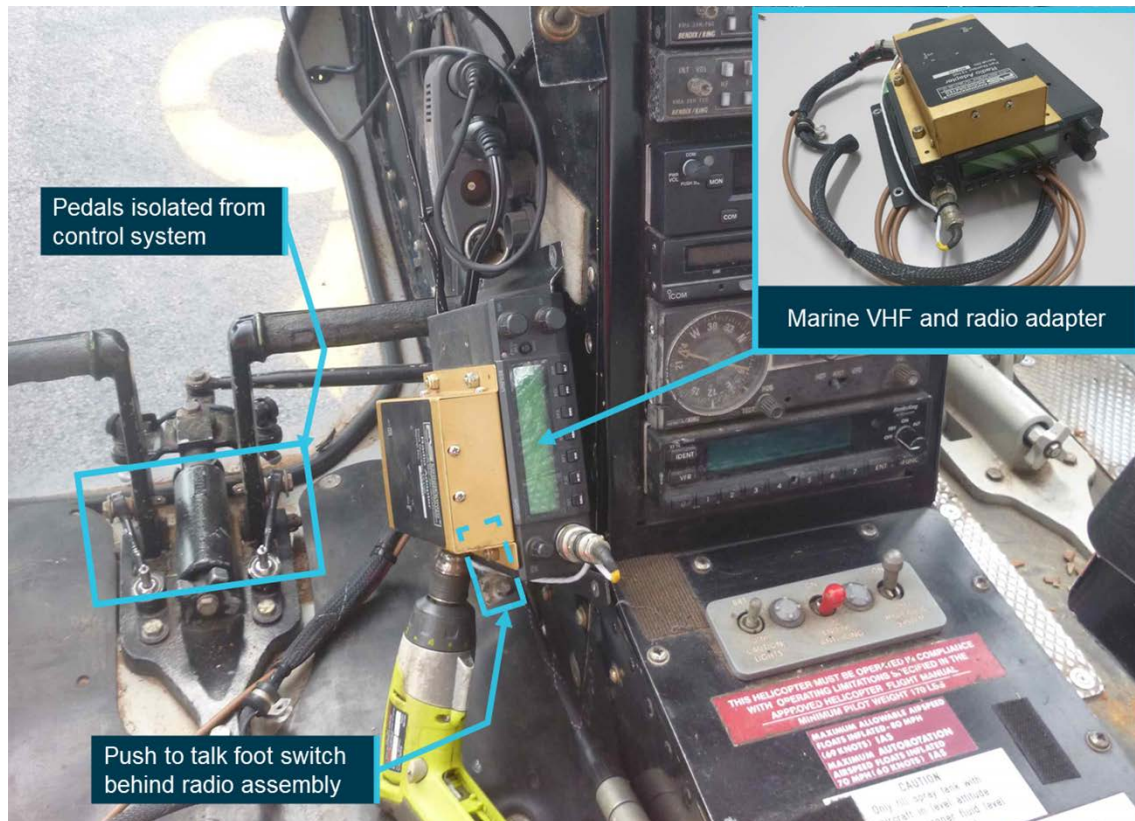
**Figure 11: Exemplar radio installation showing approximate position in footwell**

In 2015 an ancillary radio system was installed in the front passenger footwell of VH-FHW, in accordance with a CAR 35 engineering order. The installation protruded about 8 cm into the footwell (Figure 11). The radio system was a marine VHF/UHF radio, and it was not required for the aerial culling tasks. It had sharp small radii corners, and was not padded.

The pedals at the front left seat of VH-FHW were disconnected from the flight control system. That position can be equipped with flight controls for tasks that require two pilots. The protrusion of the radio installation in VH-FHW over the pedals would likely prevent a pilot from effectively operating the controls. The engineering order for the installation did not prohibit a second pilot from flying the aircraft from the left seat.
