Collision with terrain involving Airbus Helicopters AS350B3e, VH-SZS

60 km east of Woomera Airfield, South Australia, on 20 March 2019

ATSB Transport Safety Report

AO-2019-015

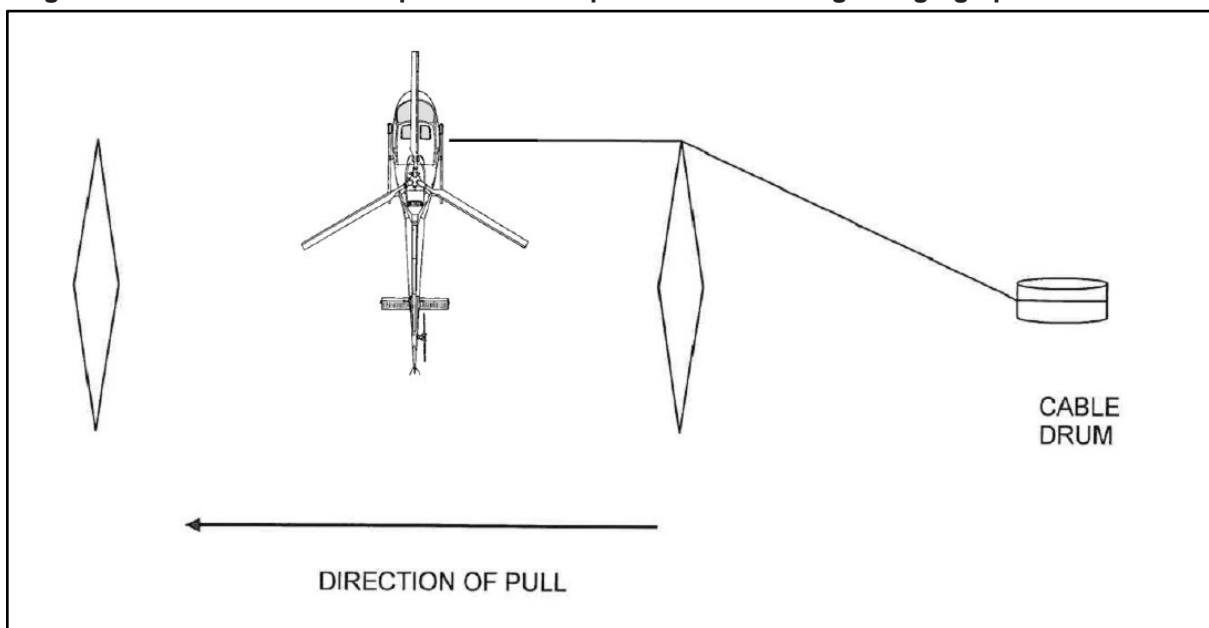
Figure 7: Orientation of helicopter relative to path of travel during stringing operations.

- A straight-line flight path is maintained between each pole.
- The helicopter hovers and traverses at an angle of about 90° (sideways) to the path of the wire. This ensures that visibility of both poles is maintained. The strung pole should be visible through the right cockpit door/window and the target pole should be visible through either the left cockpit door/window or the open rear left door (Figure 7).
