Loss of control and collision with water involving Bell UH-1H helicopter, VH-UVC

5 km south-west of Anna Bay, New South Wales, on 6 September 2019

ATSB Transport Safety Report

AO-2019-050

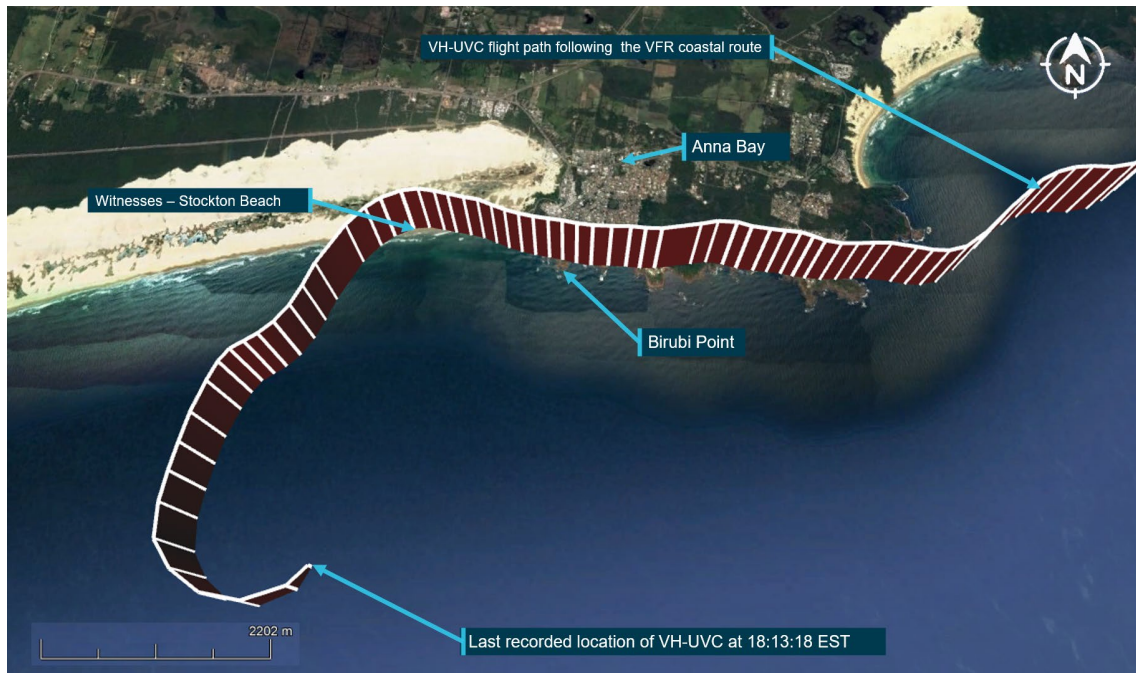
Figure 2: Flight path of VH-UVC following the VFR coastal route passing Anna Bay and the turn offshore

UVC was then observed on Williamstown ATC radar to make a left turn to the south, depart the VFR coastal route and head offshore. Automatic Dependent Surveillance - Broadcast (ADS-B)⁵ data supplied by Aireon, indicated that the helicopter's position at the beginning of the turn, at 1811:23, was 2.3 km west-south-west of Anna Bay⁶ (Figure 2).

The helicopter continued to track offshore to the south-west for about 90 seconds, maintaining an altitude of between 2,568 and 3,168 ft, before commencing a rapidly descending left turn. ADS-B data showed that the aircraft commenced this descent from 2,968 ft at 1812:55 which was about 12 minutes after published last light. At 1813:12, a short, loud but indistinct transmission, that may have originated from UVC was recorded by Williamstown ATC. The last Aireon ADS-B data point identified the aircraft passing an altitude of 93 ft at 1813:18. UVC disappeared from the Williamstown ATC radar display at 1813:26.

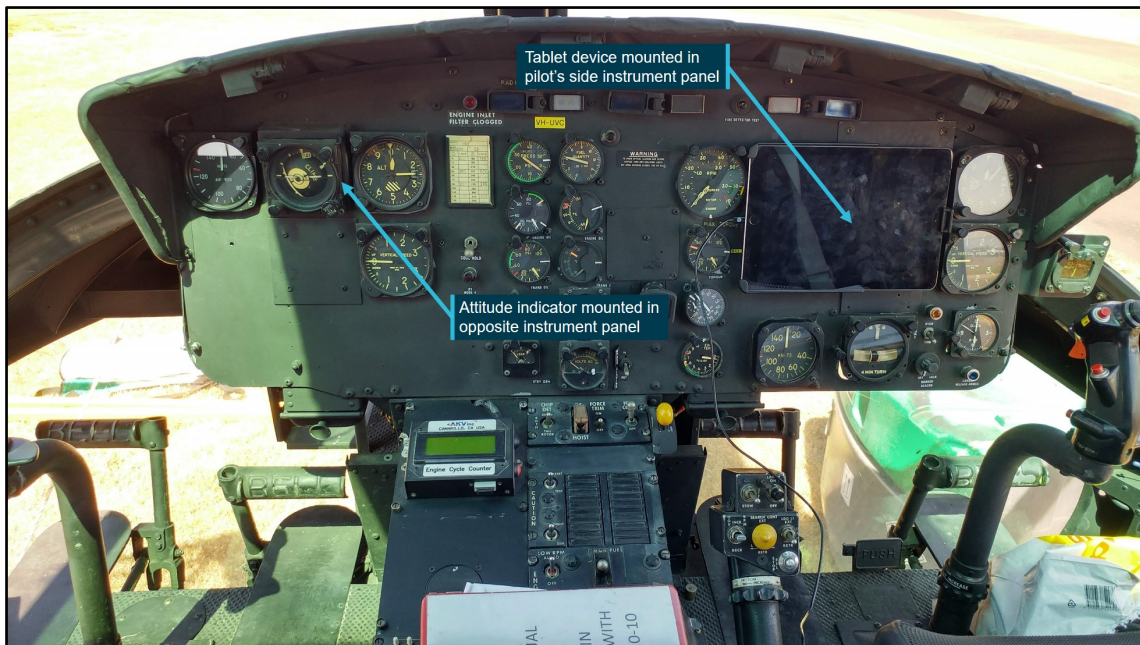
Figure 4: VH-UVC instrument panel

UVC was a standard UH-1H helicopter with no recorded airframe modifications, however a tablet device (Figure 4) was mounted on the pilot's side instrument panel. From reference to an image of UVC's cockpit and the UH-1H Operator's Manual it was determined that the pilot's side, attitude indicator and directional gyro may have been removed to accommodate the device or were obscured once the device was installed. A second attitude indicator was mounted in the left side instrument panel.

To accommodate the tablet installation, the pilot's airspeed and turn and slip indicators were relocated to new positions below the tablet device. While the UH-1H Operator's Manual did not specify the instruments that were required for VFR flight, relocation of instruments was permitted.

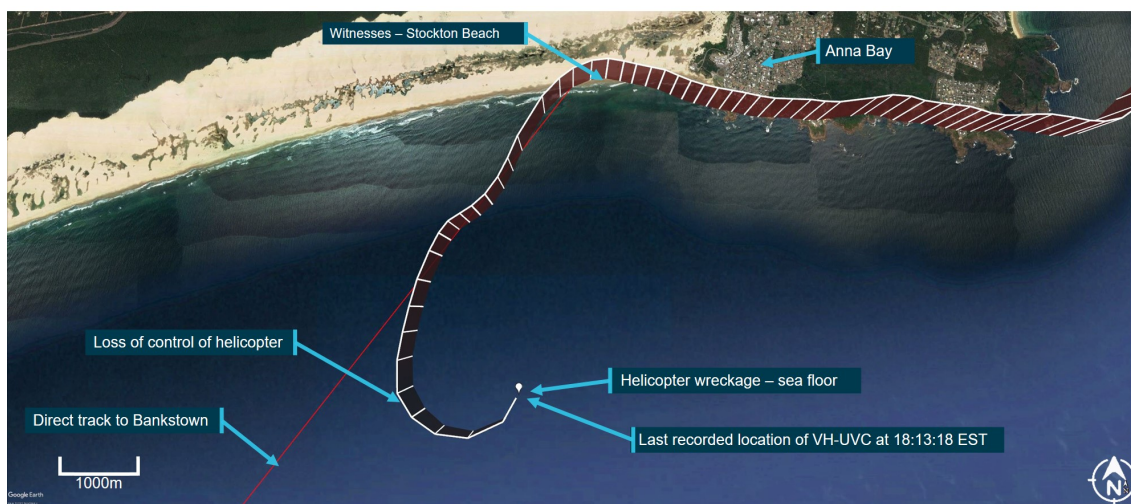
Figure 11: Overhead view of UVC flight path showing turn to seaward and spiral descent

From Broughton Island UVC tracked past Yacaaba Head, Fingal Bay then Morna Point (Figure 10). Once past Anna Bay, the pilot commenced a left turn away from the coast, aligning with a direct track to Bankstown (Figure 11 and 12). The turn and subsequent track were inside the Williamstown military control zone area boundary. The helicopter tracked offshore to the south-west for about 90 seconds before commencing a rapidly-descending, left turn followed by a collision with the ocean surface.

Once past Anna Bay, UVC's flight path from the turn to seaward to the spiral descending turn was further examined. The flight path is presented in a graphical format in (Figure 15) with key aspects noted below:

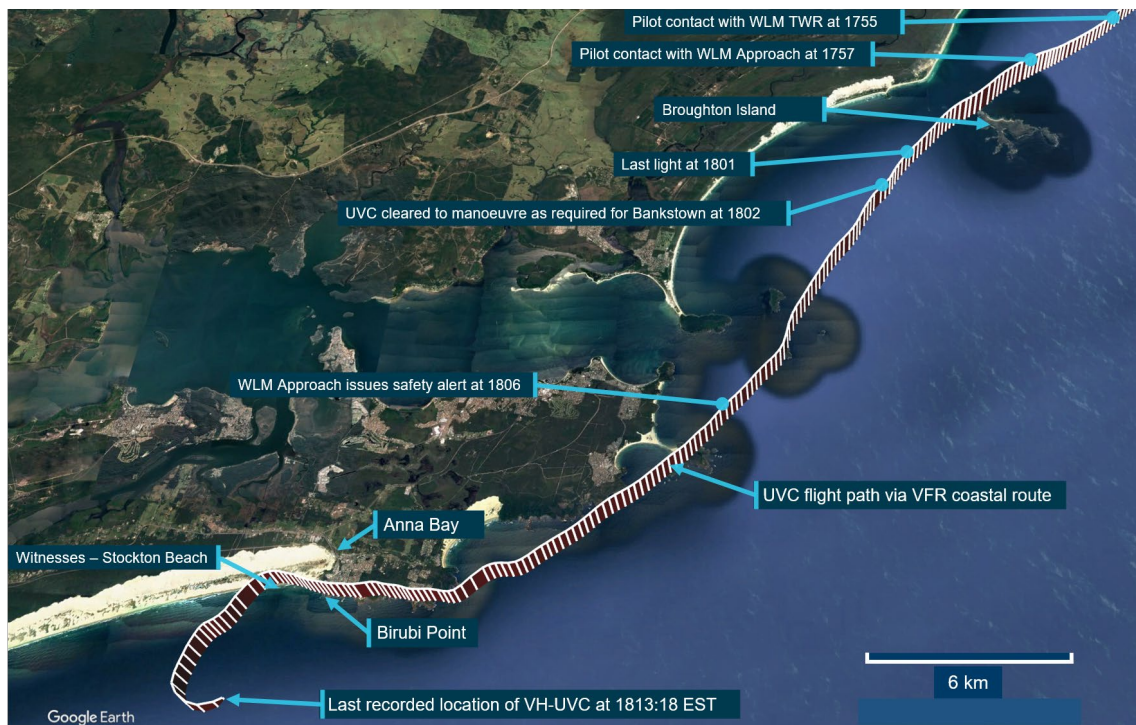
Figure 14: UVC flight path from Broughton Island

The variation in UVC's flight parameters over the final 30 minute period is presented in a graphical format (Figure 13) with key events presented in an overhead view (Figure 14). The rate of change of altitude and track, before and after last light, where the pilot appeared to be attempting to maintaining a constant altitude, were averaged and compared. For the period after last light and prior to the turn away from the coast:
