Loss of control and collision with water involving Eurocopter EC120B, VH-WII

Hardy Reef, 72 km north-north-east of Hamilton Island Airport, Queensland on 21 March 2018

ATSB Transport Safety Report Aviation Occurrence Investigation (Systemic) AO-2018-026 Final – 16 June 2021 Cover photo: CQ Plane Spotting

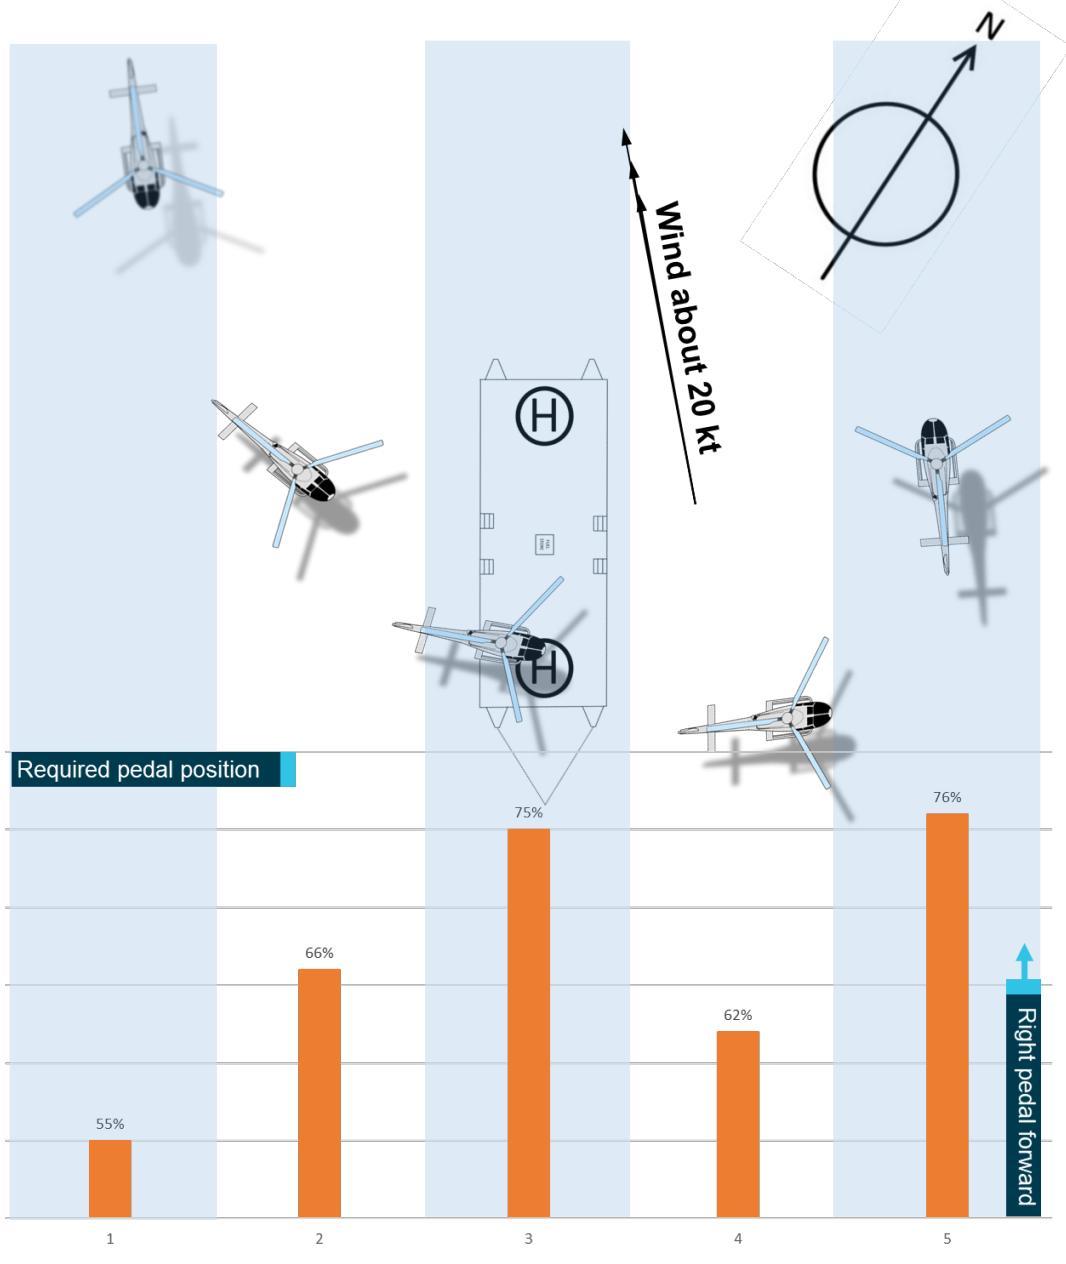
Figure 15: Indicative pedal position required during the approach and go-around (probable flight path)

Using data provided by Airbus Helicopters,²³ and the probable position of the helicopter determined during photographic analysis (Appendix A), the ATSB estimated the right pedal position required to manage the heading of the helicopter during various points of an approach and go-around at Hardy Reef (Figure 15).

- (3) Slowing to a hover over the pad at a heading of about 062° and still yawing left, the pedal position required to arrest the left yaw would increase to more than 75 per cent, with 75 per cent then required to maintain a heading of about 062°. This position corresponds to the boundary of instability with respect to yaw (see Figure 13). If the pedal input was less than 75 per cent, the helicopter would continue to yaw to the left, into the instability zone. From that point, the requirement for right pedal could outpace a pilot's input, increasing the right pedal requirement further as the helicopter continued to yaw. (Note that, from about this position, the pilot of VH-WII initiated the go-around, during which the helicopter was at maximum take-off power.)

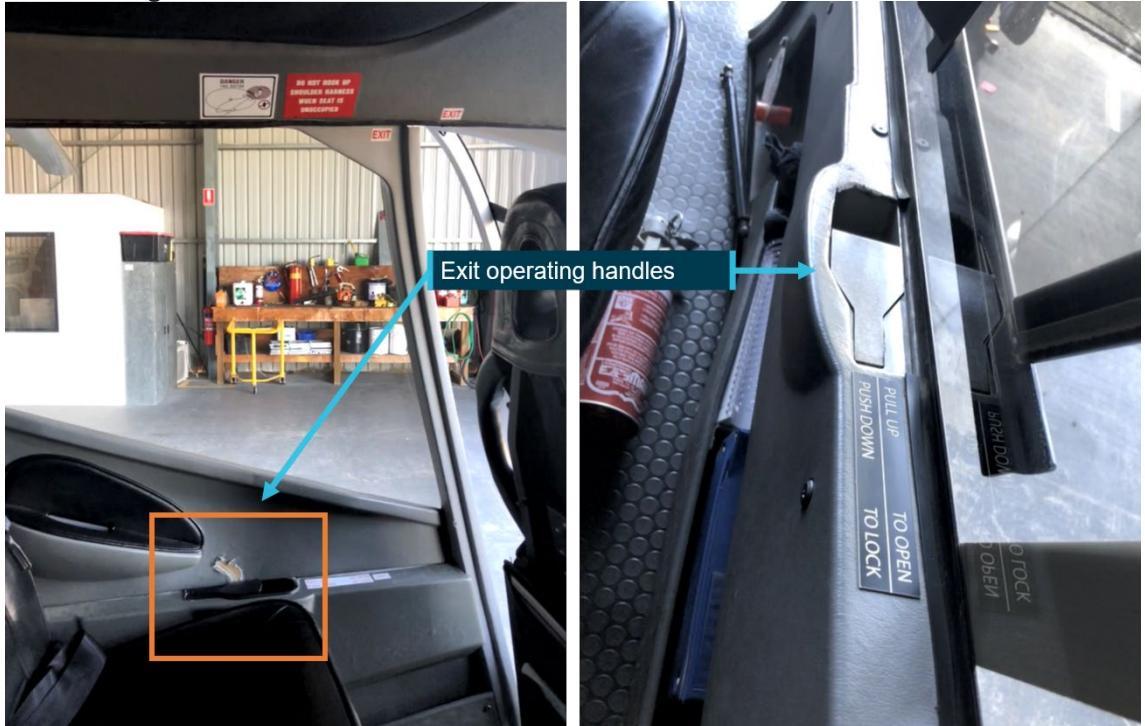
Figure 23: EC120B interior showing the operating handles of the rear left sliding door and front right door

VH-WII's doors had a dark grey trim with black operating handles that were recessed into a black surrounding casing, similar to that shown in Figure 23.

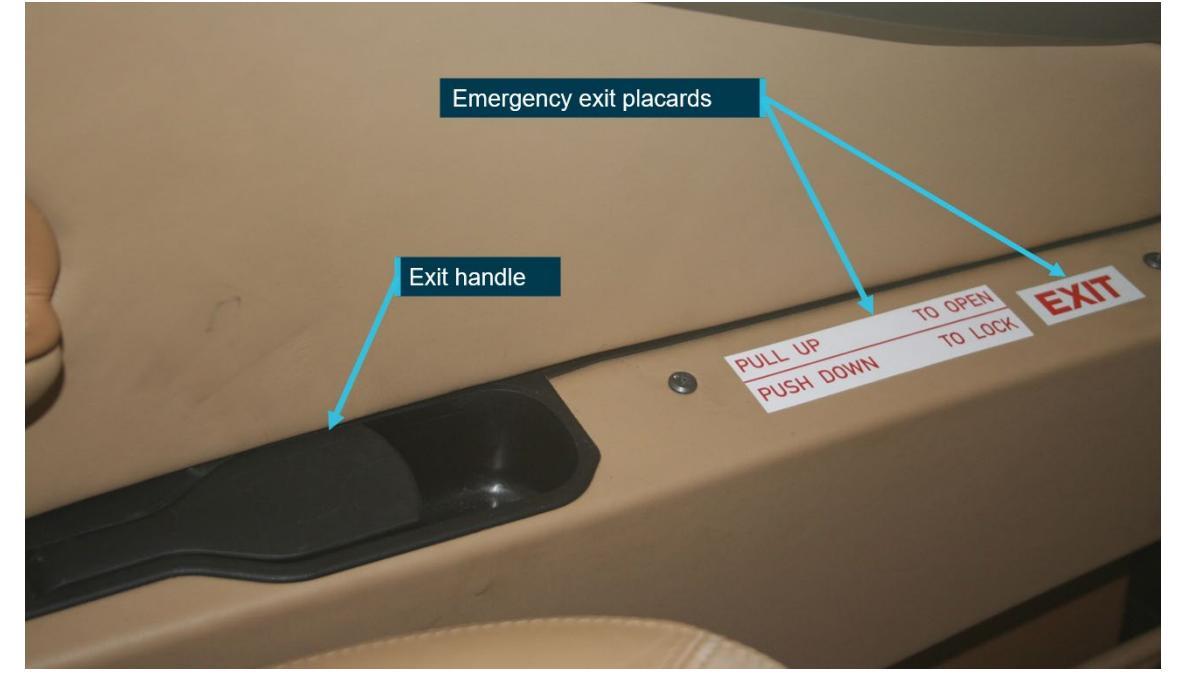
Figure 25: Manufacturer's exit markings for the EC120B rear left sliding door

The helicopter manufacturer advised the ATSB that, as the rear left sliding was an emergency exit, this placard was required to be red text on a white background, like those in Figure 25. The manufacturer also advised that, because the use of the normal operating handles of the front two doors was not the means of emergency operation, the placards for the operating handles on those doors could be any colour.

The above photographs are of another Australian registered EC120B, with emergency exit placards in the required colour scheme. Source: ATSB

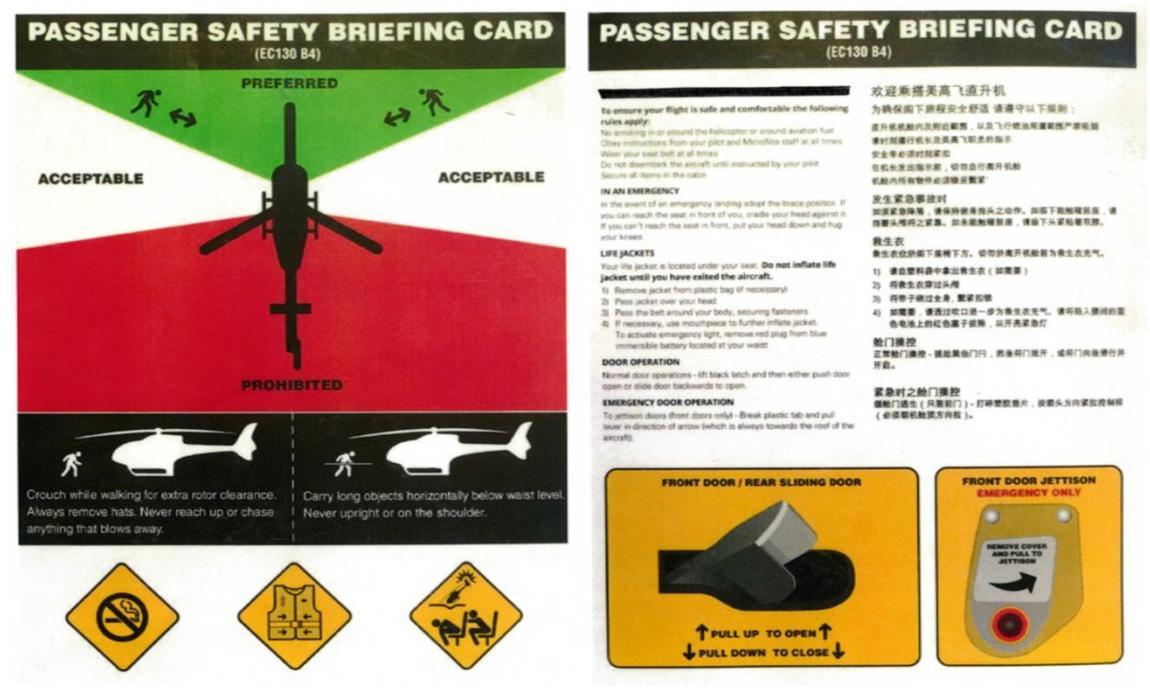
Figure 30: Front page of the safety briefing card used by the operator for the EC120B helicopter

The operator provided the ATSB with a copy of a safety briefing card that was in use at the time of the accident (Figure 30). The card depicted was used for the EC120B, however the content on the card referred to the EC130 type helicopter, which has seven seats in its basic configuration, but the same type of life jacket, similar exit location, and similar exit operation as the EC120B.

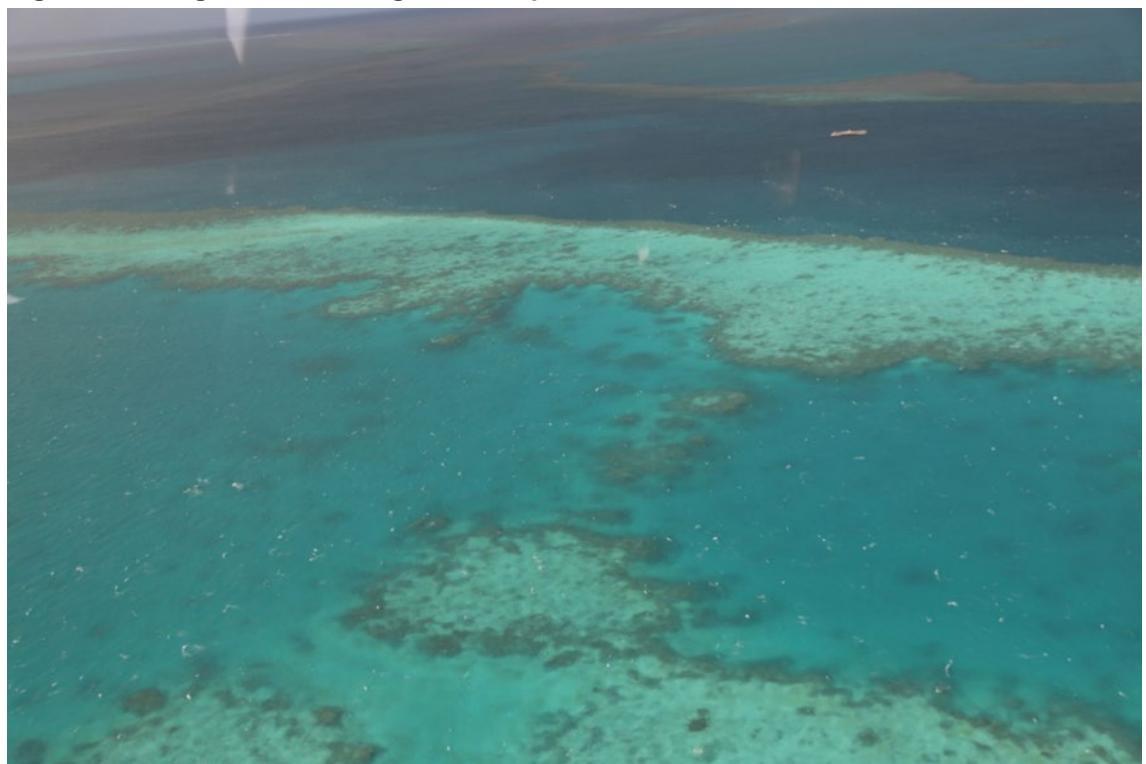
Figure A1: Image 0617 showing northern pontoon

To estimate the position of the pontoon at the time of the accident, the ATSB used image 0617, which showed the pontoon in the channel and some of the reef on each side. The pontoon's relative position between pairs of reef features was established using straight lines (Figure A7), and its absolute position was determined by aligning the same features in overhead photographs using Google Earth. This analysis focused on the southern (upwind) end of the pontoon, which was the end being used by the pilot for the intended landing.

The northern pontoon's orientation was estimated using a variety of methods. The best source of information was image 0617. The long edges of the pontoon were well defined, but their orientation could not be directly referenced with straight lines to identifiable reef features. The short edges of the pontoon were not as well defined but could be directly oriented to reef features. By comparing the pontoon's edges with the angles of lines between identifiable reef features it was estimated that the short edges were aligned at about 55° (to the nearest 5°).

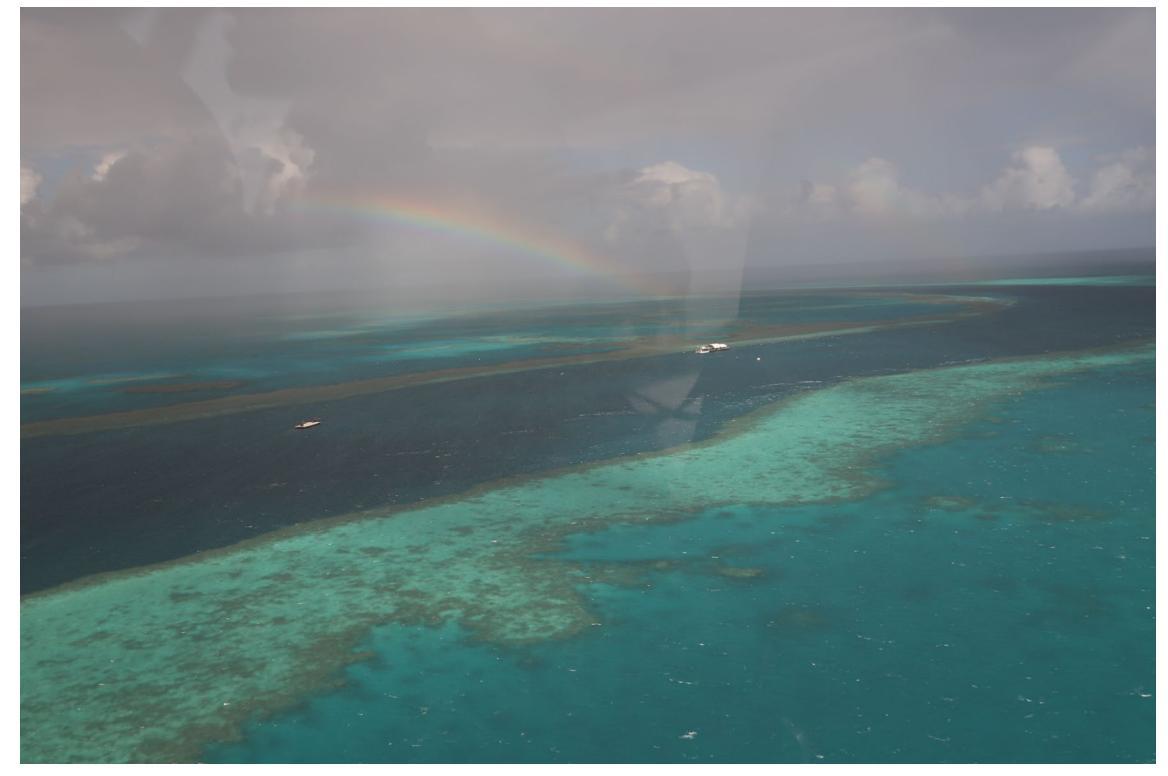
Figure A2: Image 0618 showing southern pontoon and Reefworld

A similar approach to analysing the southern pontoon in image 0618 indicated that pontoon's short edge was oriented at about 60° (to the nearest 5°), and an analysis of the northern pontoon in image 0620 using perspective lines indicated an orientation of about 60° (to the nearest 5°). It is likely that both pontoons were orientated fairly similarly.

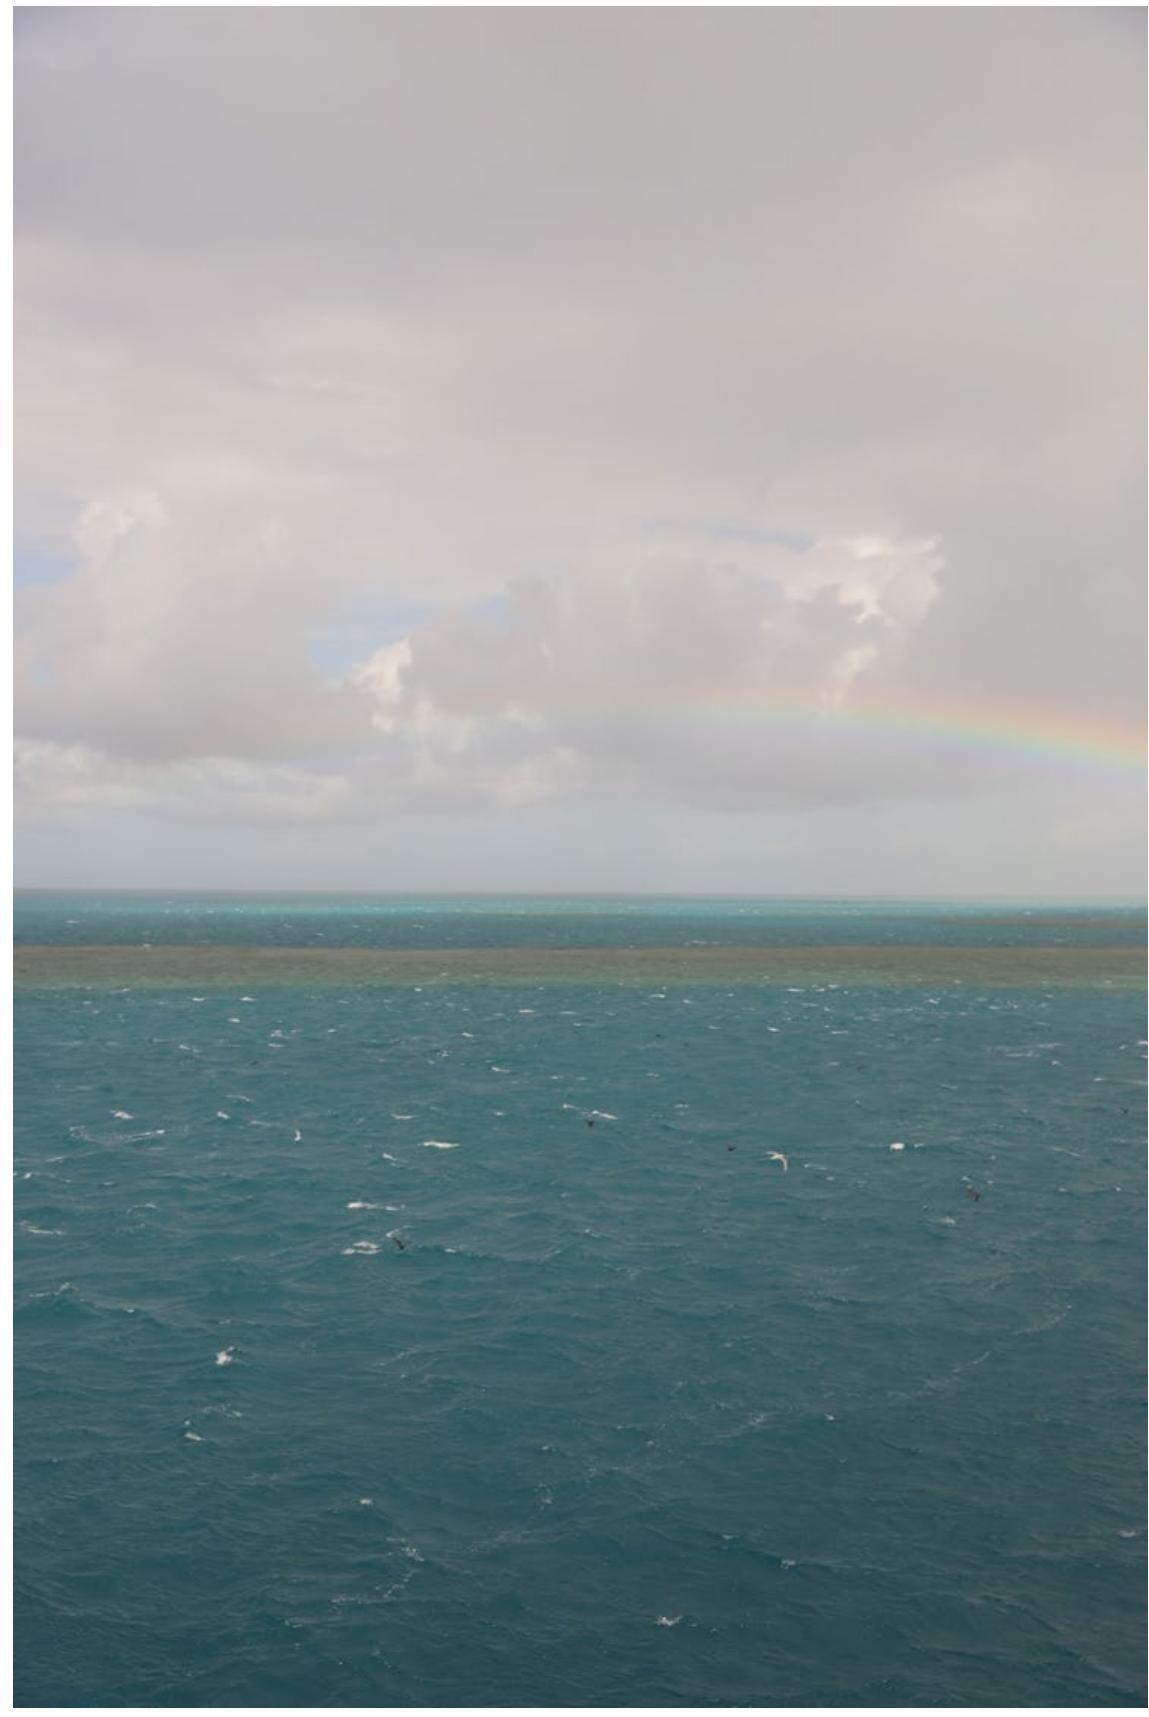
Figure A5: Image 0621 showing similar reef features and sky as image 0620

As noted above, the passenger moved the camera to minimise the amount of reflection when taking images of the rainbow. Image 0620 shows a significant amount of reflection whereas image 0621 shows no reflection. The image also did not show a pillar between windows.

Tests conducted involving another helicopter found that image 0621 had to be taken through the window that was right of the pillar shown in image 0620. EXIF data showed it was also taken with a longer focal length (44 mm compared to 25 mm), and therefore had a narrower field of view.

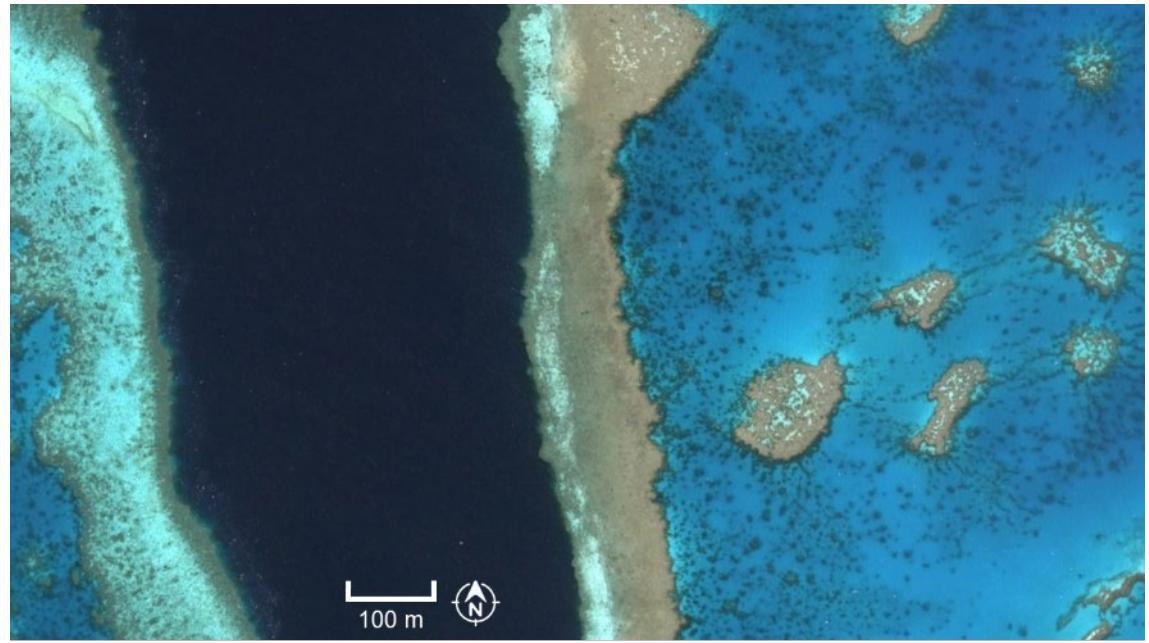
Figure A6: Overhead image from Google Earth showing reef features used in image analysis

Overhead images from Google Earth were used to match, locate and measure reef features (Figure A6). In some cases, the camera's sensor dimensions, image size in pixels, and the recorded lens focal length setting were used to calculate angles from the camera's optical axis (assumed to be the centre of the image) to visible features.

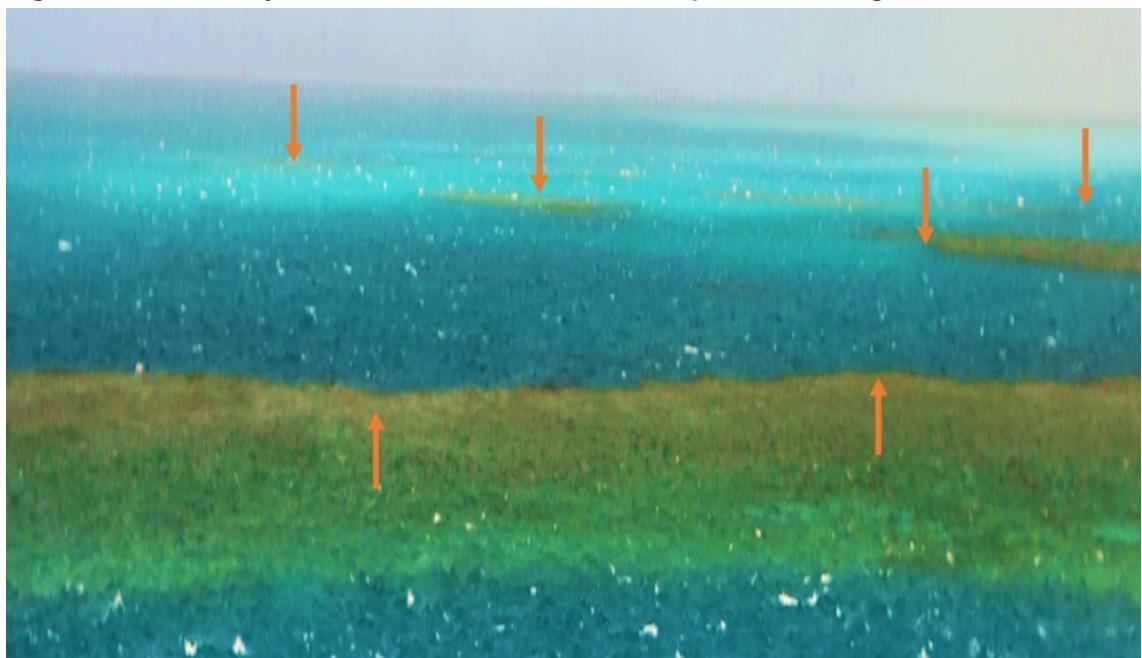
Figure A12: Vertically stretched and colour-enhanced portion of image 0621

Image 0621 was taken at a longer focal length and greater height than image 0620, so the reef features were clearer (Figure A12). This image was analysed using the same methodologies as for image 0620, as well as the following additional analyses:

Arrows show location of some of the reef features that were used throughout the analysis. Source: Passenger photograph and ATSB.

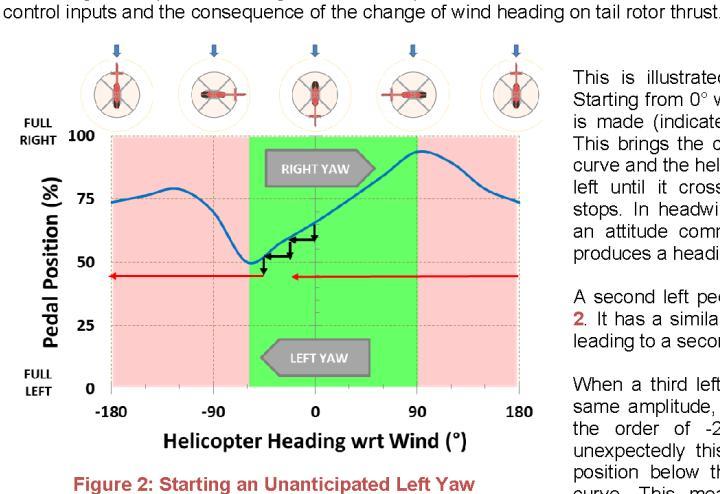
This is illustrated in the graph in Figure 2. Starting from 0° wind heading, a left pedal step is made (indicated by a vertical black arrow). This brings the control position below the trim curve and the helicopter therefore rotates to the left until it crosses the trim curve, where it stops. In headwind conditions, pedal provides an attitude command : a control step mainly produces a heading step.

A second left pedal step is included in **Figure 2**. It has a similar effect to the first pedal step, leading to a second heading step.

The gap between the current pedal position (red arrow) and the blue trim curve gives an indication of the encountered yaw rate. In the **Figure 2** example, after passing the minimum of the blue curve (about -60° heading), that gap increases drastically. It is not due to a pedal input, but to a trim position that is moving away. The pilot has no indication of this changing trim position and the resulting yaw acceleration is therefore wrongly perceived as being uncommanded, attributable to some external factor.
