Collision with water involving Textron Aviation (Cessna) 206, VH-AEE

near Happy Valley, Fraser Island, Queensland on 29 January 2020

ATSB Transport Safety Report

AO-2020-010

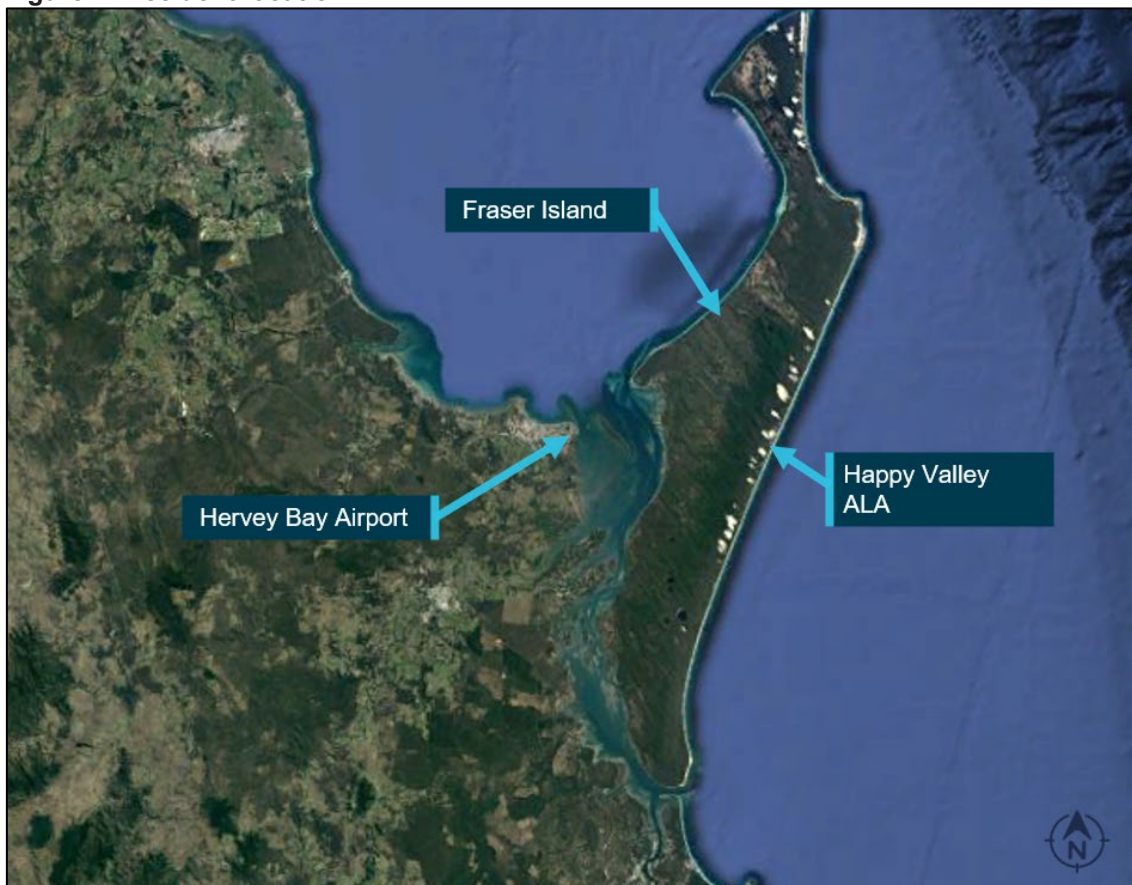
Figure 1: Accident location

At 1322 Eastern Standard Time,¹ on 29 January 2020, a Cessna Aircraft Company² (Cessna) U206G aircraft, registered VH-AEE (AEE) and operated by Air Fraser Island, was being used for emergency procedure training at a beach aircraft landing area (ALA), south of Happy Valley, Fraser Island, Queensland (Figure 1). There were two pilots onboard, including a trainee pilot (trainee), who had just commenced flying with the company. The trainee was seated on the left and was flying the aircraft.

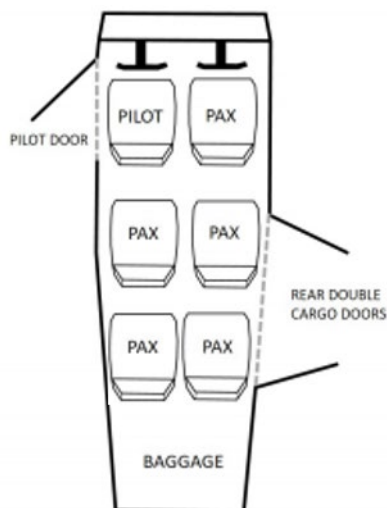
Figure 5: Cessna U206 showing location of pilot door and double clamshell cargo/cabin door

The ATSB also recommends that the United States Federal Aviation Administration and the Civil Aviation Safety Authority take safety action to address the certification basis for the design of the cargo door in the Cessna 206, as wing flap extension beyond 10° will block the forward portion of the rear double door, significantly hampering emergency egress.

The U206⁷ has a door adjacent to the left pilot's seat and a double clamshell cargo/cabin door in the passenger compartment on the right, adjacent to the second and third seat rows (Figure 5).

The ATSB has recommended that Textron Aviation take safety action to address the procedure for ditching and forced landing in the pilot operating handbook for the Cessna 206, to ensure pilots are aware that extending the flaps beyond 10° will significantly restrict emergency egress via the cargo door.
