# Unreliable airspeed indication involving Pilatus PC-12/47E, VH-OWI

on descent to Albany Airport, Western Australia on 22 June 2020

ATSB Transport Safety Report Aviation Occurrence Investigation (Short) AO-2020-030 Final – 21 July 2021 Released in accordance with section 25 of the Transport Safety Investigation Act 2003

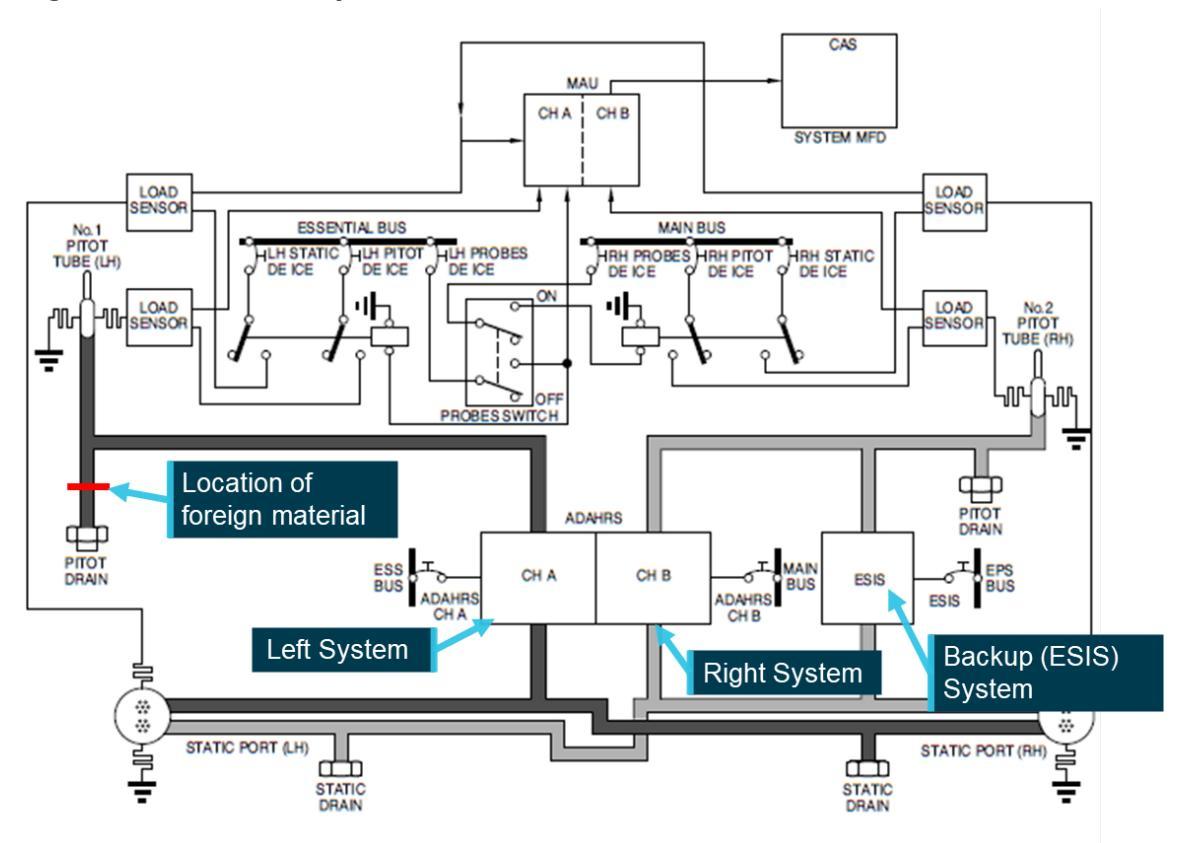
Figure 5: ADAHRS unit system schematic

OWI was fitted with a Honeywell KSG7200 air data attitude heading reference system (ADAHRS). The ADAHRS unit reads data from a range of sensors and inputs throughout the aircraft including aircraft attitude, GPS, magnetometer, air pressure and temperature.

The processed data is then displayed on the relevant PFD. The system consists of two separate units, channel A taking inputs from the sensors on the left of the aircraft for display on the left PFD and channel B, which receives inputs from sensors on the right of the aircraft for display PFD (Figure 5).
