# Engine failure and collision with water involving Garlick Helicopters UH-1H, VH-ONZ

Ben Boyd Reservoir, New South Wales, on 9 January 2020

## **ATSB Transport Safety Report**

AO-2020-003

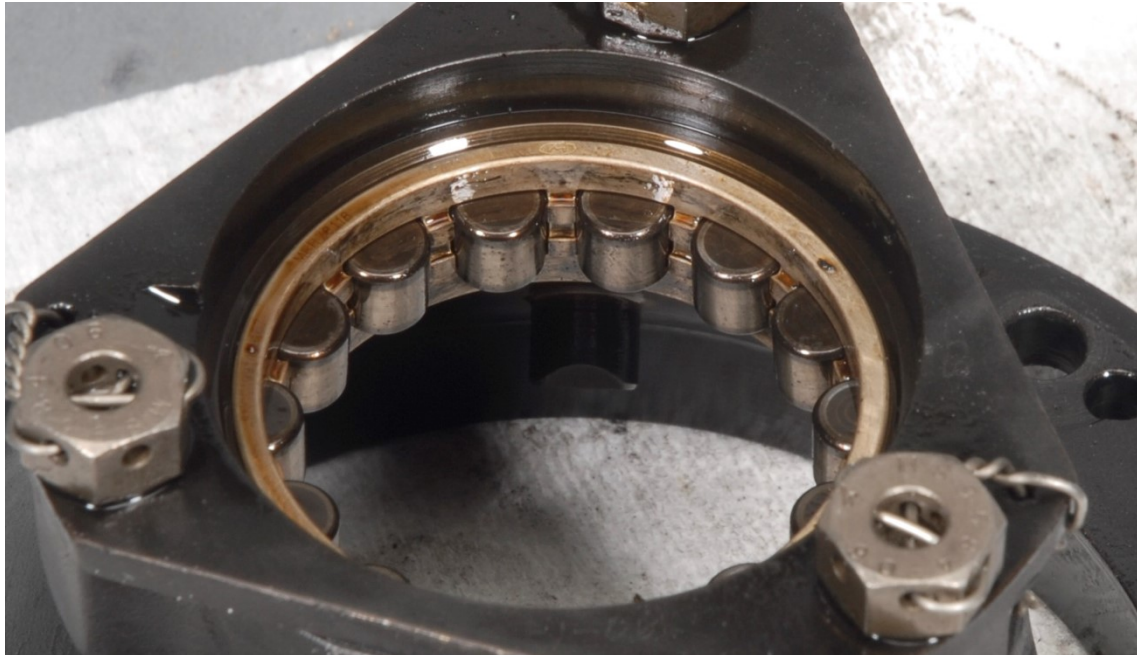
**Figure 8: Comparison no. 21 bearing**

the shaft at the location of the no. 21 bearing. Figure 8 depicts a comparison no. 21 bearing fitted to its power shaft bearing retainer.
