# Engine failure and collision with terrain involving Cessna P210N, N210BA

Near Moruya Airport, New South Wales, on 19 December 2019

ATSB Transport Safety Report Aviation Occurrence Investigation (Defined) AO-2019-075 Final – 2 November 2021 Cover photo: Aidan Pullino

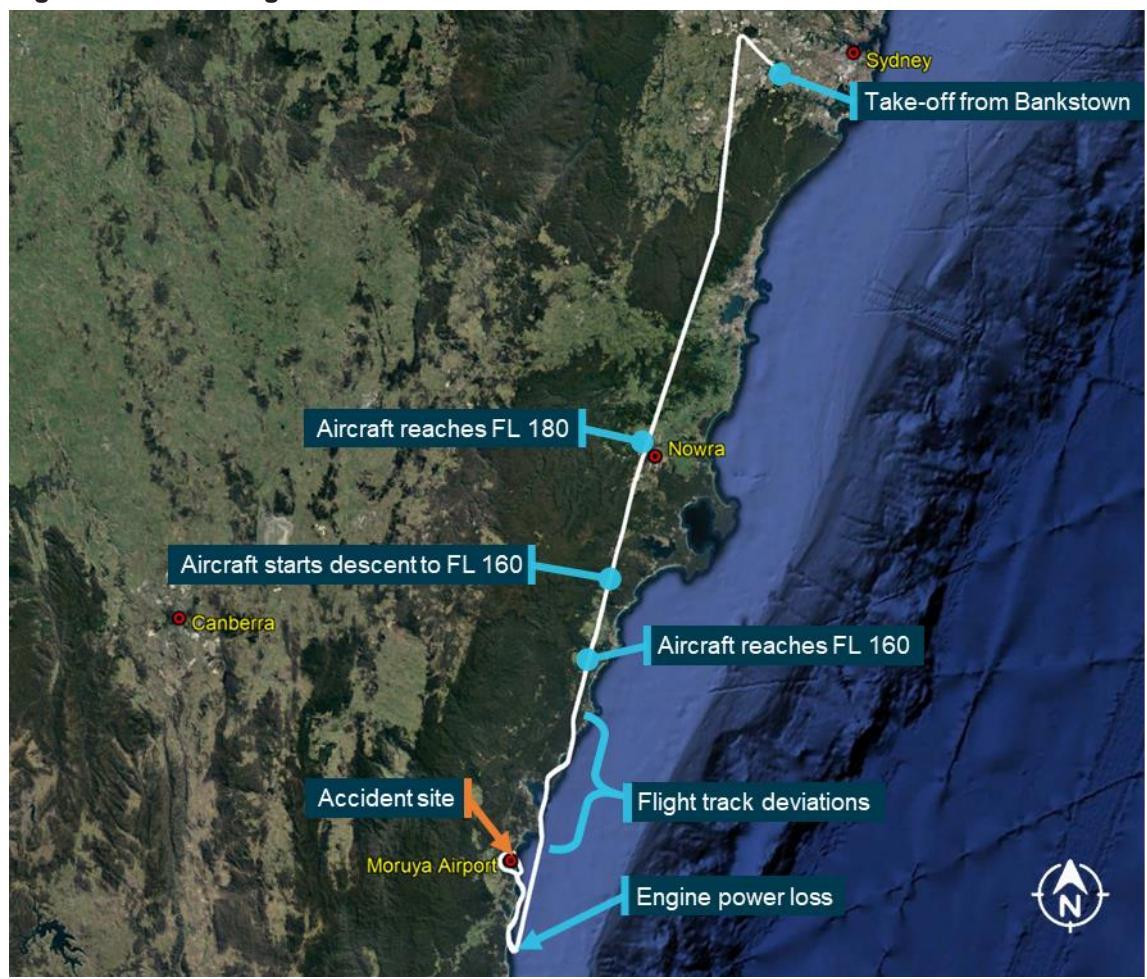
Figure 2: N210BA flight track

At about 1246, approximately 22 km south-south-east of Moruya Airport, the aircraft's engine lost all power (Figure 2). The pilot recalled not hearing any grinding, popping, or banging noises from the engine at the time, and that it sounded similar to the engine being shut down normally. About 5 seconds later, the pilot made a right turn towards the coastline and unsuccessfully attempted to restart the engine (see the section titled *Unsuccessful engine restarts*). Thirty seconds after the engine failure, the pilot called ATC, declared MAYDAY,<sup>7</sup> and was provided a heading to Moruya Airport. The pilot then tried restarting the engine again, without success.

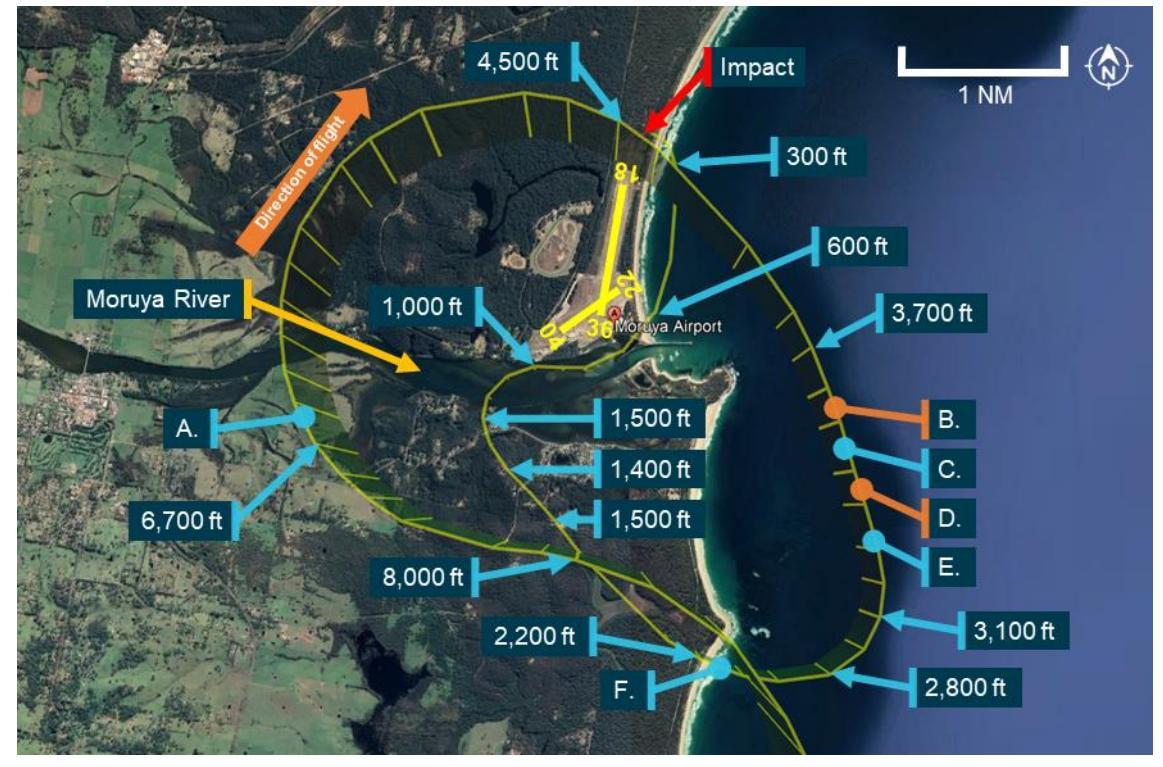
Figure 3: N210BA flight track in the vicinity of Moruya Airport (see Note)

At about 1255, the P210N pilot broadcast being on a '...no engine, right base approach to runway one eight' (Figure 3 and Table 1). Shortly after, the aircraft briefly climbed from 1,400 ft to 1,500 ft while approaching the Moruya River, before turning east and descending to about 1,000 ft (Figure 3). The pilot recalled experiencing windshear and an increased rate of descent at this point, resulting in an assessment that there was insufficient remaining height to conduct a glide approach to runway 18. Consequently, the pilot decided to land on either runway 36 or runway 22.

Note: Labels 'A' to 'F' are the approximate locations of CTAF radio calls between the pilots of N210BA and the R44. A transcript of these radio calls is included in Table 1. All altitudes are in AMSL. Source: Google Earth, annotated by ATSB

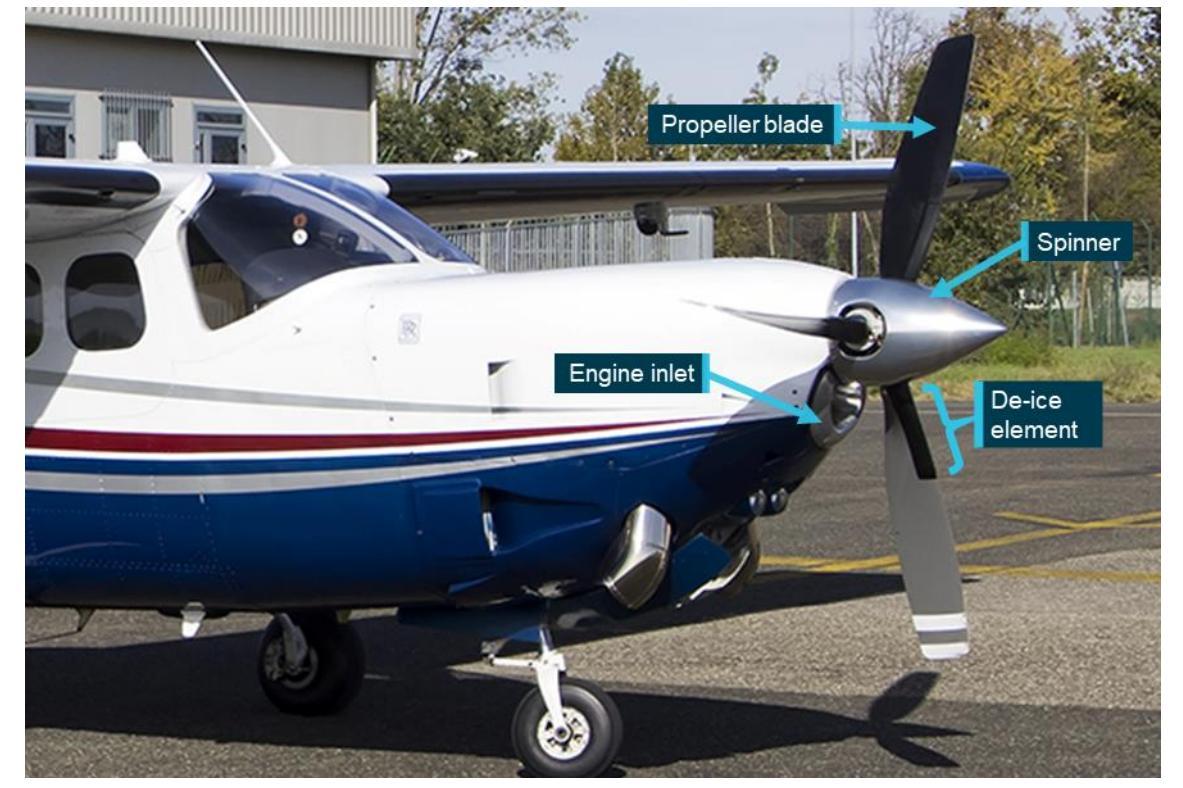
#### Figure 4: Side view of an exemplar P210N propeller and engine inlet

The aircraft's flight manual prohibited flight into known icing conditions (see the section titled *lcing conditions*). The aircraft was not fitted with any airframe anti-ice or de-ice protection systems. However, the aircraft was fitted with ice-protection systems in case of an unexpected icing encounter. These consisted of heating for the pitot probe and the windshield, while the propeller blades had electrically heated elements that provided de-ice protection by cycling every 20 seconds. In addition, the engine had the following ice-protection systems (Figure 4 and Figure 5):

- Engine inlet<sup>21</sup> mounted to the compressor front support (compressor inlet) with compressor bleed air providing anti-ice protection. A cockpit gauge provided the heated air temperature.
- Compressor inlet the compressor inlet consists of an outer skin, hollow radial struts, and a hub (bullet nose). Compressor bleed air provides anti-ice protection.
- Continuous engine ignition the igniter sparks continuously to relight the fuel-air mixture in the event combustion is extinguished due to a momentary change in the fuel-air ratio.
