In-flight break-up, Stolp Acroduster II SA-750, VH-YEL

16 km north-east of Caboolture Airfield, Queensland, 18 August 2021

ATSB Transport Safety Report

AO-2021-032

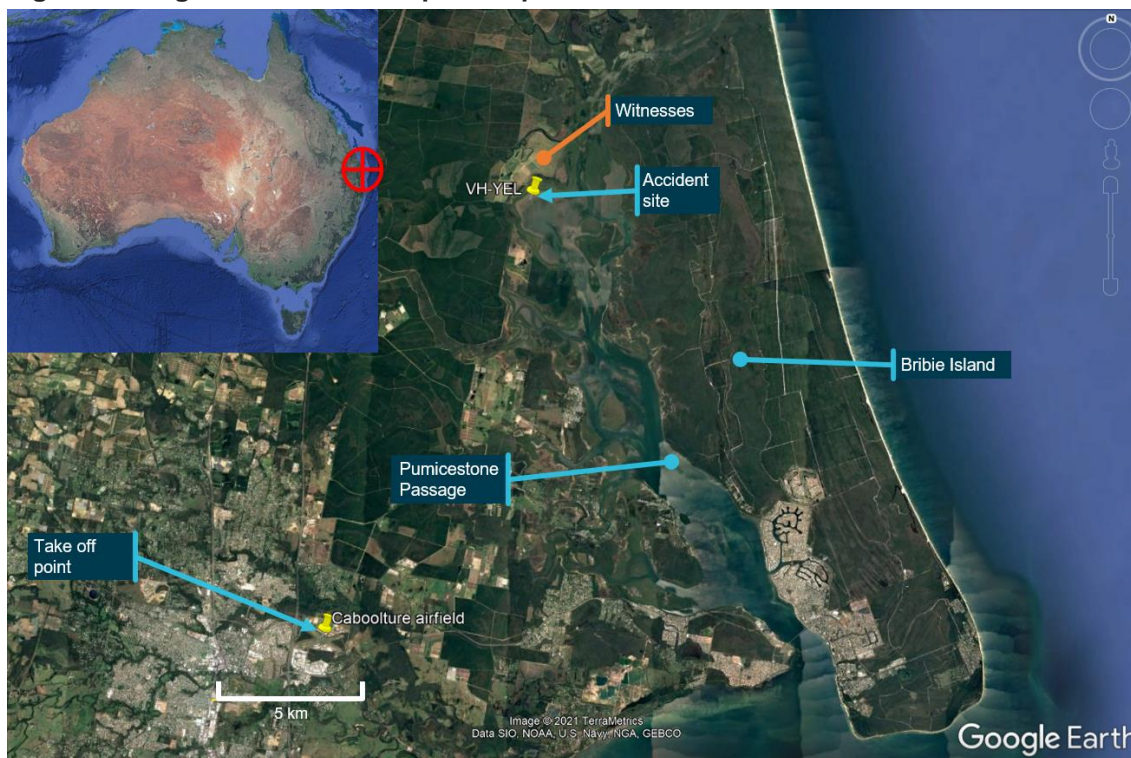
Figure 1: Image of the aircraft departure point and accident location

The wreckage was in tidal wetlands, about 30 m from the mainland shoreline of Pumicestone Passage, adjacent to Bribie Island (Figure 1). The aircraft was destroyed and the pilot was fatally injured.

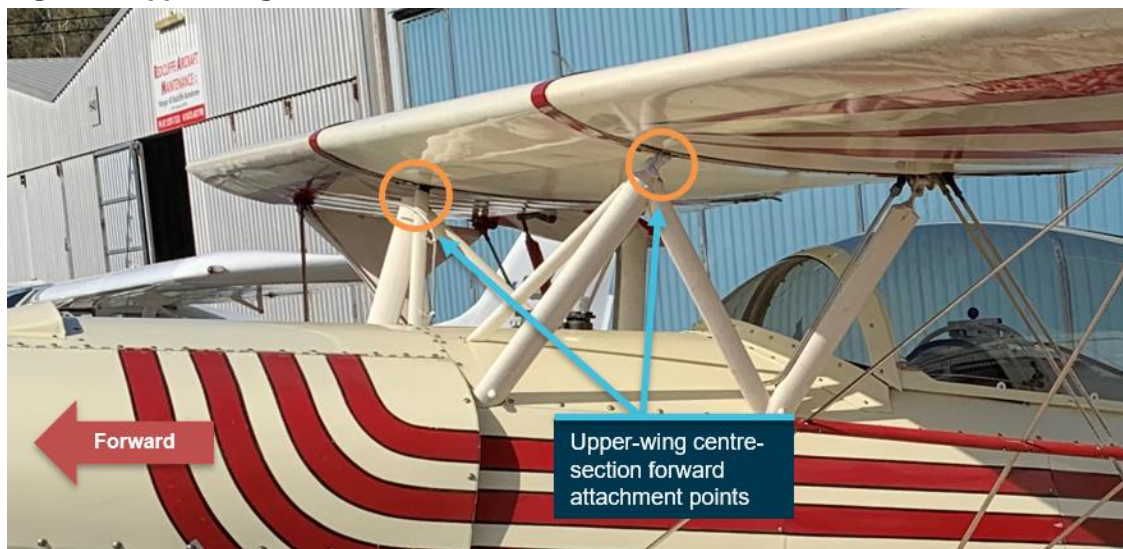
Figure 4: Upper-wing centre-section attachment

Cabane struts and roll braces were provided to support and attach the centre-section of the upper wing to the fuselage. Eye bolts had been manufactured to thread into the upper portion of each cabane strut and completed the attachment between the upper-wing centre section and the cabane struts. The eye bolts were adjustable in length through their threaded section (Figure 4).
