# In-flight break-up involving Cessna T210M, VH-SUX

25 km north-east of Mount Isa Airport, Queensland on 26 May 2019

## **ATSB Transport Safety Report**

AO-2019-026

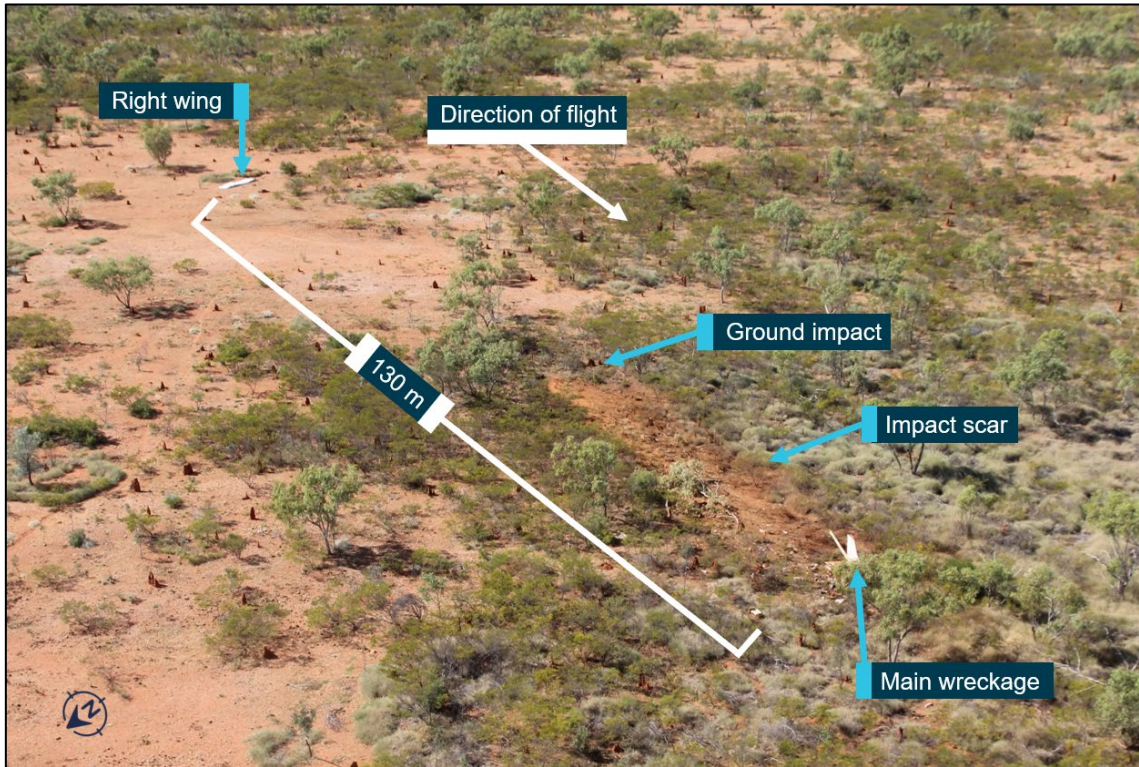
**Figure 10: Accident site overview looking south-east**

The accident site was located about 25 km north-east of Mount Isa Airport in flat, arid scrub land (Figure 10). The wreckage trail was on an approximate east to west heading, in line with the survey flight path. The right wing (Figure 11) was the first major component in the wreckage trail and was located about 130 m from the main wreckage. The aircraft impacted terrain about 90 m from the right wing, coming to rest a further 40 m away.

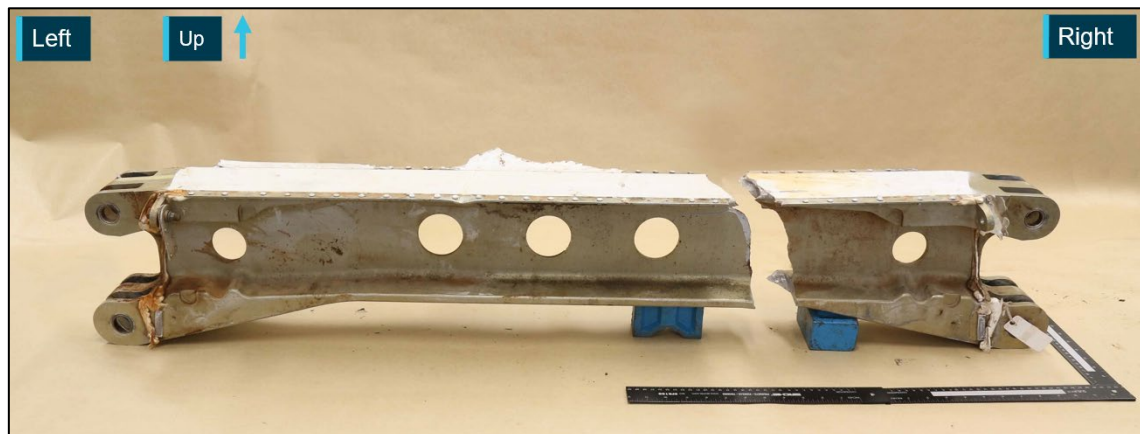
**Figure 15: The carry-through spar in the ATSB laboratory**

Almost the entirety of the spar was a light yellow/green colour, which was consistent with the application of the specified corrosion inhibiting chromate surface film. No evidence was found to indicate the chromate had been reapplied since manufacture. The foam section normally glued to the underside surface of the carry-through structure was absent. The uppermost portion of the spar had been painted white, consistent with the C210M design where that portion of the spar formed a segment adjoining the external roof skin panels of the aircraft (Figure 15).

The visual examination also identified that pitting corrosion damage had developed at multiple discrete locations along the underside surface of the spar (Figure 16). The corrosion damage was also identified adjacent to the fracture plane and confined to the underside surface with no evidence of corrosion on other parts of the structure.

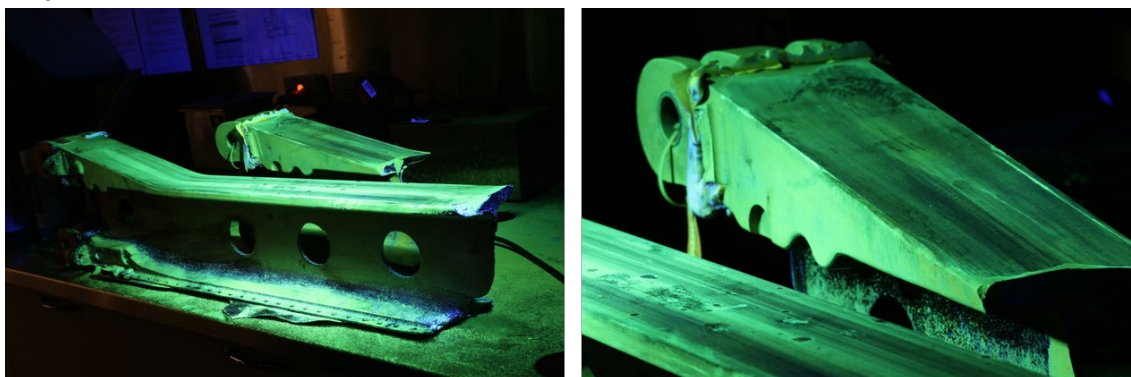
**Figure 22: Composite image of the carry-through spar during liquid fluorescent penetrant inspection**

Detailed visual inspection of the corrosion damage on the underside surfaces suggested there were no other secondary micro-cracks present in the structure. To confirm that visual assessment, a non-destructive examination of the spar structure was completed using fluorescent penetrant techniques (Figure 23 **Error! Reference source not found.**). No additional cracks were detected on the structure, including the underside surface (where the cracking had initiated) as well as the outboard attachment lugs.

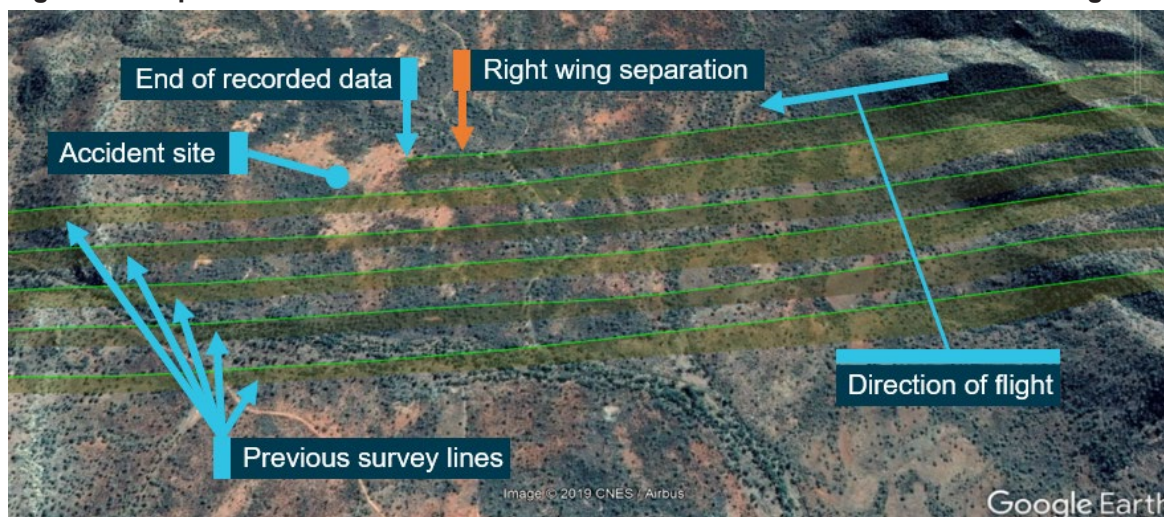
**Figure 25: Depiction of the recorded GPS data of the final moments of the accident flight**

The data showed that immediately prior to the in-flight breakup, the aircraft was in near level flight at a height of 193 ft AGL and a ground speed of 147 kt.

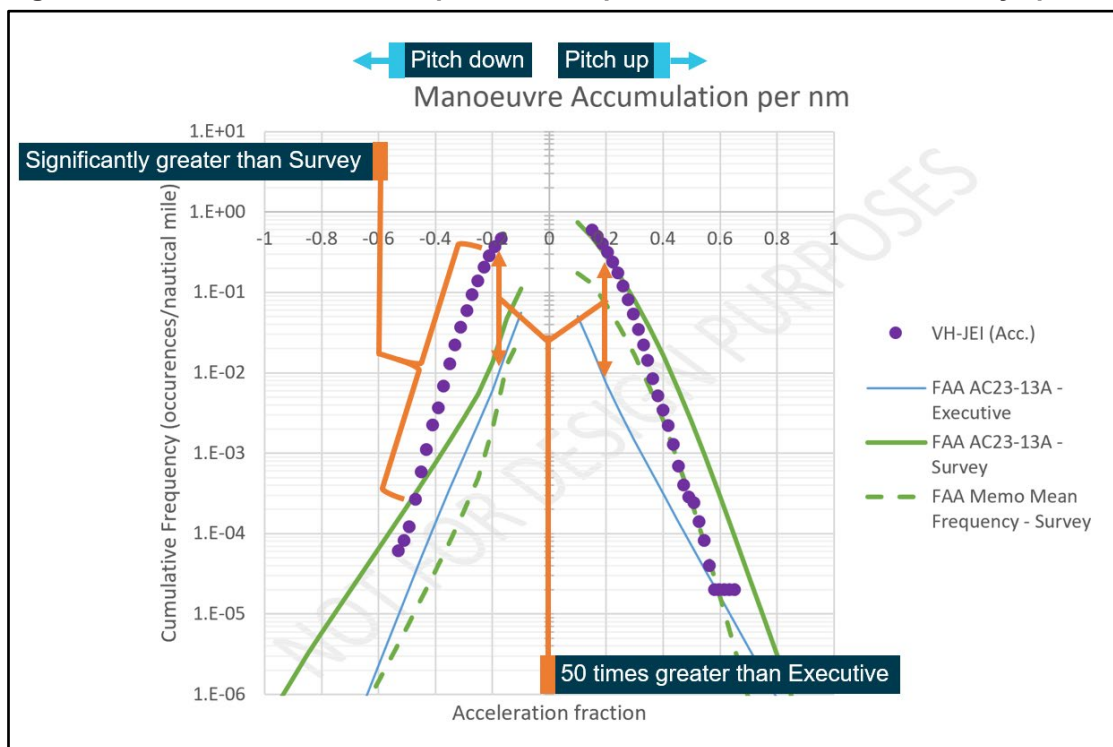
**Figure 26: Recorded manoeuvre spectrum compared with executive and survey spectra**

When assessed against the executive usage profile presented in AC 23-13A (Figure 27) the results showed that the aircraft exceeded usage assumptions for lighter pitch up manoeuvres and far outstripped pitch down manoeuvres. It was up to 50 times the rate for 0.5g pitch up and pitch down manoeuvres ( $\pm 0.2$  acceleration fractions<sup>16</sup>).

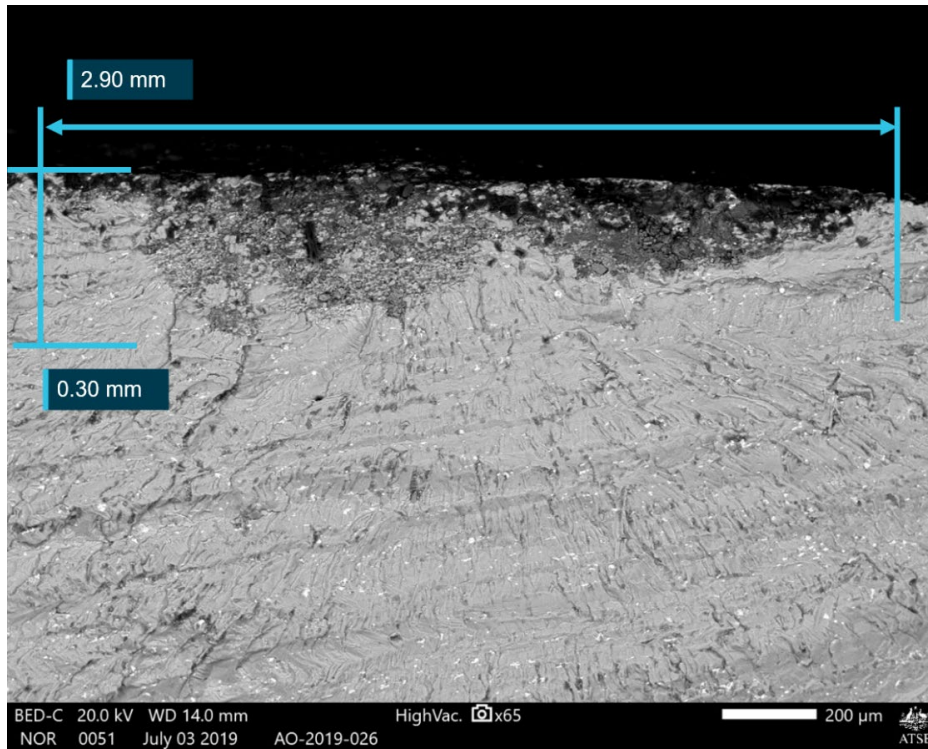
**Figure A2: Scanning electron microscopy (back-scattered image) of the fracture surface at the fatigue crack origin**

It was confirmed that the fatigue cracking initiated from a single corrosion pit cluster which then propagated through the structure from that location.  
Source: ATSB

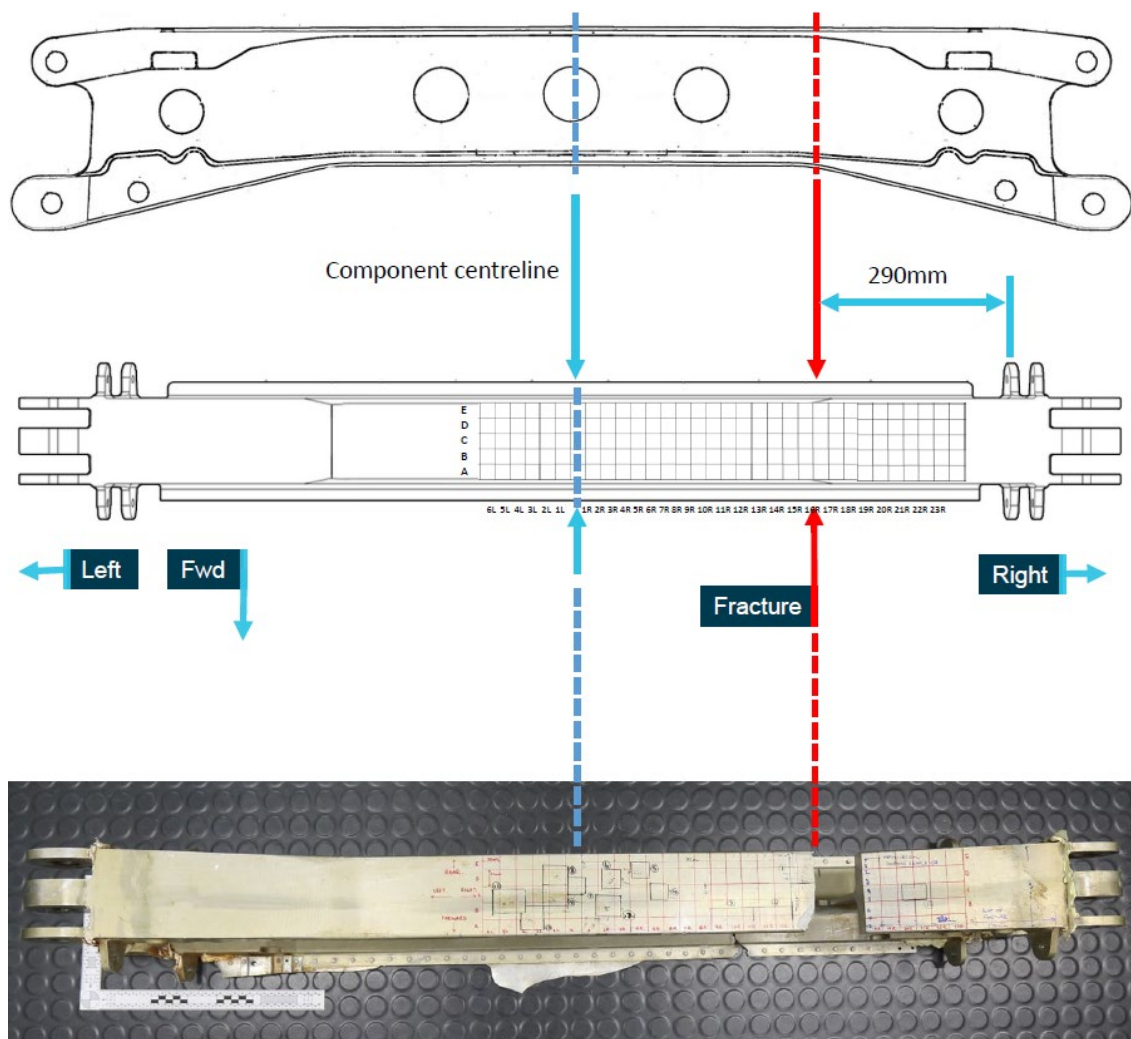
**Figure A9: Mapping out and measuring the corrosion damage on the underside surface of the carry-through**

Several pit clusters were selected for metallographic sectioning to determine the morphology of the corrosion damage. The cross-section demonstrated the invasive nature of the intergranular corrosion and how a network of fine sub-surface cracks is likely to have had metallurgical stress-raising effect on the initiation of fatigue cracking within the spar (Figures A10 to A12).

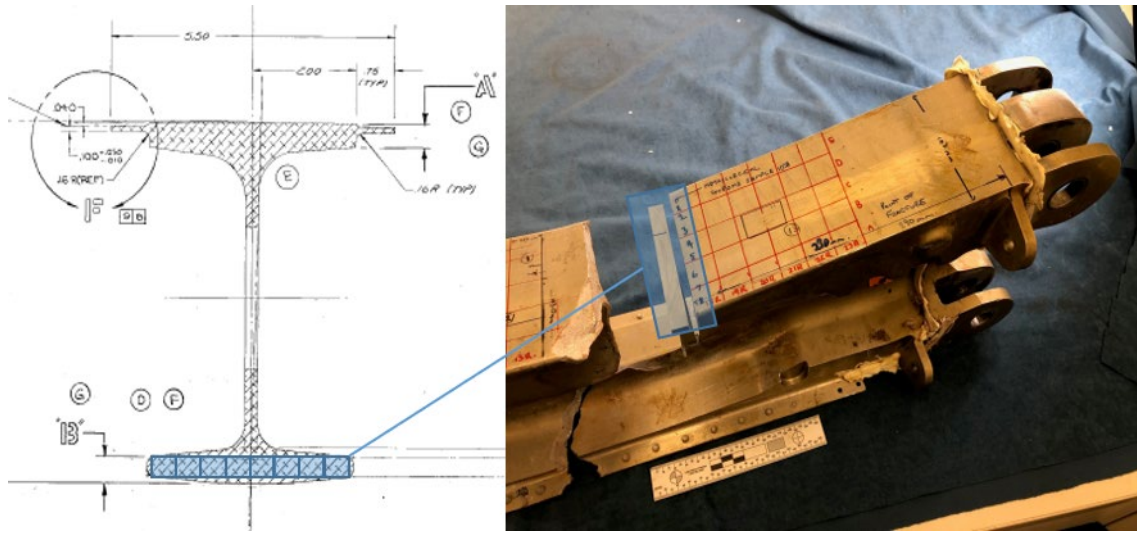
**Figure A13: The section of carry-through structure adjacent the fracture plane removed for hardness testing and chemical characterization**

Quantitative chemical analyses of metallurgical samples taken from the spar (Figure A13) was completed using Inductively Coupled Plasma-Optical Emission Spectroscopy. The results of the that testing are contained in Table A5 and are displayed as elemental weight percentage. The carry-through spar from VH-SUX was found to conform to the chemical composition for aluminium alloy 2014, as specified in QQ-A-367.
