In-flight break-up involving Cessna T210M, VH-SUX

25 km north-east of Mount Isa Airport, Queensland on 26 May 2019

ATSB Transport Safety Report

AO-2019-026

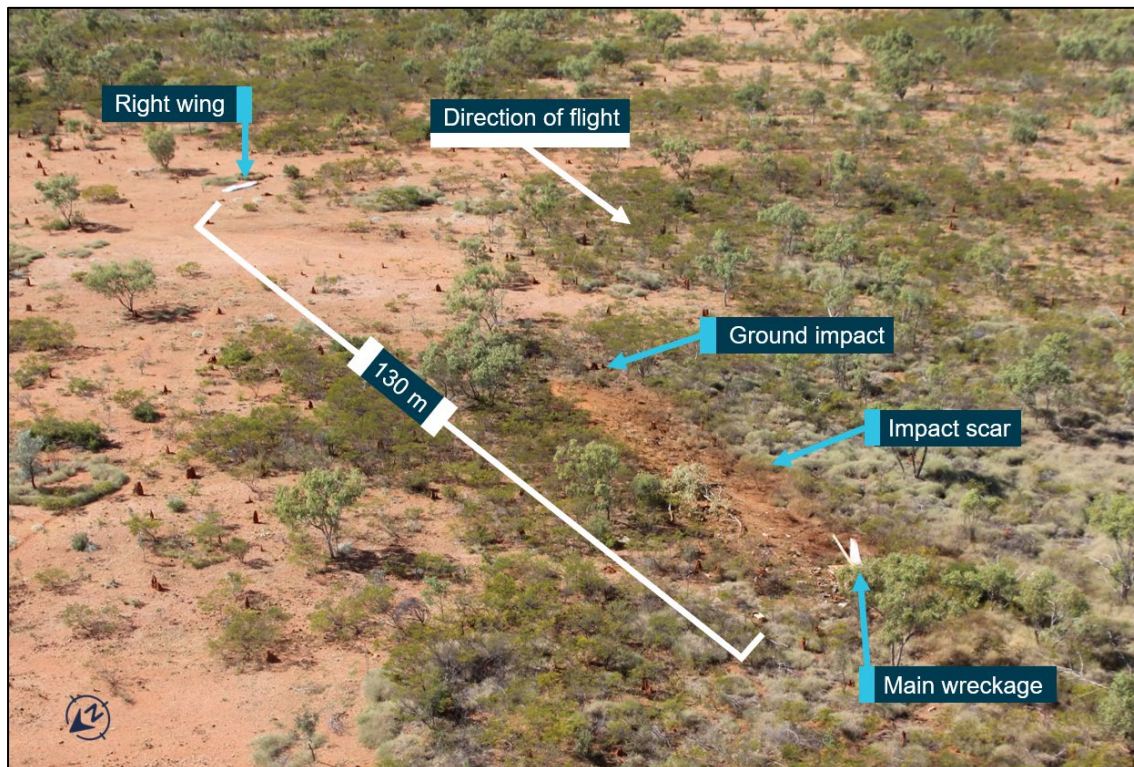
Figure 10: Accident site overview looking south-east

The accident site was located about 25 km north-east of Mount Isa Airport in flat, arid scrub land (Figure 10). The wreckage trail was on an approximate east to west heading, in line with the survey flight path. The right wing (Figure 11) was the first major component in the wreckage trail and was located about 130 m from the main wreckage. The aircraft impacted terrain about 90 m from the right wing, coming to rest a further 40 m away.

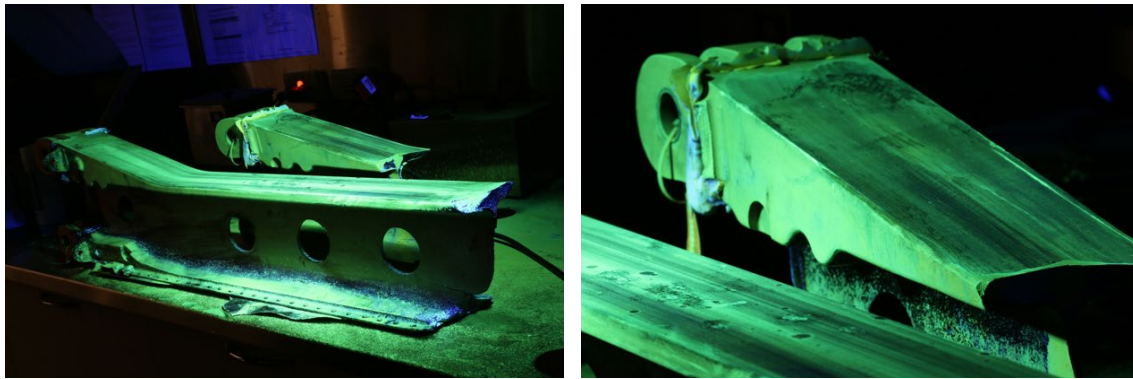
Figure 23: Composite image of the carry-through spar during liquid fluorescent penetrant inspection

Detailed visual inspection of the corrosion damage on the underside surfaces suggested there were no other secondary micro-cracks present in the structure. To confirm that visual assessment, a non-destructive examination of the spar structure was completed using fluorescent penetrant techniques (Figure 23). No additional cracks were detected on the structure, including the underside surface (where the cracking had initiated) as well as the outboard attachment lugs.

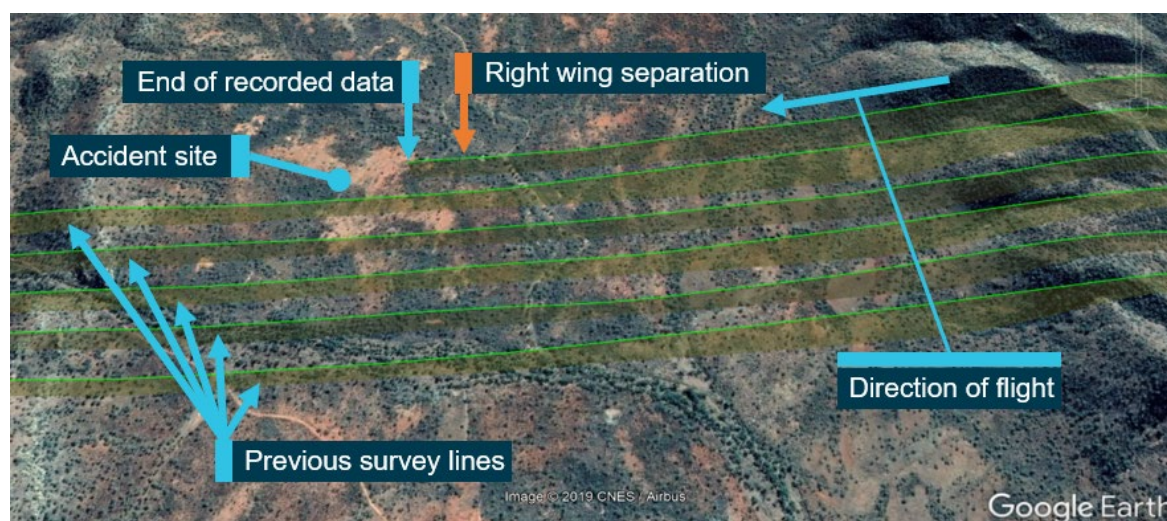
Figure 26: Depiction of the recorded GPS data of the final moments of the accident flight

The data showed that immediately prior to the in-flight breakup, the aircraft was in near level flight at a height of 193 ft AGL and a ground speed of 147 kt.

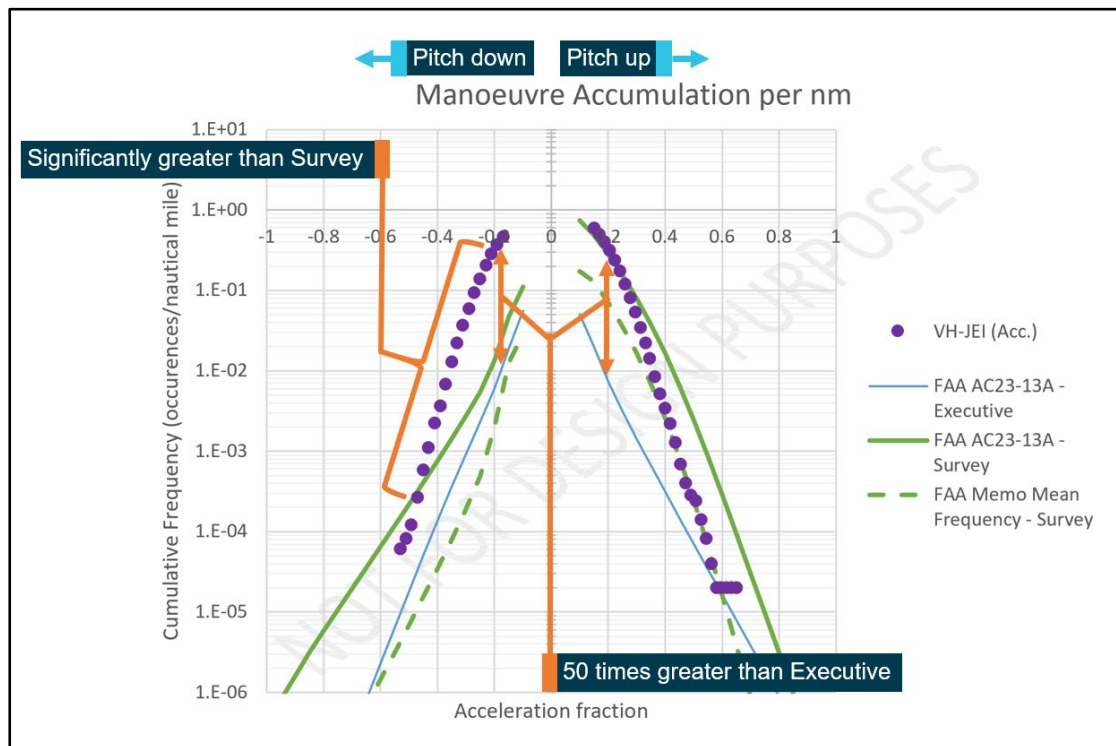
Figure 27: Recorded manoeuvre spectrum compared with executive and survey spectra

When assessed against the executive usage profile presented in AC 23-13A (Figure 27) the results showed that the aircraft exceeded usage assumptions for lighter pitch up manoeuvres and far outstripped pitch down manoeuvres. It was up to 50 times the rate for 0.5g pitch up and pitch down manoeuvres (± 0.2 acceleration fractions¹⁶).

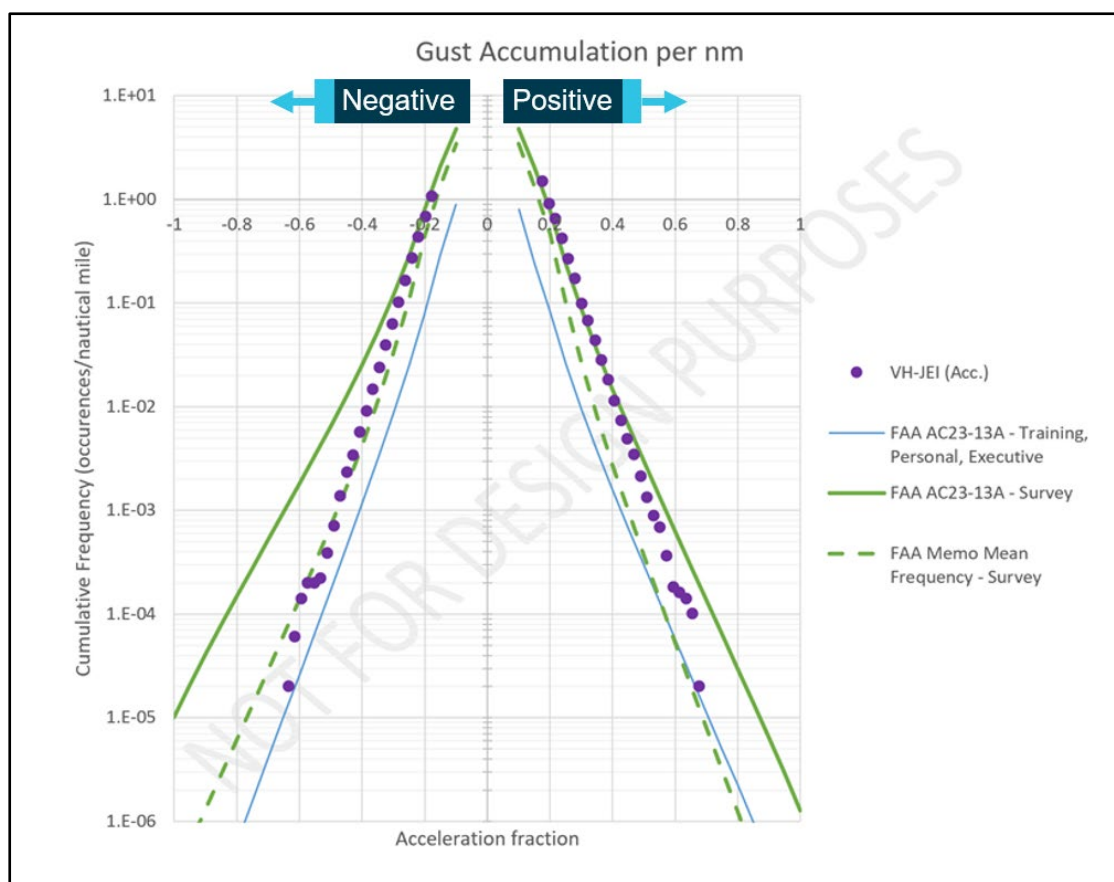
Figure 28: Recorded gust spectrum

When assessed against the survey usage profile presented in AC 23-12A (Figure 28), positive gusts were generally found to be slightly higher than the design criteria for light gust (<1.8g), reducing to slightly below design criteria for more severe positive gusts (>1.8g) though remaining well above mean frequency. This data was collected in late autumn and did not contain summer data that would be expected to include more turbulence,¹⁷ though this may be offset by winter data. For negative gusts, again the aircraft experienced light gusts around design criteria above +0.5g with the accumulation of more severe gust experiences dropping to about average by -0.5g and below average by -1.5g.

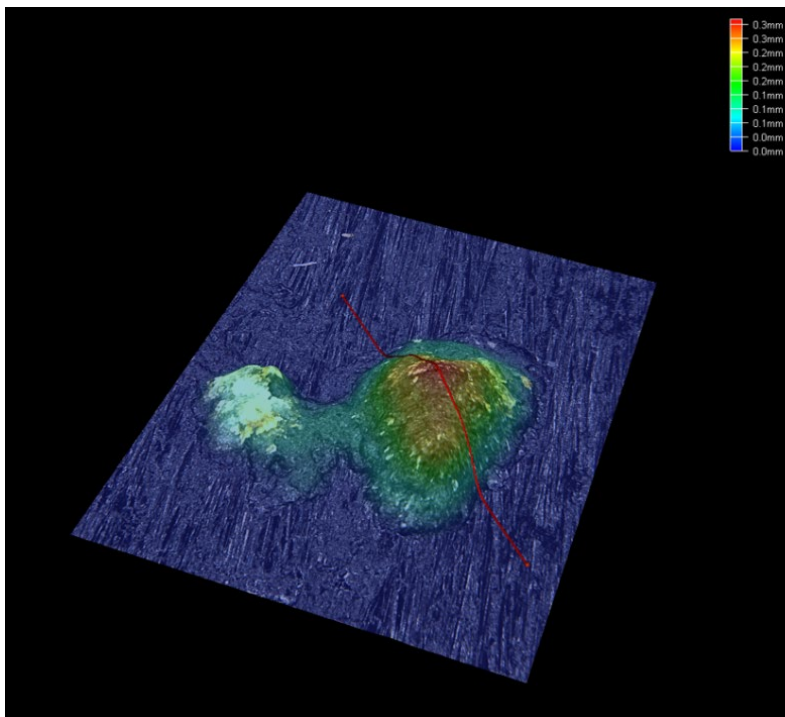
Figure A12: Depth map of a corrosion pit on the underside surface of the carry-through structure

The visual examination also identified that pitting corrosion damage had developed at multiple discrete locations along the underside surface of the spar (Figure 16). The corrosion damage was also identified adjacent to the fracture plane and confined to the underside surface with no evidence of corrosion on other parts of the structure.

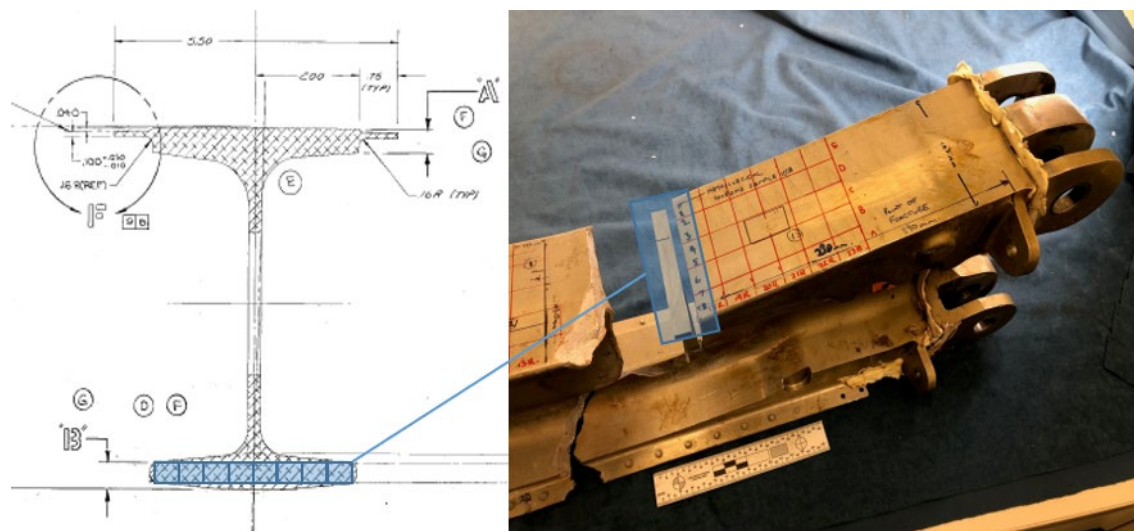
Figure A13: The section of carry-through structure adjacent the fracture plane removed for hardness testing and chemical characterization

Quantitative chemical analyses of metallurgical samples taken from the spar (Figure A13) was completed using Inductively Coupled Plasma-Optical Emission Spectroscopy. The results of the that testing are contained in Table A5 and are displayed as elemental weight percentage. The carry-through spar from VH-SUX was found to conform to the chemical composition for aluminium alloy 2014, as specified in QQ-A-367.
