# Flight below minimum safe altitude, Piper PA-31 Mojave, VH-XGW

Near Bankstown Airport, New South Wales, on 22 March 2021

ATSB Transport Safety Report Aviation Occurrence Investigation (Short) AO-2021-014 Final – 6 December 2021 Released in accordance with section 25 of the Transport Safety Investigation Act 2003

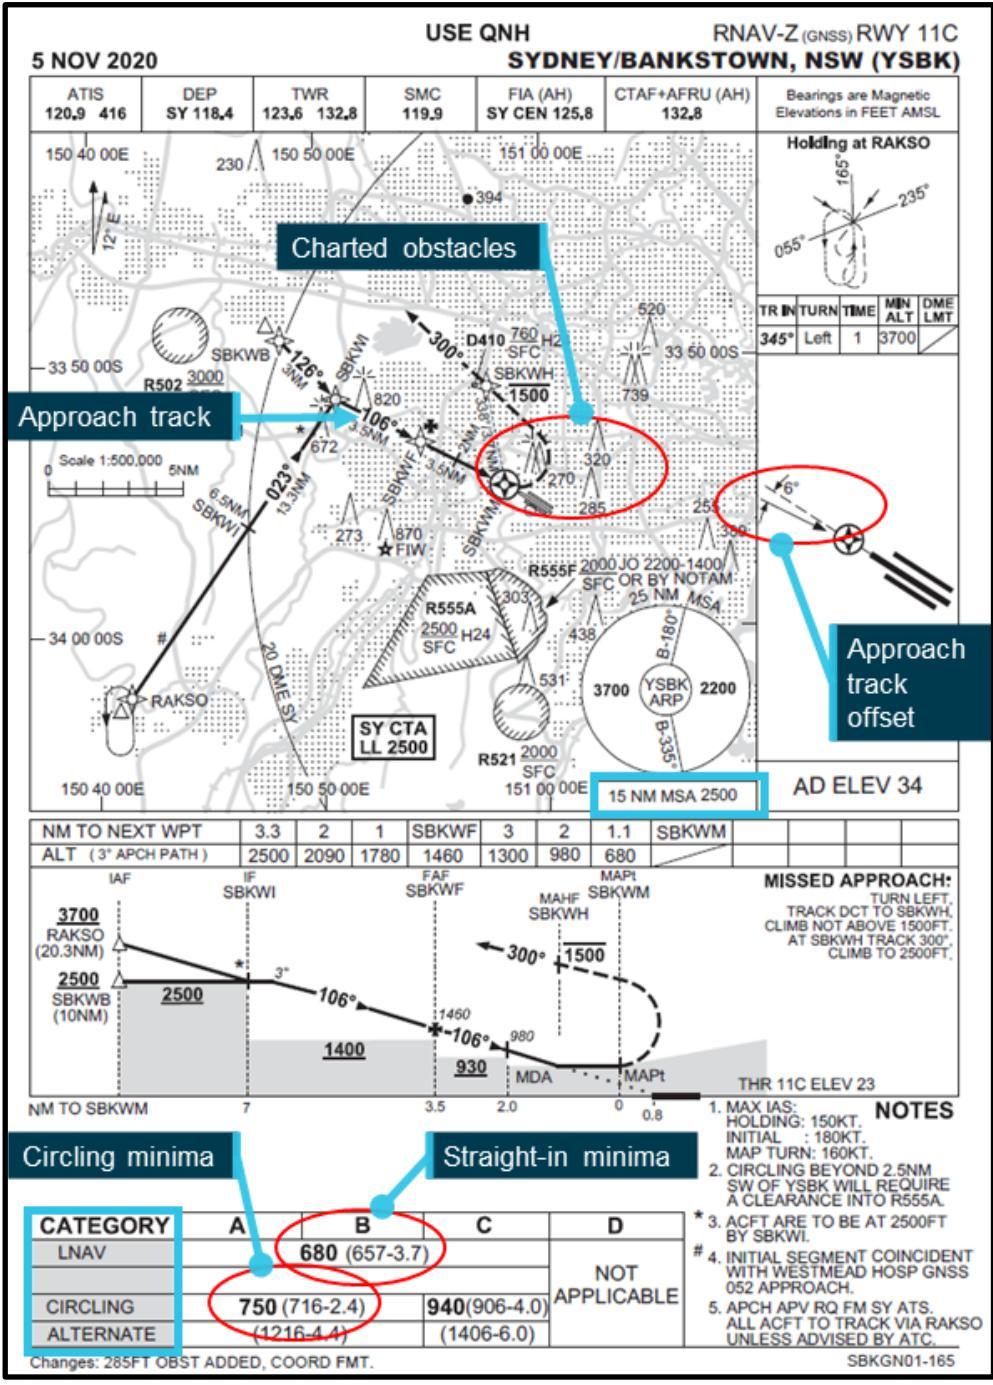
Figure 3: The RNAV-Z<sub>(GNSS)</sub>RWY 11C approach procedure chart

The RNAV-Z<sub>(GNSS)</sub>RWY11C approach procedure (Figure 3) is a non-precision approach (NPA) that uses GNSS signals for a 2-dimensional instrument approach procedure. The following features from the chart are relevant to the approach:

- for the straight-in approach, the minimum descent altitude (MDA) of 580 ft AMSL
- for the circling approach, the MDA of 650 ft AMSL.
- The plan profile of the chart identified several obstacles around the approach and missed approach track. The highlighted obstacles had the potential to directly affect the approach and/or missed approach flight paths when below the approach minima.<sup>11</sup>
- The minimum safe altitude within 15 NM of Bankstown Airport was 2,500 ft AMSL.

<sup>&</sup>lt;sup>11</sup> The approach minima indicate that the limiting obstacles for the straight-in and circling approaches are probably 334 ft for the straight-in approach and 355 ft AMSL for the circling approach.

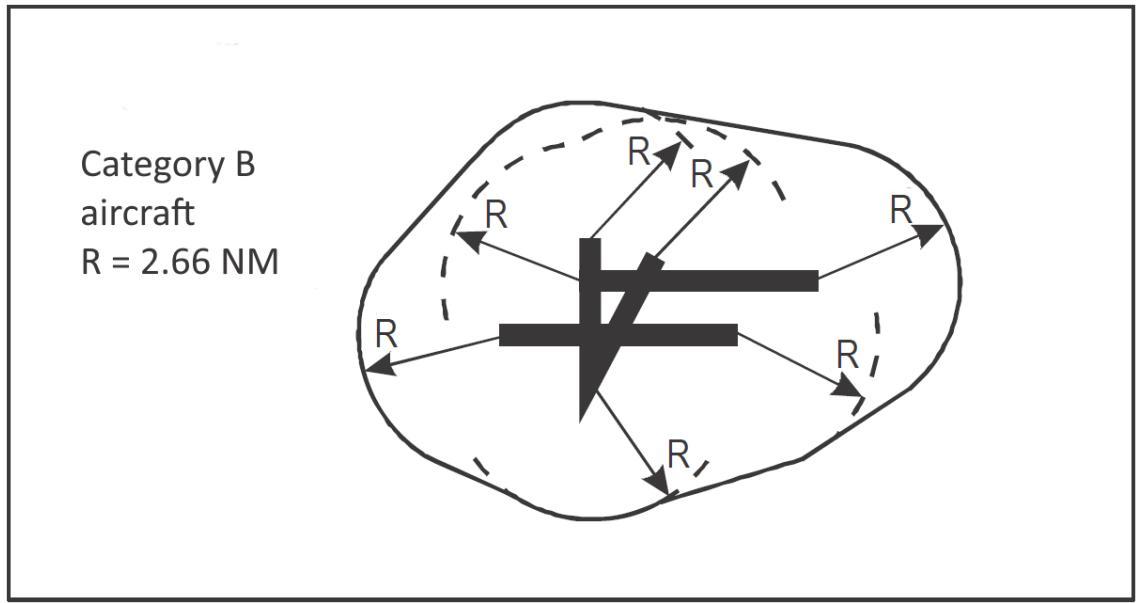
#### Figure 4: CAT B circling area construction

The required obstacle clearance for circling approaches is established by applying a radius distance, which is based on the aircraft's performance category, to the threshold of all runways usable by that category of aircraft. For a CAT B aircraft, that radius is 2.66 NM. Tangents are then drawn from the extremities of the arcs to complete the circling area (Figure 4). The circling minima is then determined by applying the required obstacle clearance value of 90 m, or approximately 300 ft, to the highest obstacle within that area.

The pilot also stated that at no time was the aircraft's barometric altimeter observed to go below 400 ft. However, with an accurate QNH set, that instrument measures height AMSL within defined accuracy tolerances. Consequently, operating at an altitude of 400 ft within the CAT C circling area for Bankstown Airport did not provide the required terrain clearance as it did not allow for the terrain elevation and obstacles.
