# Collision with terrain, Garlick Helicopters UH-1H, VH-HUE

24 km south-east of Talbingo, New South Wales, on 17 April 2018

Aviation Occurrence Investigation (Systemic)

AO-2018-031

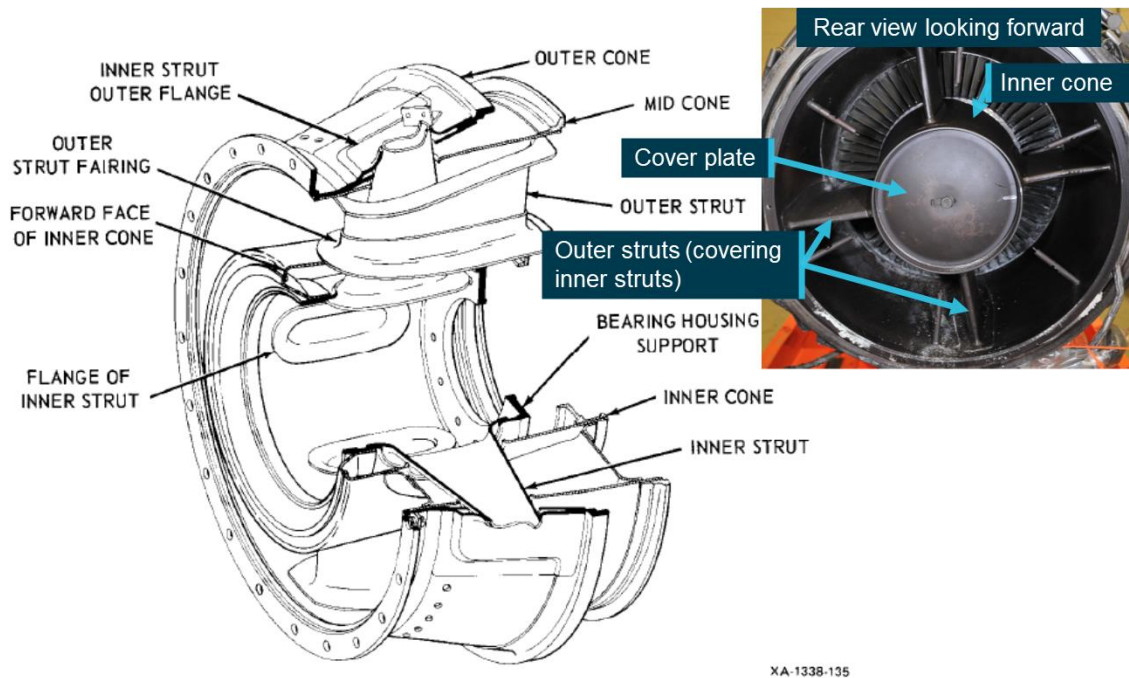
**Figure 9: Exhaust diffuser assembly schematic and photograph (inset)**

The engine was shipped to Honeywell's facilities in Phoenix, Arizona, in the US and underwent a teardown examination under the supervision of a representative from the US National Transportation Safety Board. The purpose of the examination was to identify the technical failure mechanism, or mechanisms of the engine failure. This included a detailed examination of the exhaust diffuser assembly illustrated in Figure 9.

The Honeywell engine teardown identified extensive fatigue cracking in the exhaust diffuser inner struts (Figure 10 inset). The inner struts were a critical engine component that supported the rear of the power turbine assembly through the number 3 and number 4 bearings (Figure 10). Note for reference that Figure 10 (inset) shows missing material in the exhaust diffuser inner cone also shown in Figure 8. Honeywell identified the location of the cracking for each of the four inner struts:

The analysis by Honeywell determined that the cracking in the inner struts resulted in the complete loss of structural integrity of the four struts. This led to the power turbine assembly moving rearward, indicated by the arrow labelled 'direction of PT movement' in Figure 10. The rearward movement was sufficient for the rear tapered section of the power turbine drive shaft (labelled 'PT drive shaft rear taper') to contact the adjacent rear shaft of the compressor assembly, highlighted in blue. Due to the compressor and turbine assemblies rotating in opposite directions, the contact resulted in considerable friction, and deformation of the rear compressor shaft. This led to the compressor assembly contacting the walls of the engine case.

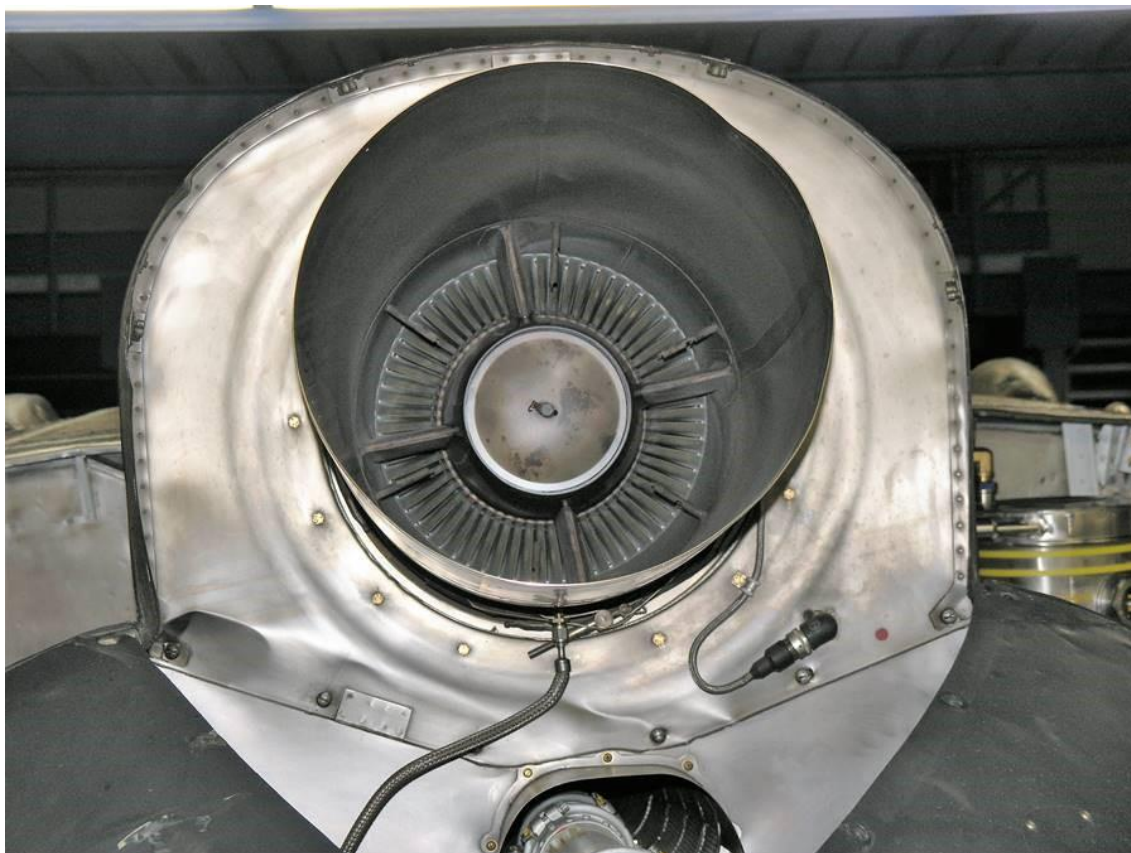
**Figure 11: Typical exhaust, showing accessibility for inspection**

The tailpipe and exhaust diffuser could be readily accessed via a ladder (Figure 11). Inspection of this area was typically carried out with the aid of a bright torch and mirror. A borescope could also be utilised if closer inspection was warranted.

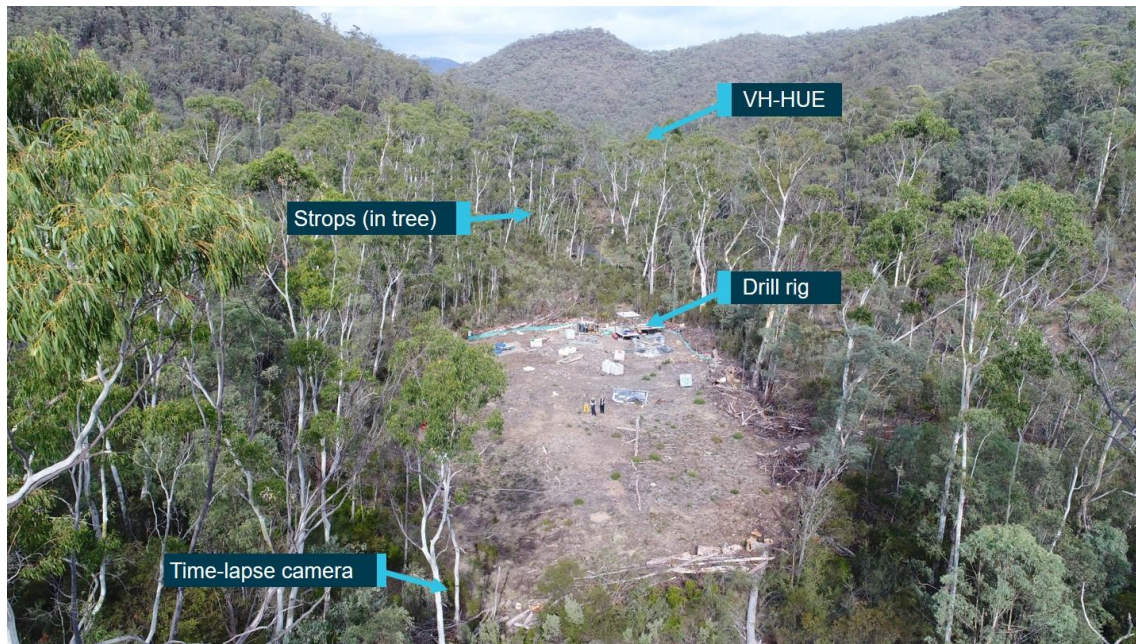
**Figure 12: Drill site looking in direction of flight**

The pilot reported that there were personnel working in and around the drill site when the helicopter was on approach to hook-up the load (the drill site also included a helipad). This was supported by time-lapse images from the drill site, which confirmed ground personnel moving in and around the drill site, including this approach. Consequently, when the engine failed, the pilot attempted to autorotate<sup>11</sup> the helicopter clear of the drill site and towards the river to keep clear of ground personnel. When asked where the pilot would have conducted the forced landing if the drill site was assured to be clear of personnel, the pilot reported that the drill site (Figure 12) would have been used. Figure 12 also shows the high trees and generally inhospitable terrain surrounding the drill site.

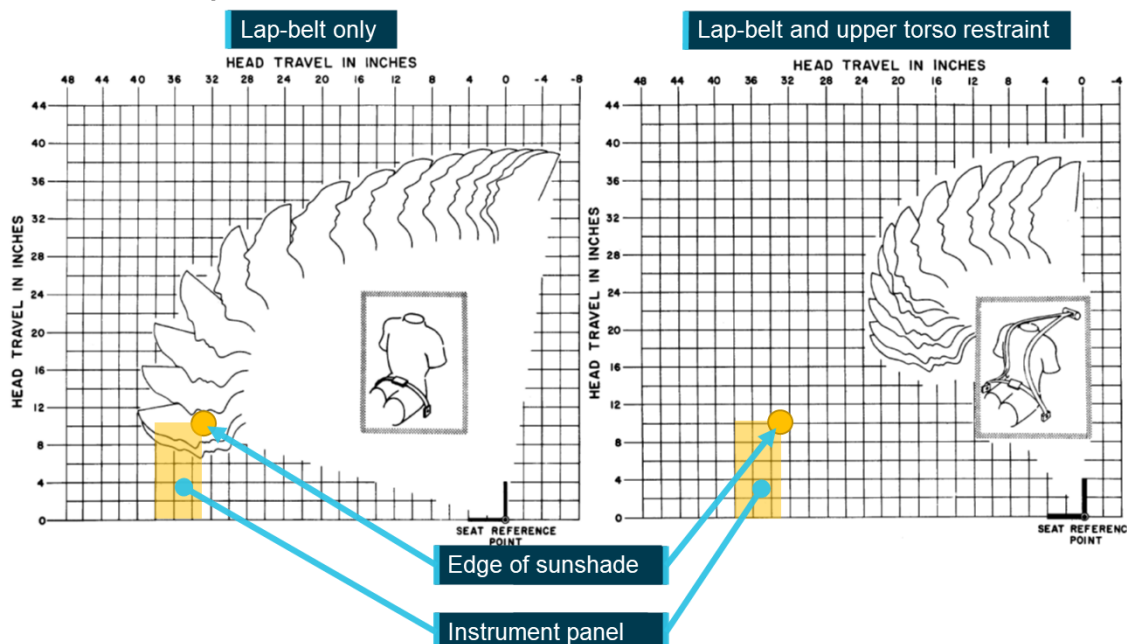
**Figure 17: Comparison of lap-belt and UTR effectiveness, with approximate location of HUE instrument panel and sunshade**

The left diagram of Figure 17 shows the empirical projections of the dummy wearing a lap-belt only (from Figure 4 of Young (1967)) intersecting the approximate location of the instrument panel and sunshade. In contrast, the right diagram shows considerable distance between all dummy projections and the instrument panel (Figure 11 of Young (1967)). These results were consistent with the instrument panel damage and injuries sustained by the pilot.
