Collision with water involving Cessna 182, VH-WNR

6 km north-west of Moreton Island, Queensland, on 22 January 2020

ATSB Transport Safety Report Aviation Occurrence Investigation (Defined) AO-2020-006 Final – 10 February 2022

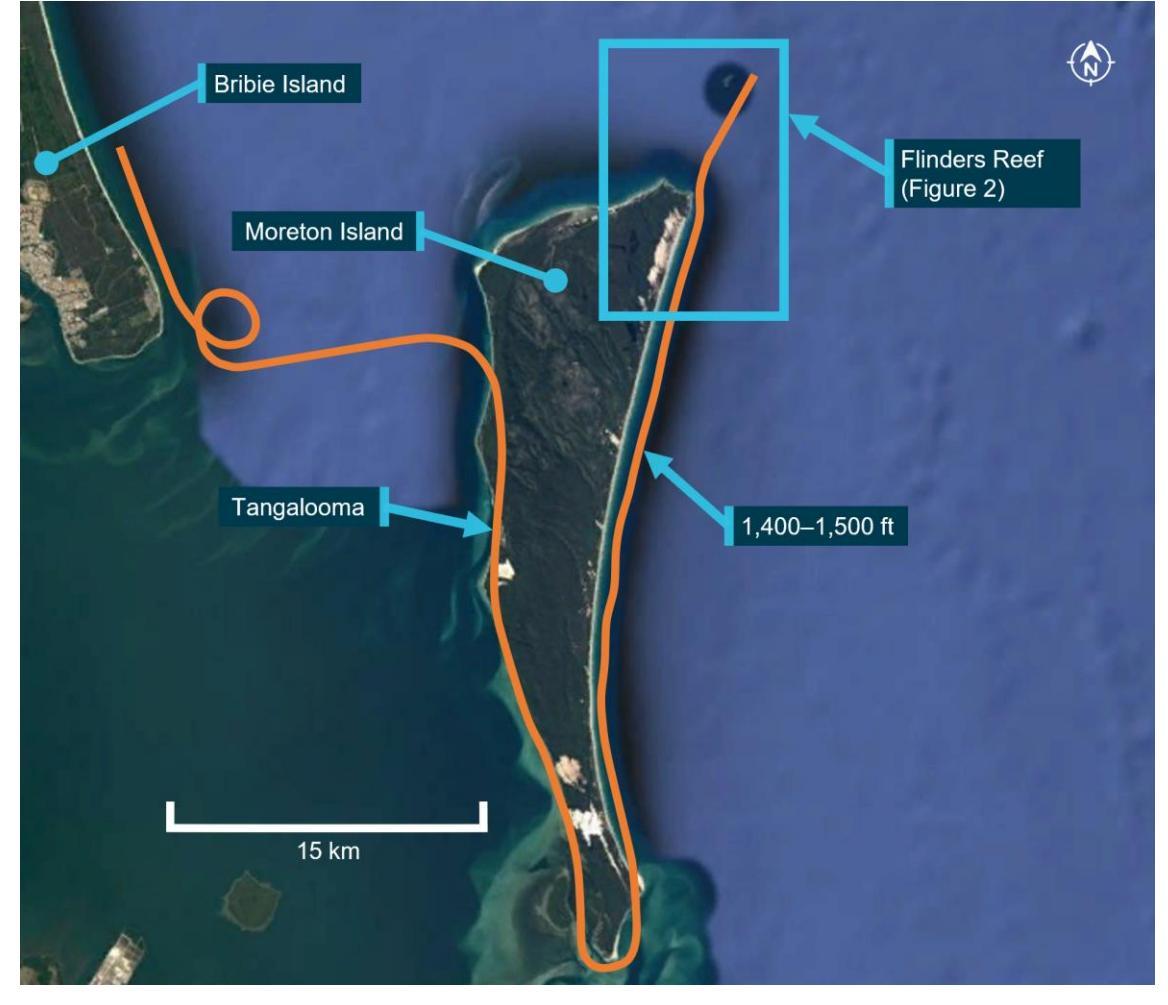
Recorded radar data at 5-second intervals indicated that, from about 1613, the aircraft flew north along Moreton Island's eastern coastline at 1,400–1,500 ft above mean sea level with a groundspeed of 100–110 kt (Figure 1). The wind was about 19 kt from the north-north-east, meaning the aircraft's airspeed would have been about 120–130 kt.

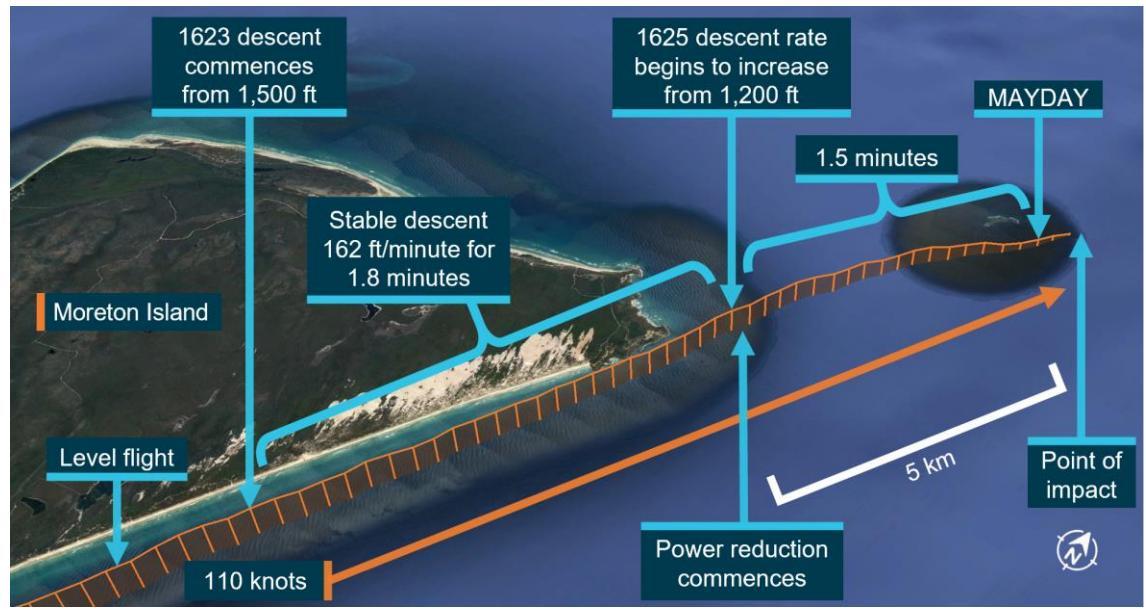
At 1623, the aircraft commenced a shallow descent (about 162 ft/min) from 1,500 ft. At 1625, the aircraft passed Cape Moreton at the northern tip of the island at about 1,300 ft and continued north-east towards Flinders Reef, at a similar airspeed and descent rate (Figure 2).

An aerial and marine search was immediately initiated. The aircraft was located on the ocean floor on 29 January 2020, north-east of Flinders Reef (Figure 2). The pilot and passenger were not located.

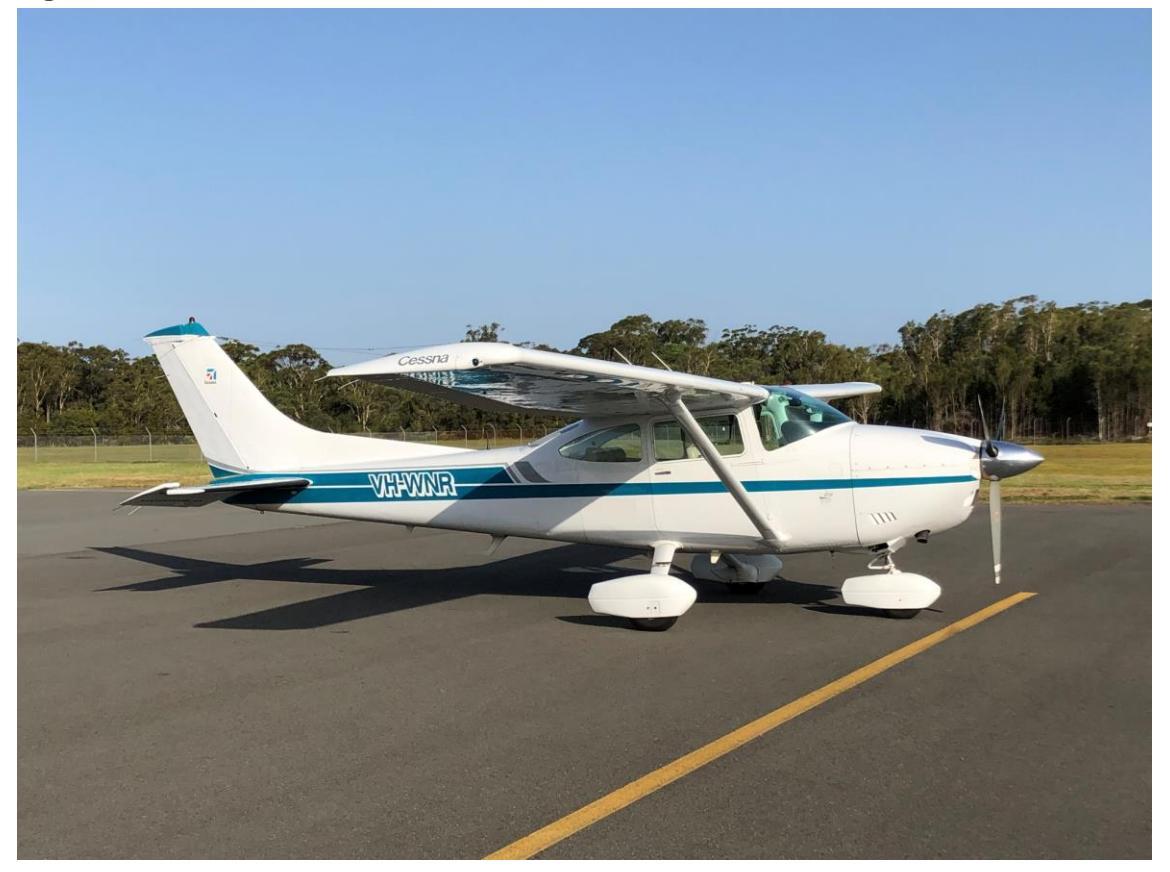
Figure 3: VH-WNR in 2019

VH-WNR (Figure 3) was manufactured in 1978 and was first registered in Australia in the same year. The aircraft was privately hired by the pilot for the flight.

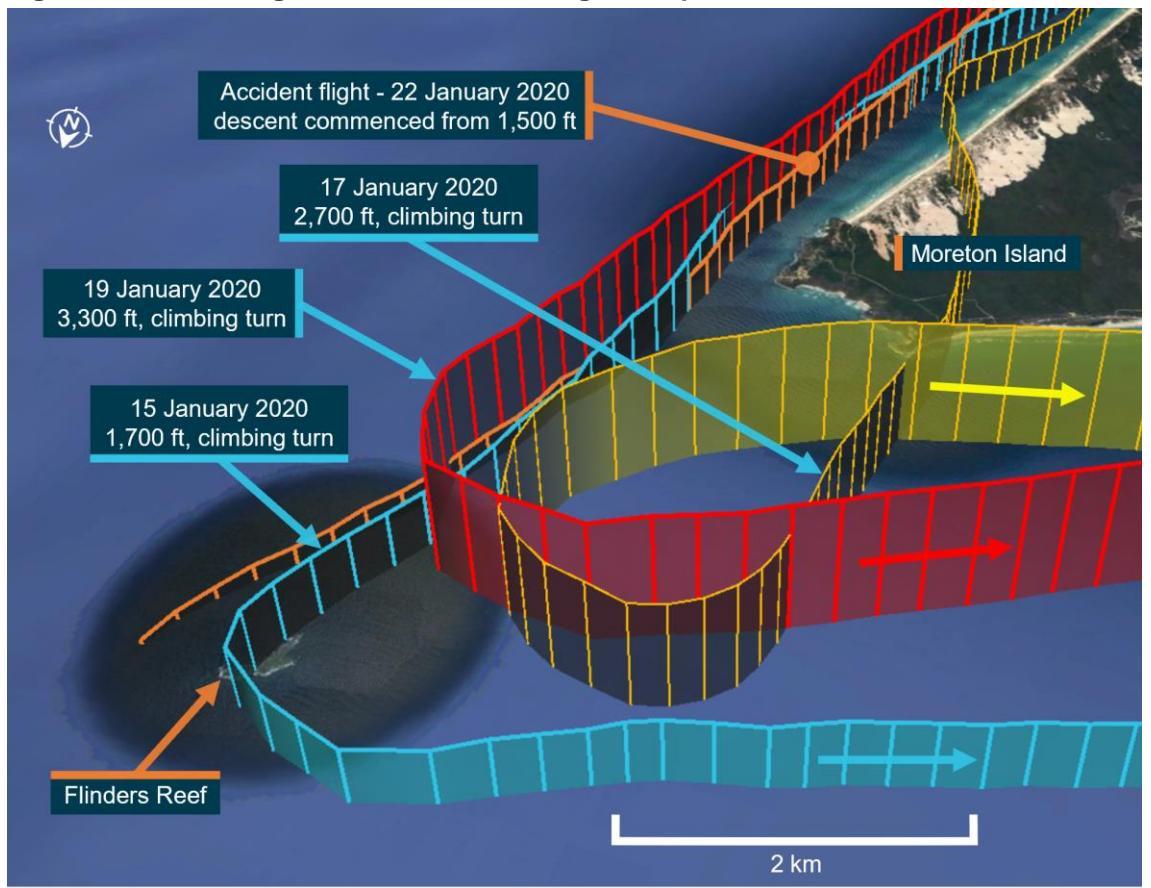
On the 15 January flight, the pilot transited between Bribie Island and Moreton Island at about 2,000 ft and 80–90 kt groundspeed. The flight profile was broadly similar to the accident flight past Cape Moreton towards Flinders Reef (Figure 8). On the return leg, the pilot flew from Flinders Reef direct to Bribie Island at about 1,800 ft.

ATSB analysis indicated that two segments of the 15 January flight, including between Moreton Island and Flinders Reef, were further from land than the aircraft was capable of gliding with no engine power. Although complete analysis of glide distances was not feasible, the ATSB estimated that the aircraft was also flown near or beyond the limits of its glide range to land on other flights in this area. During the accident flight on 22 January, the aircraft similarly reached a point further from glide distance to land about halfway between Moreton Island and Flinders Reef.

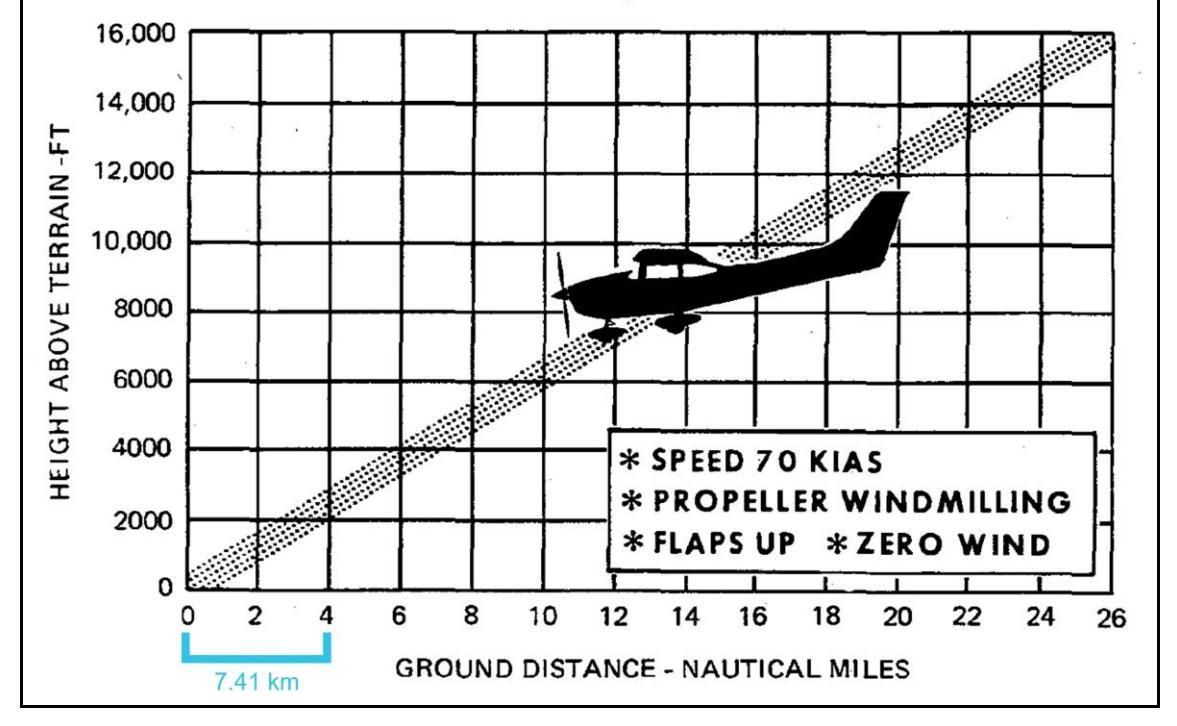
Figure 10: Cessna 182Q maximum glide distance chart

The POH for the Cessna 182Q contained an emergency procedure for an engine failure in flight. For this scenario, pilots were required to establish a best glide speed of 70 kt with the wing flaps retracted, and to identify a suitable landing area (Figure 10).
