VFR into IMC and controlled flight into terrain involving Pilatus Britten-Norman BN2A, VH-OBL

98 km west-south-west of Hobart Airport, Tasmania, on 8 December 2018

ATSB Transport Safety Report

AO-2018-078

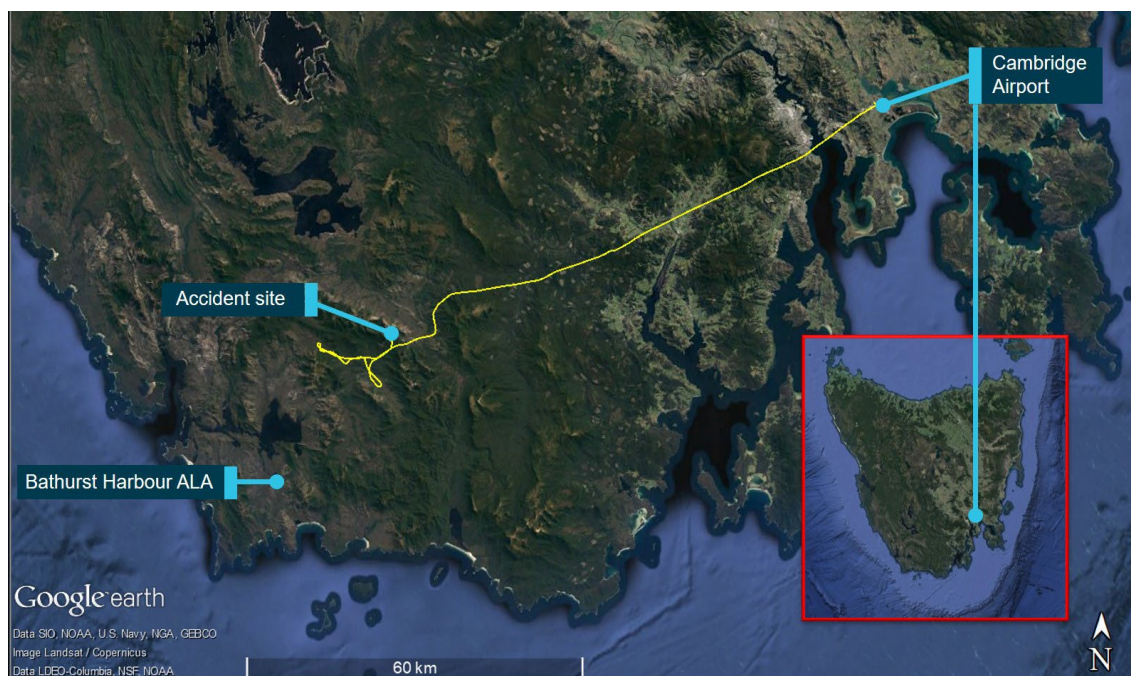
Figure 1: Track of VH-OBL from Cambridge Airport towards Bathurst Harbour, showing the accident location

Automatic dependent surveillance broadcast (ADS-B)³ position and altitude data (refer to the section titled *Recorded information*) showed the aircraft tracked to the south-west towards Bathurst Harbour (Figure 1). At about 0816, the aircraft approached a gap in the Arthur Range known as 'the portals'. The portals are a saddle (lowest area) between the Eastern and Western Arthur Range, and was an optional route that Airlines of Tasmania used between Cambridge and Bathurst Harbour when the cloud base prevented flight over the mountain range. After passing through the portals, the aircraft proceeded to conduct a number of turns below the height of the surrounding highest terrain. The final data point recorded was at about 0828.

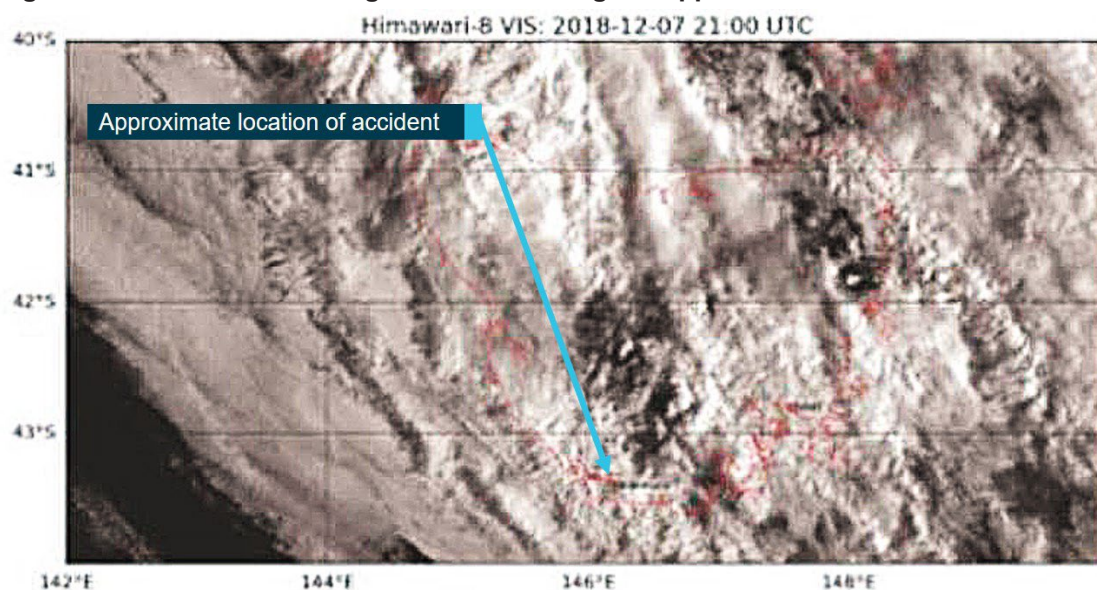
Figure 4: Visible satellite image at 0800 showing the approximate accident location

The satellite images showed that there was an 'extensive layer of middle and high cloud associated with the passage of the trough'. Similarly, high-resolution images also indicated the presence of low-level cloud in the area, including the accident location (Figure 4).

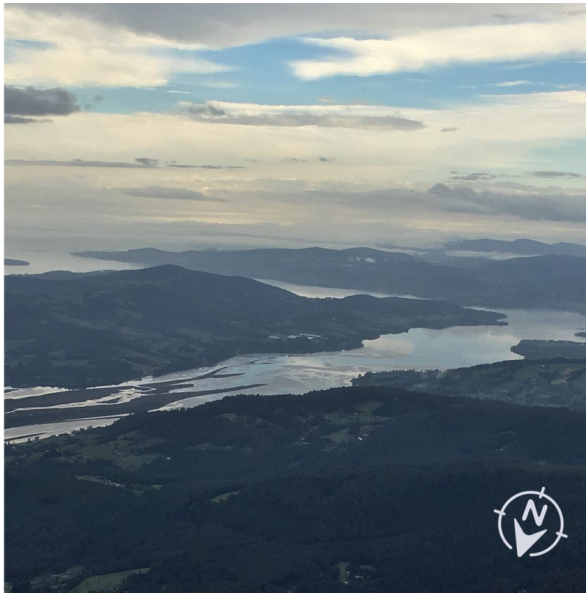
Figure 5: Photograph captured by the pilot as the aircraft passed near Huonville

Early in the accident flight, the pilot took a photograph as the aircraft passed near Huonville (about 40 NM (74 km) south-west of Cambridge Airport) and sent this to a colleague. Another company pilot viewed the photograph and reported that there was a 'little bit of low-lying stratus cloud around, but it was blue skies' (Figure 5).

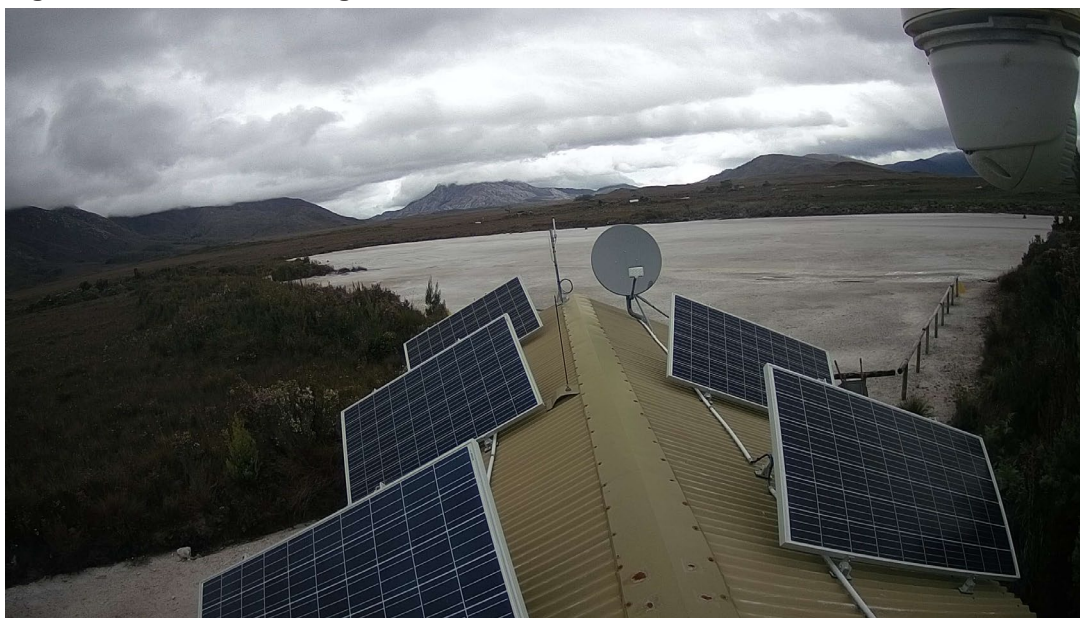
Figure 7: Web camera image from Bathurst Harbour

Following the accident, the chief pilot accessed the cameras and recorded a number of images. The images during the earlier part of the day were not saved by the camera. Figure 7 was taken from the south facing camera at 1020 on 8 December 2018, looking out toward the landing area.

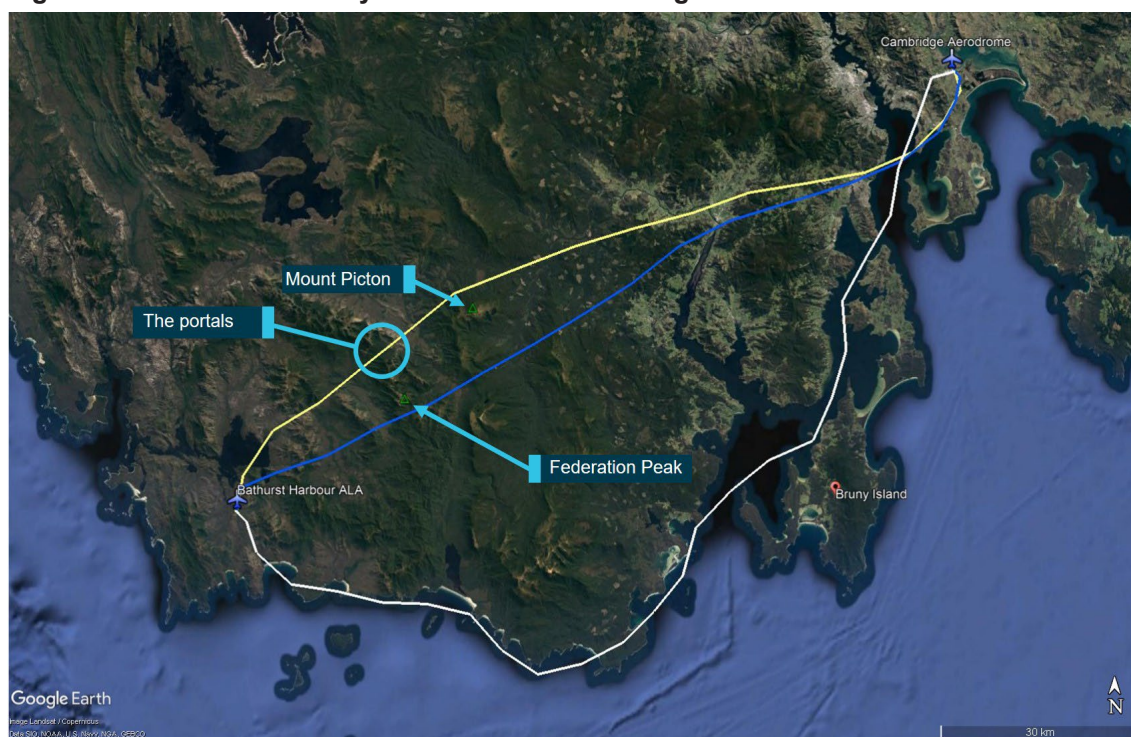
Figure 11: Routes commonly used between Cambridge and Bathurst Harbour

- The 'direct' route was approximately on a straight line between Cambridge and Bathurst Harbour. This route was a distance of about 68 NM (126 km) and about 30 minutes in duration. When the weather was fine, with a high cloud base, the route was south of Mount Picton and Federation Peak. However, in lower cloud conditions, the route passed north of Mount Picton and then through 'the portals' gap between the Western and Eastern Arthur Range.
- The 'coastal route' was about 90 NM (167 km) and about 40 minutes duration. The route tracked south from Cambridge, past Bruny Island and then along the southern coastline to Bathurst Harbour.

As discussed above, the portal route was used in lower cloud conditions. The operator advised, that, while a diversion or turn back could be made at any point in the flight, it was noted by the ATSB that the portals were considered to be a critical location on the route, due to the surrounding mountainous terrain. In discussion with the chief pilot, and a number of other company pilots who regularly flew to the south-west, the general procedure was to approach the portals at a safe altitude no lower than 500 ft AGL. The pilots were directed to pass to the west of Mt Picton (Figure 11) to allow sufficient room to manoeuvre for a turnback if required. If the pilot could maintain visual contact with Bathurst Harbour (the water) the flight could proceed through the portals. If visual contact was unable to be established or maintained, the pilot was to divert to Bathurst Harbour via the coastal route. It was also reported that there was an emphasis on always having an 'escape' route.
